AC Inspection as Found

Tokai Carbon
3931 Carbon Plant Road
Ozark, AR 72949

AC Inspection - Rev. 2

Location: MOTOR SHOP LR
Serial Number: 8004
Description: 40/10HP WESTINGHOUSE
1800/900RPM 326T

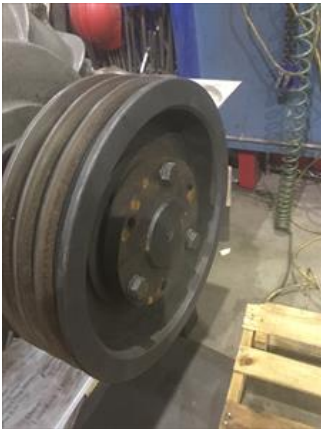
4. Describe the Overall Condition of the Equipment as Received
Serviceable.

5. Distance from the end of the shaft to the Coupling/Sheave
3/16 s.o.

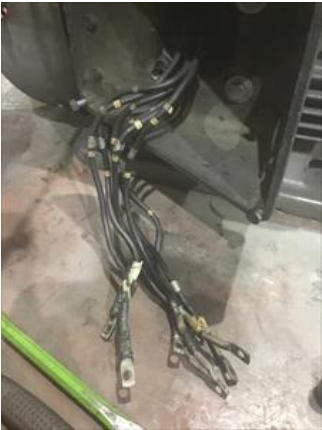
●	11. Lead Condition	(P) Pass	P55
■	#1,2,3. 4,5,6

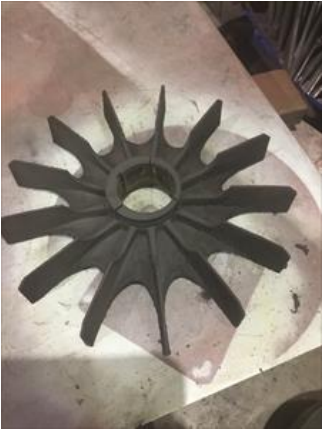
12. Lead Length	15 Inches	
	13. Frame Condition	pass	
●	14. Fan Condition	(P) Pass	P94

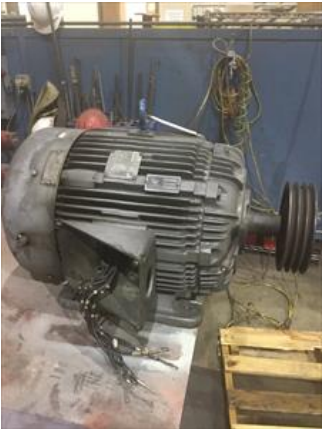
15. Broken or Missing Components	top connection box cover missing	P98

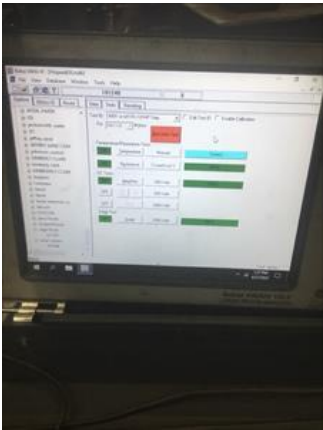
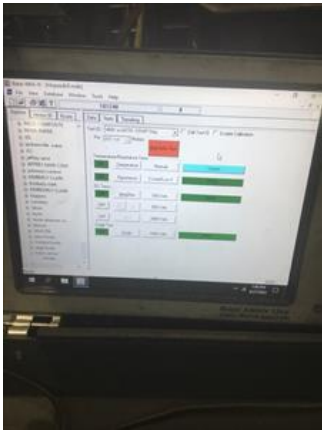
17. Winding Resistance	1-2	1-3	2-3	
18. Perform Surge Test				(P) Pass P57
<div>

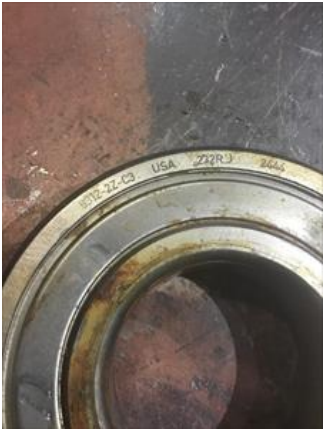
23. Drive End Bearing Brand				fag
24. Drive End Bearing Number-				P32
<div>

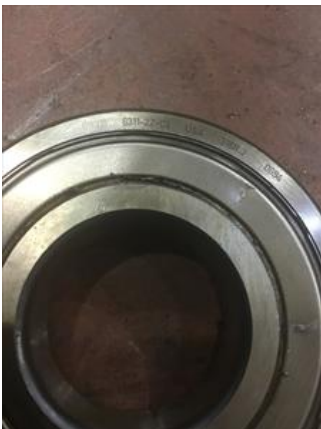
32. Opposite Drive End Bearing Number-

6311

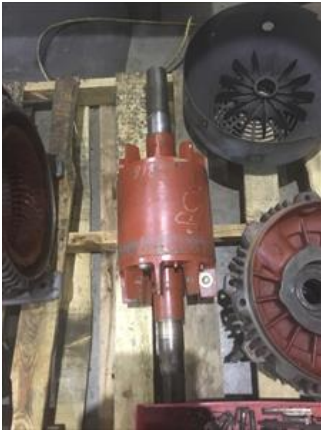
41. Rotor Type/Material	(Squirrel Aluminum) Squirrel Cage Aluminum Die Cast	P3
-------------------------	--	----
