AC Inspection as Found

Tokai Carbon
3931 Carbon Plant Road
Ozark, AR 72949

AC Inspection - Rev. 2

Description: 40/10HP WESTINGHOUSE
1800/900RPM 326T

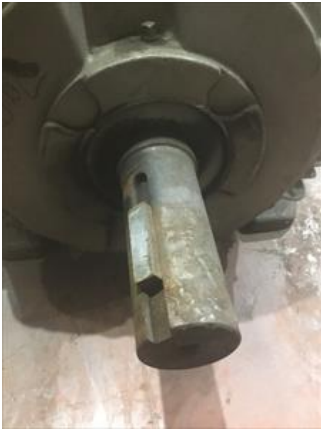
7. Does Shaft Have Visible Damage?

(No) No

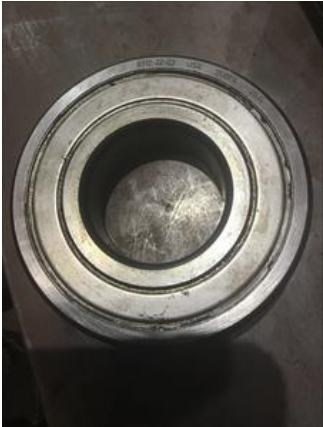
19.	Number of Stator Slots		
20.	Stator Condition		
21.	Stator Thermistors/Ohms		
22.	Stator Overloads/Ohms		
Mechanical Inspection			
23.	Drive End Bearing Brand	FAG	
24.	Drive End Bearing Number-	6312	P32

25.	Drive End Bearing Qty.	1	
26.	Drive End Bearing Type	(Ball) Ball Bearing	
27.	Drive End Lubrication Type	(Grease) Grease Lubricated	
28.	Drive End Bearing Insulation or Grounding Device?	none	
29.	Drive End Wavy Washer/Snap-Ring Other Retention Device?	none	
30.	Drive End Bearing Condition	replace	
31.	Opposite Drive End Bearing Brand	FAG

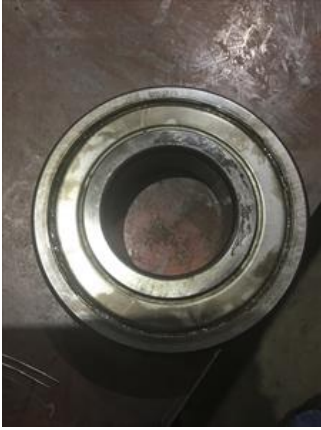
33. Opposite Drive End Bearing Qty.	1
34. Opposite Drive End Bearing Type	(Ball) Ball Bearing
35. Opposite Drive End Lubrication Type	(Grease) Grease Lubricated
36. Opposite Drive End Bearing Insulation or Grounding Device?	none
37. Opposite Drive End Wavy Washer/Snap-Ring Other Retention Device?	none
38. Opposite Drive End Bearing Condition	replace
39. Drive End Seal	none
40. Opposite Drive End Seal	none

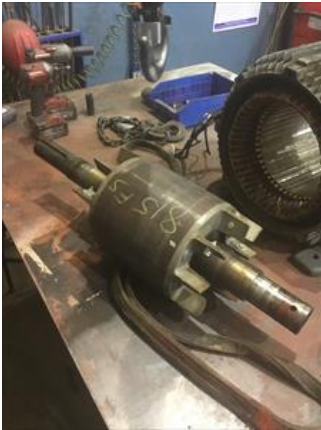
41. Rotor Type/Material	(Squirrel Aluminum) Squirrel Cage Aluminum Die Cast
-------------------------	--

42. Growler Test	
43. Number of Rotor Bars	
44. Rotor Condition	
45. List the Parts needed for the Repair Below	
6312 & 6311 sleeves for both housing fits. Rewind stator, and hand Polish both shaft fits.	
46. Signature of Technician that Disassembled Motor	Terrence Holland
