AC Inspection as Found

Flywheel Energy (12096)

AC Inspection - Rev. 2

Description: 20HP TECO 1800RPM 256T

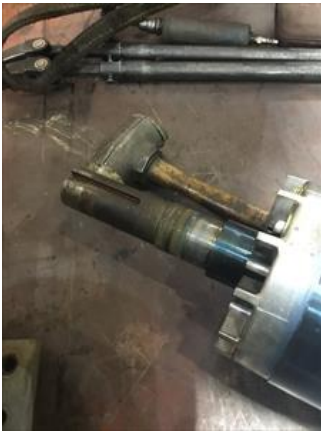
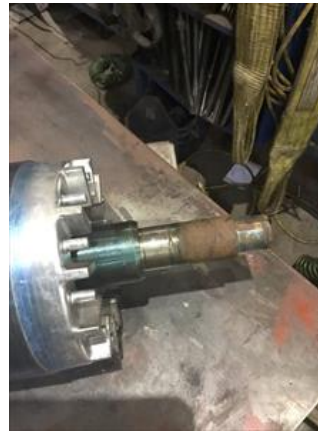
5. Does Shaft Turn Freely? (Yes) Yes
6. Does Shaft Have Visible Damage? (No) No P20

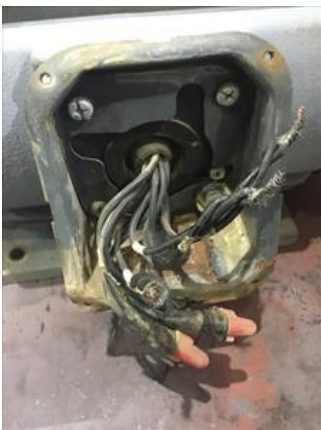
10. Lead Condition (P) Pass P55

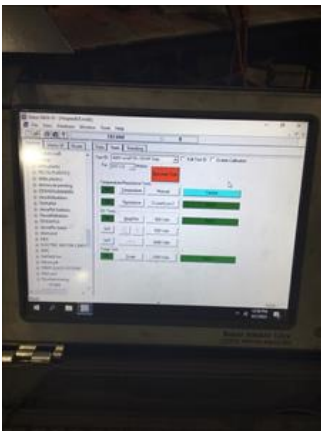
17. Perform Surge Test

(P) Pass

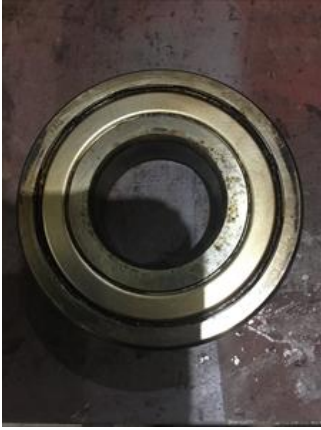
22. Drive End Bearing Brand

Fag

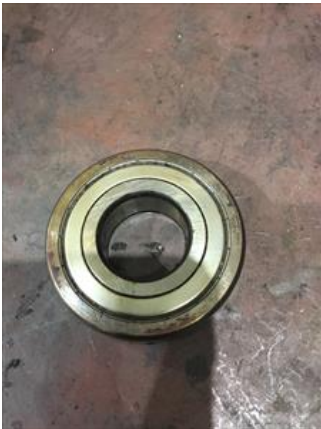
24. Drive End Bearing Qty.	1
25. Drive End Bearing Type	(Ball) Ball Bearing
26. Drive End Lubrication Type	(Grease) Grease Lubricated
27. Drive End Bearing Insulation or Grounding Device?	none
28. Drive End Wavy Washer/Snap-Ring Other Retention Device?	none
29. Drive End Bearing Condition	replace
30. Opposite Drive End Bearing Brand	
31. Opposite Drive End Bearing Number-	6307

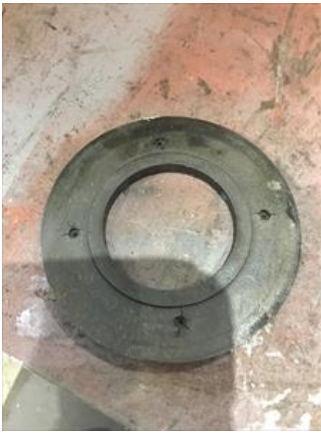
32. Opposite Drive End Bearing Qty.	1
33. Opposite Drive End Bearing Type	(Ball) Ball Bearing
34. Opposite Drive End Lubrication Type	(Grease) Grease Lubricated
35. Opposite Drive End Bearing Insulation or Grounding Device?	none
36. Opposite Drive End Wavy Washer/Snap-Ring Other Retention Device?	wavy washer
37. Opposite Drive End Bearing Condition	replace
38. Drive End Seal

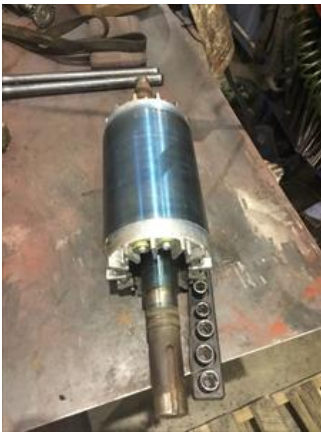
40. Rotor Type/Material

(Squirrel Aluminum) Squirrel
Cage Aluminum Die Cast
