## AC Inspection as Found

Dassault Falcon Jet (11751)

### AC Inspection - Rev. 2

Description: 30HP BALDOR 3600RPM 286TS

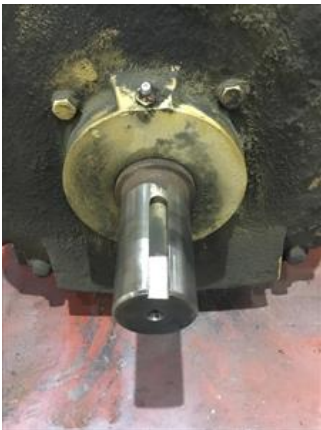
| 6. Does Shaft Have Visible Damage? | (No) No | P20 |

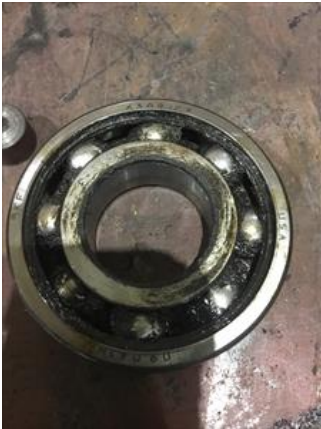
37. Opposite Drive End Bearing Condition

replace

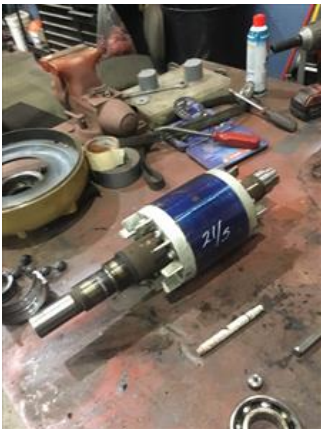
43. Rotor Condition

D.E shaft fit worn

*Machine ODE housing, & d.e. bearing journal.*

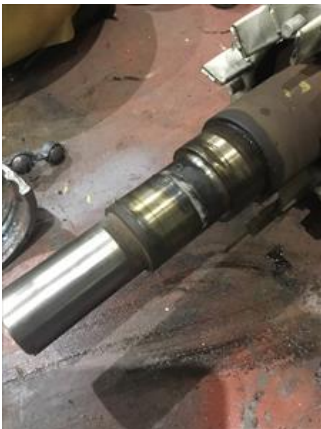
*Bearing was welded to the shaft.*

51. Drive End Bearing Shaft Fit Condition

**(F) Fail**

60.	End Bell Air Seal Fits	
	Drive End Air Seal                      Opposite Drive End Air Seal	
61.	List Machine Work Needed Below <i>ODE housing fit &amp; DE shaft bearing fit.</i>
