AC Inspection as Found

Flywheel Energy (12096)

Description: 15HP EMERSON 1800RPM 254T

Hi-Speed Job Number: 101504

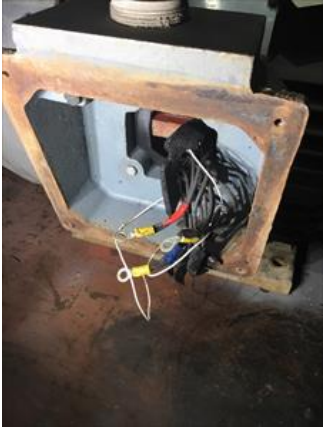
11. Lead Condition	(P) Pass	P55

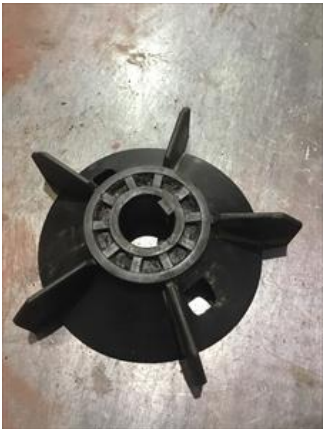
12. Lead Length	6 Inches	
13. Frame Condition	pass	
14. Fan Condition	(P) Pass	P94

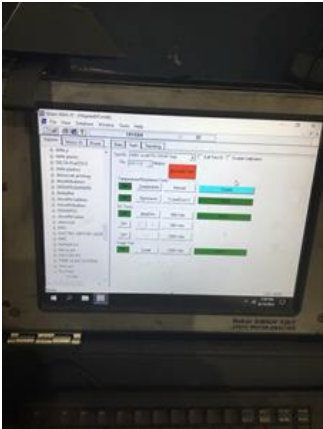
18. Perform Surge Test	(P) Pass	P57
------------------------	----------	-----

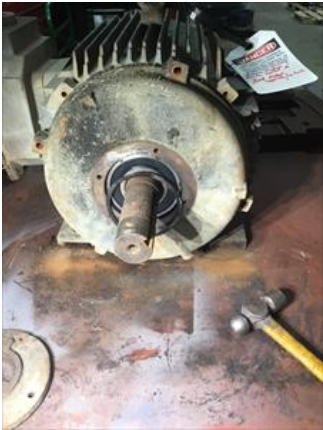
23.	Drive End Bearing Brand		
24.	Drive End Bearing Number-	6309	
25.	Drive End Bearing Qty.	1	
26.	Drive End Bearing Type	(Ball) Ball Bearing	
27.	Drive End Lubrication Type	(Grease) Grease Lubricated	
28.	Drive End Bearing Insulation or Grounding Device?	none	
29.	Drive End Wavy Washer/Snap-Ring Other Retention Device?	yes	P73

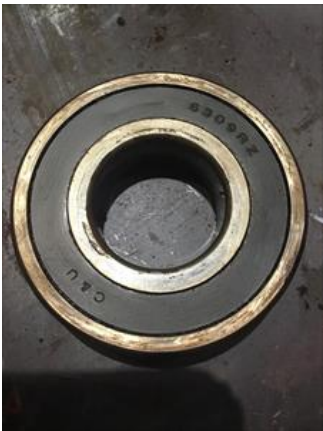
30.	Drive End Bearing Condition	replace	
31.	Opposite Drive End Bearing Brand	C & U	P86

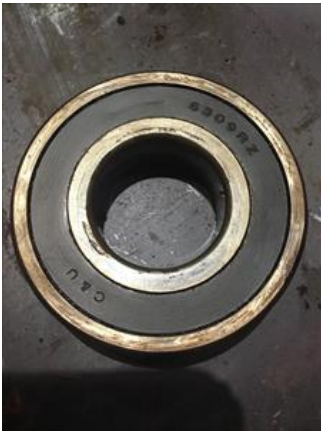
32.	Opposite Drive End Bearing Number-	6309RZ	
33.	Opposite Drive End Bearing Qty.	1	
34.	Opposite Drive End Bearing Type	(Ball) Ball Bearing	P93

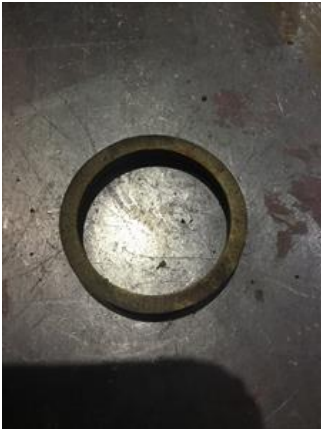
| 38. Opposite Drive End Bearing Condition | replace |
| 40. Opposite Drive End Seal | P102 |
