AC Inspection as Found

AC Inspection - Rev. 2

Location: MOTOR SHOP LR

Description: 15HP BALDOR 1800RPM 254TC

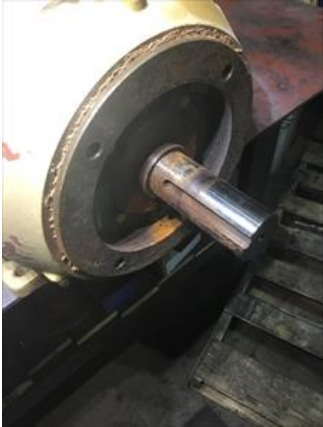
7.	Does Shaft Have Visible Damage?	(No) No	P20

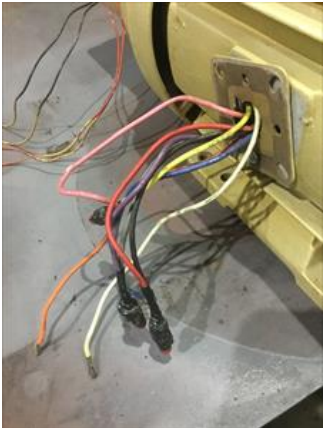
8.	Assembled Shaft Runout		
9.	Assembled Shaft End Play		
10.	Air Gap Variation <10%		
● 11.	Lead Condition	(P) Pass	P55

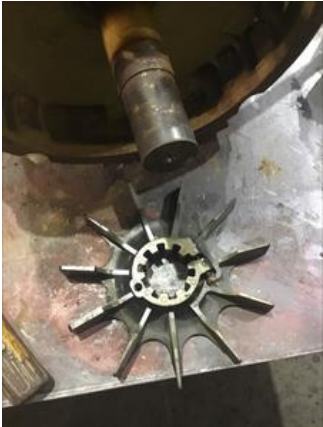
12.	Lead Length	11.5 Inches	
13.	Frame Condition	pass	
● 14.	Fan Condition	(P) Pass	P94

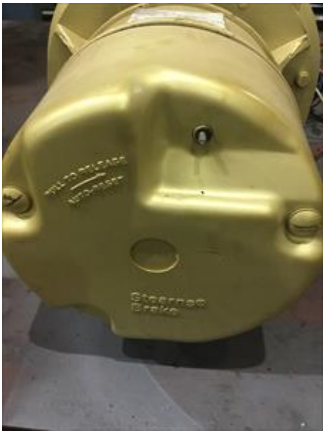
15.	Broken or Missing Components	connection box	P98
■	Auto release knob on sterns brake missing

Need new brake assembly

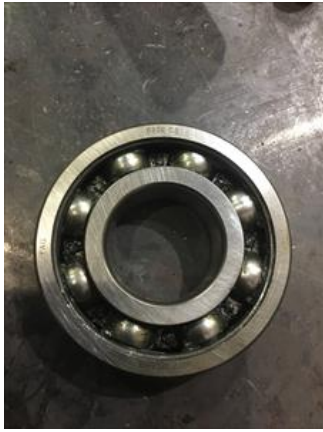
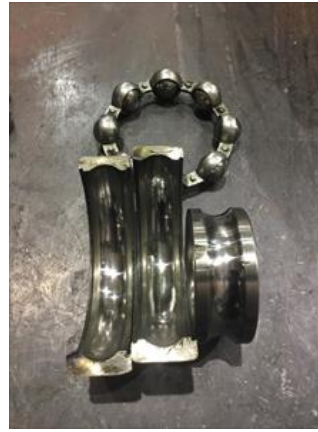
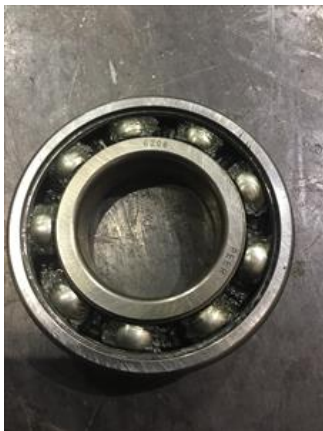
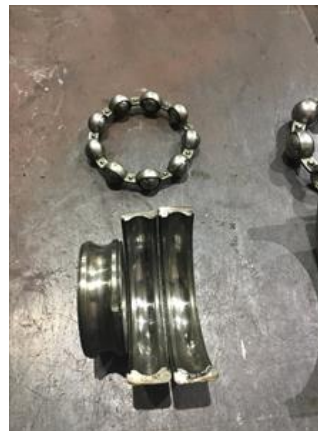
24. Drive End Bearing Number-	6309 C3
25. Drive End Bearing Qty.	1
26. Drive End Bearing Type	(Ball) Ball Bearing
27. Drive End Lubrication Type	(Grease) Grease Lubricated
28. Drive End Bearing Insulation or Grounding Device?	none
29. Drive End Wavy Washer/Snap-Ring Other Retention Device?	none
30. Drive End Bearing Condition	replace
31. Opposite Drive End Bearing Brand	PEER
32. Opposite Drive End Bearing Number-	6208 C3

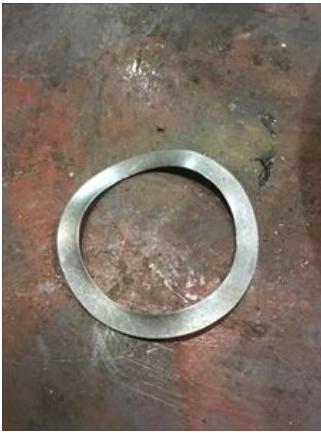
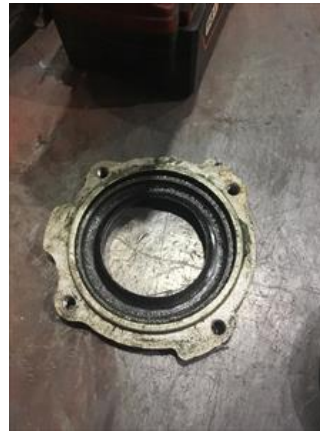
33. Opposite Drive End Bearing Qty.	1
34. Opposite Drive End Bearing Type	(Ball) Ball Bearing
35. Opposite Drive End Lubrication Type	(Grease) Grease Lubricated
36. Opposite Drive End Bearing Insulation or Grounding Device?	none
37. Opposite Drive End Wavy Washer/Snap-Ring Other Retention Device?	wavy washer

38. Opposite Drive End Bearing Condition

replace

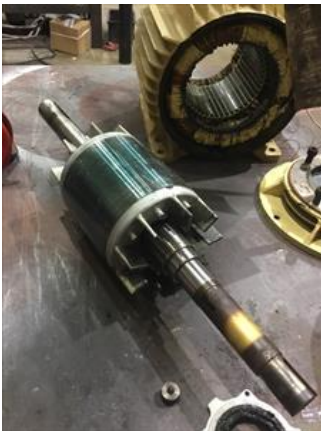
P3

(Squirrel Aluminum) Squirrel
Cage Aluminum Die Cast

good
