AC Inspection as Found

Twin Rivers

AC Inspection - Rev. 2

Description: 350HP GE 900RPM 8266/8288S

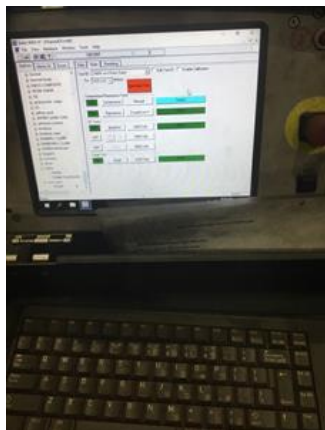
22. Number of Stator Slots	72 Megohms
23. Stator Condition	dirty
24. Stator Thermistors/Ohms	none
25. Stator Overloads/Ohms	none

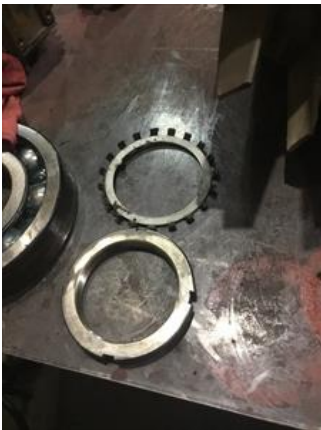
33. Drive End Bearing Condition

replace

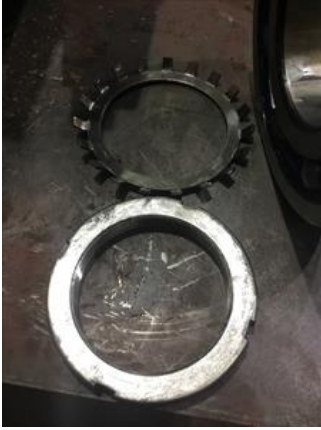
| 41. Opposite Drive End Bearing Condition | replace |

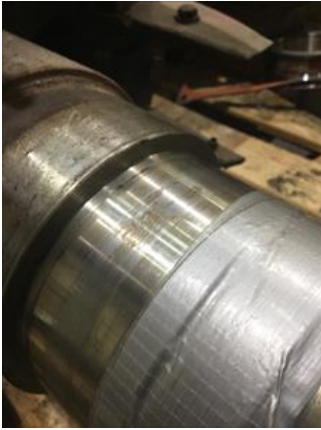
54. Drive End Bearing Shaft Fit

0 Degrees	60 Degrees	120 Degrees
4.7244	4.7251

Lip worn in

55. Drive End Bearing Shaft Fit Condition

(F) Fail

64.	End Bell Air Seal Fits		
	Drive End Air Seal	Opposite Drive End Air Seal	
65.	List Machine Work Needed Below <i>D.E. Shaft fit bad. Has lip worn in. D.E housing fit has excessive pitting.</i>

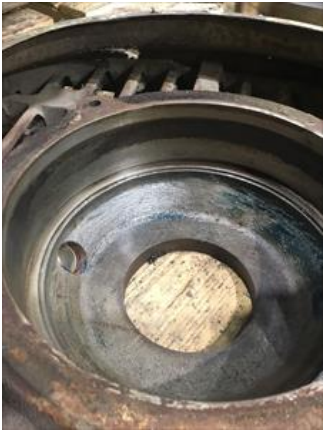
59. Drive End - Endbell Bearing Fit

0 Degrees	60 Degrees	120 Degrees
10.2373	10.2375	10.2376
