AC Inspection as Found

Sage V Foods

Description: 50HP BALDOR

Hi-Speed Job Number: 101627

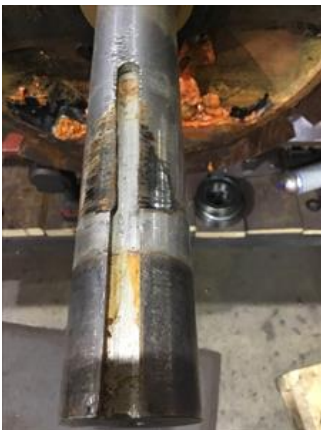
| ● | 6. Does Shaft Have Visible Damage? | (Yes) Yes | P17 |
| ■ | <i>Key way wallowed.</i> | | |

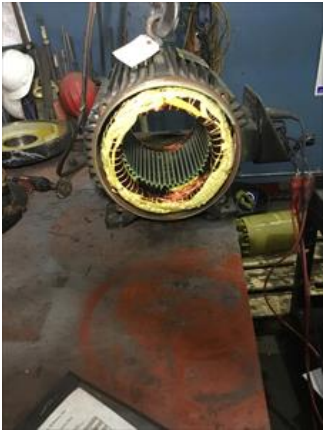
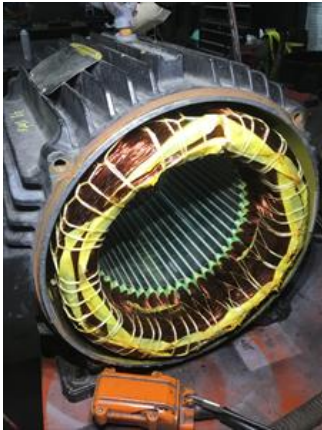
12. Lead Numbers	1-9	
13. Frame Condition	pass	P105
<div>

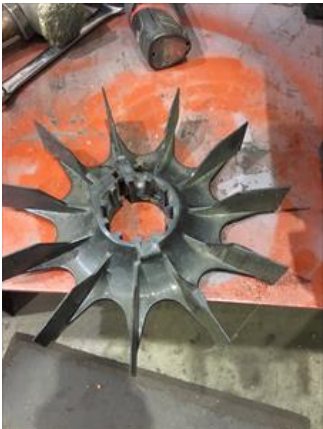
</div>		
14. Fan Condition	(P) Pass	P109
<div>

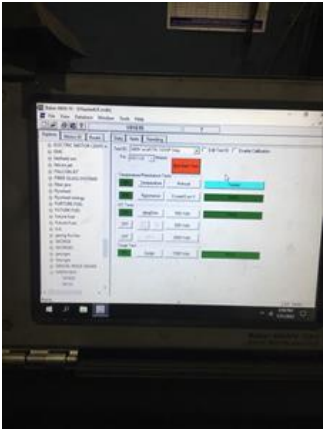
16. Insulation Resistance/Megger		
17. Winding Resistance		
1-2	1-3	2-3
18. Perform Surge Test	(P) Pass	P58
<div>

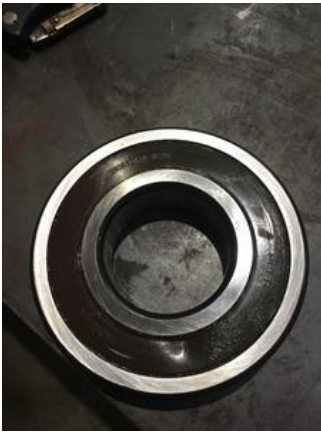
38.	Opposite Drive End Bearing Condition	replace	P116

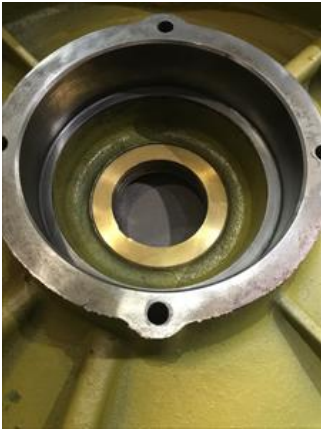
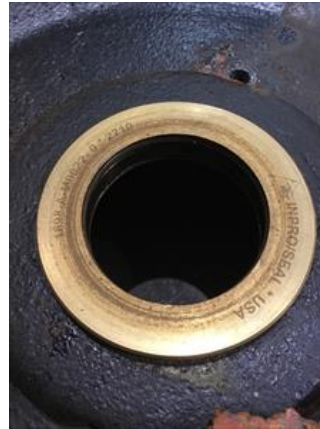
39. Drive End Seal

in pro

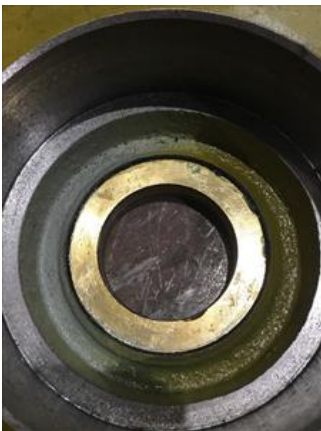
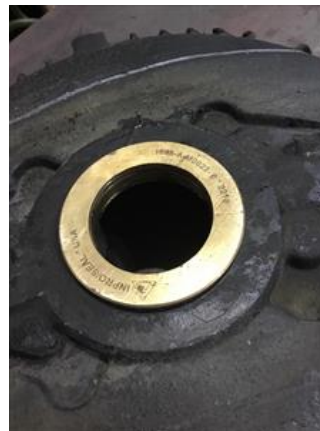
40. Opposite Drive End Seal

in pro

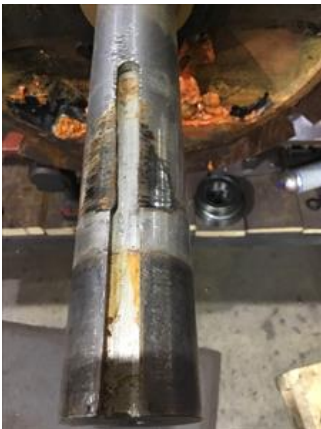
P40

44. Rotor Condition shaft replacement needed.

Shaft bent more than .90. And key way wallowed.

45. List the Parts needed for the Repair Below
New shaft, and new bearings.

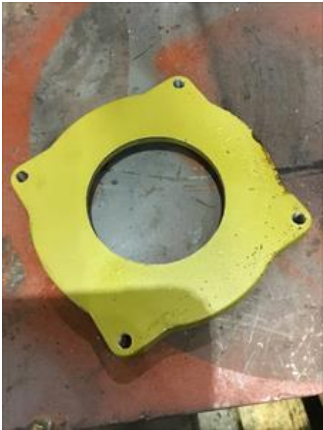
5.1187	5.1185	5.1186
59.	Opposite Drive End - Endbell Bearing Fit Condition		(P) Pass
60.	Bearing Cap Condition		
	Drive End Bearing Cap	Opposite Drive End Bearing Cap	
	pass

61.	End Bell Air Seal Fits		
	Drive End Air Seal	Opposite Drive End Air Seal	
62.	List Machine Work Needed Below		
	New shaft
