AC Inspection as Found

Arauco-Malvern MDF (10298)

AC Inspection - Rev. 2

Description: 150HP SIEMENS 900RPM 447T

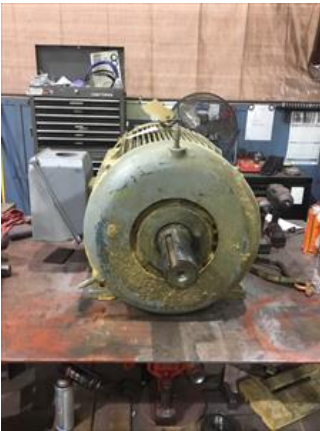
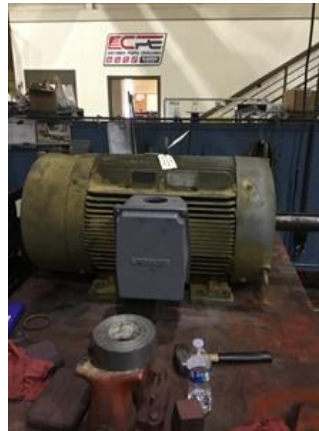
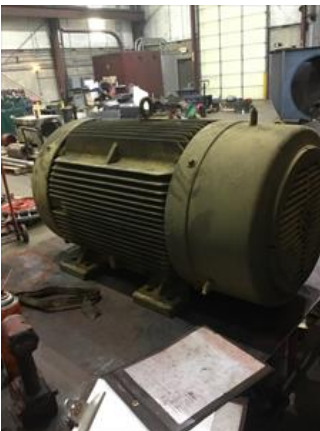
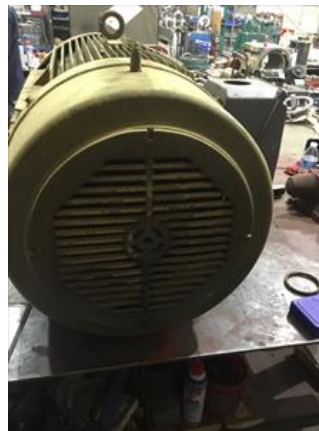
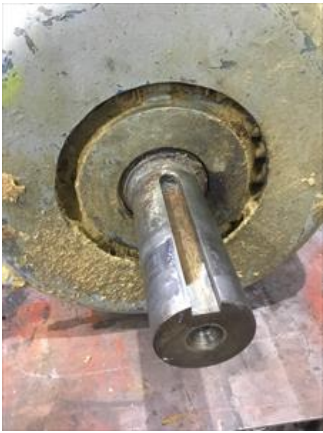
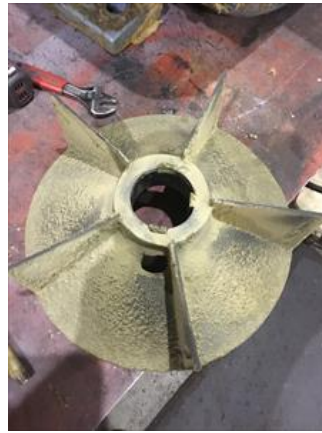
3. Photos of all six sides of the machine.

4. Describe the Overall Condition of the Equipment as Received
Serviceable

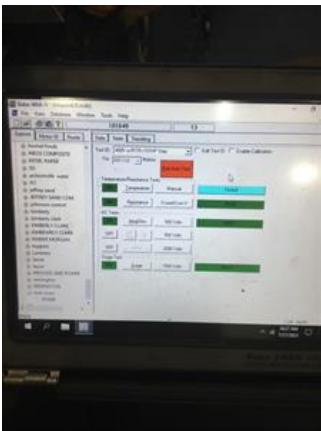
18. Perform Surge Test

(P) Pass

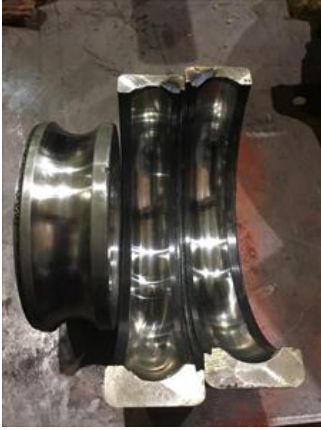
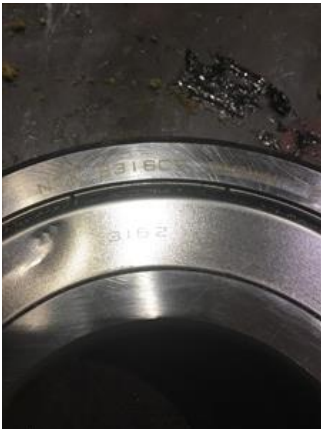
24. Drive End Bearing Number-	6320
25. Drive End Bearing Qty.	1
26. Drive End Bearing Type	(Ball) Ball Bearing
27. Drive End Lubrication Type	(Grease) Grease Lubricated
28. Drive End Bearing Insulation or Grounding Device?	none
29. Drive End Wavy Washer/Snap-Ring Other Retention Device?	none
30. Drive End Bearing Condition	replace
31. Opposite Drive End Bearing Brand	NTN
32. Opposite Drive End Bearing Number-	6316 C3

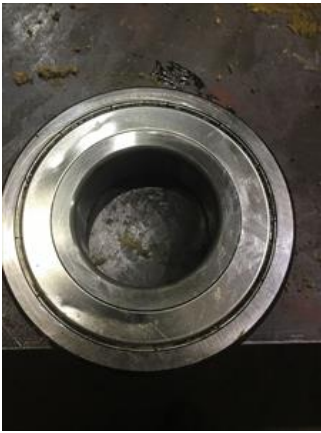
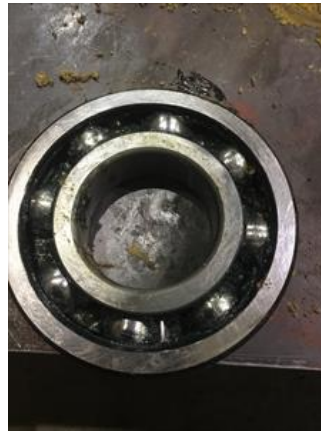
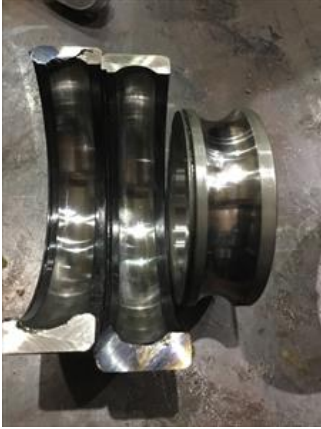
35. Opposite Drive End Lubrication Type	(Grease) Grease Lubricated
36. Opposite Drive End Bearing Insulation or Grounding Device?	none
37. Opposite Drive End Wavy Washer/Snap-Ring Other Retention Device?	snap ring
38. Opposite Drive End Bearing Condition	replace
39. Drive End Seal	
40. Opposite Drive End Seal
