AC Inspection as Found

Peco Foods
 625 S. Allen Street
 Batesville, AR 72501

AC Inspection - Rev. 2

Location: Shop
Serial Number: C1204191062
Description: 50HP BALDOR 1800RPM 326TC

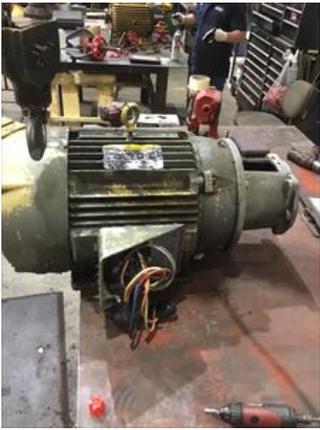
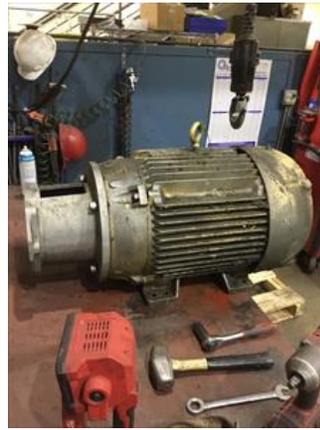
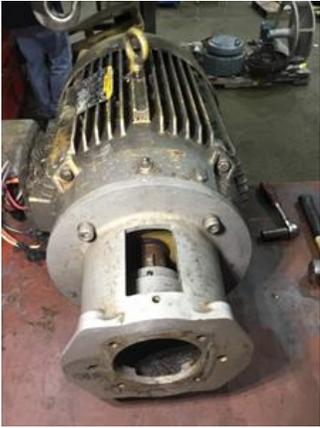
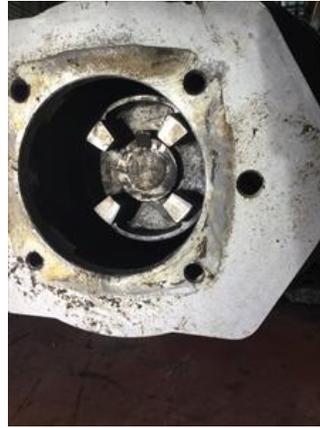
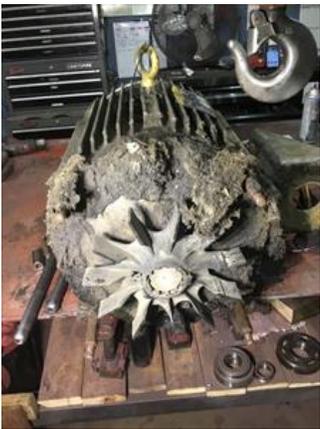
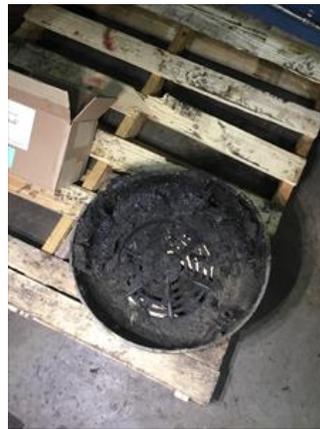
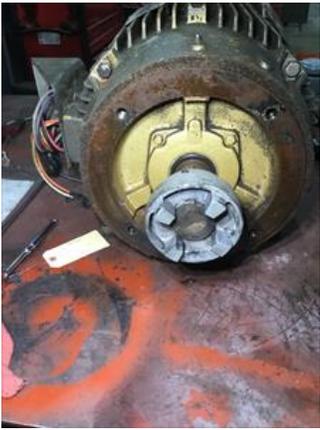
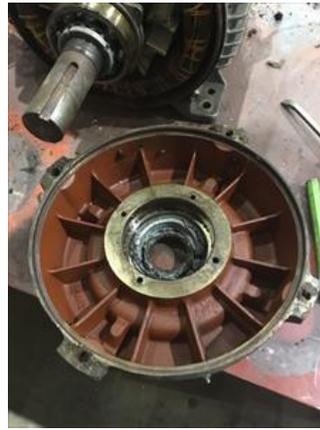
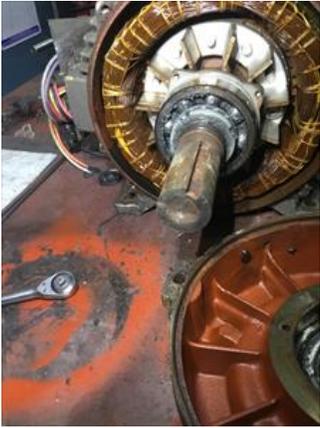
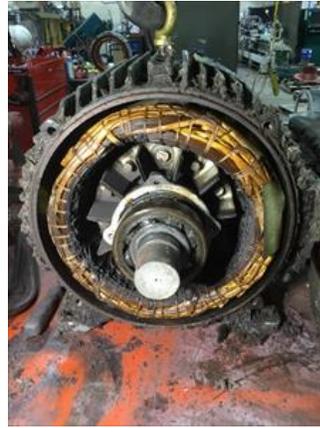
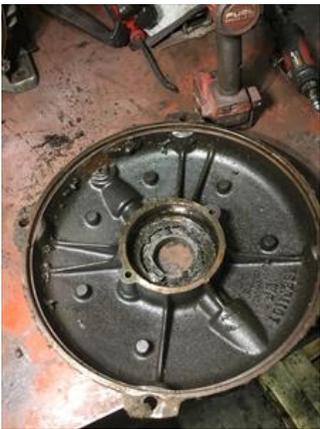
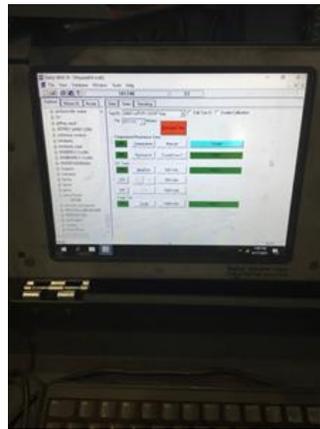
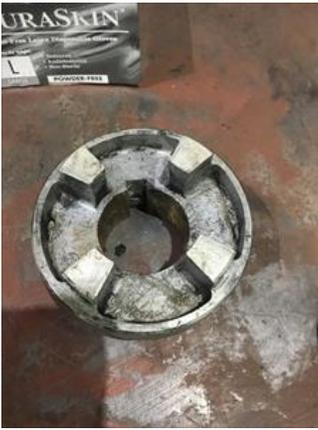
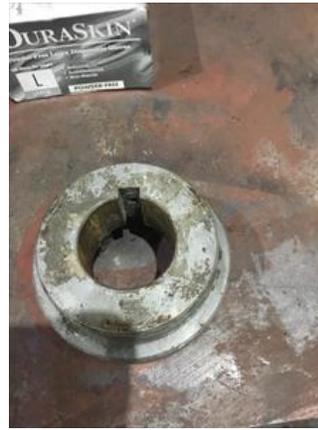
- 3. Photos of all six sides of the machine.
- 4. Describe the Overall Condition of the Equipment as Received
Serviceable.

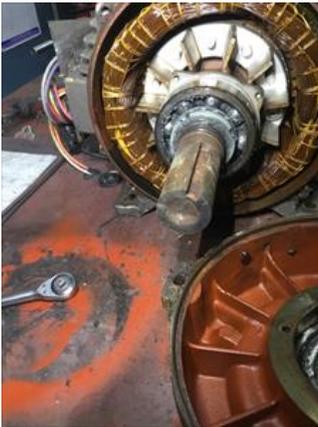
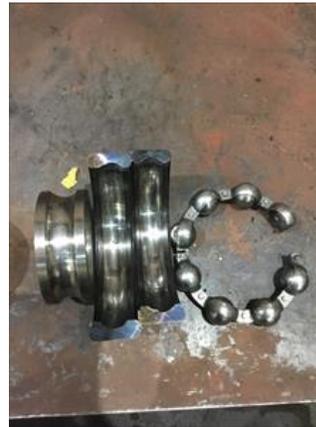
30. Drive End Bearing Condition

fail

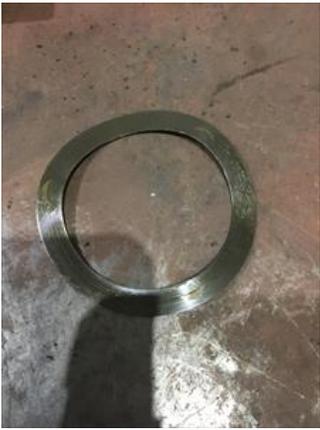
38. Opposite Drive End Bearing Condition

replace

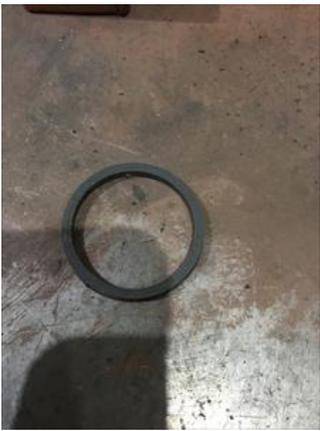
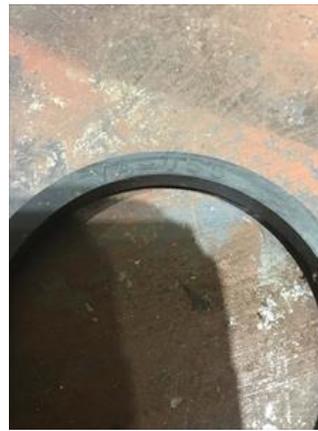
39. Drive End Seal

lip seal VA-055

Replace

45. List the Parts needed for the Repair Below
Repair O.D.E shaft bearing journal. Replace lip seal VA-055.

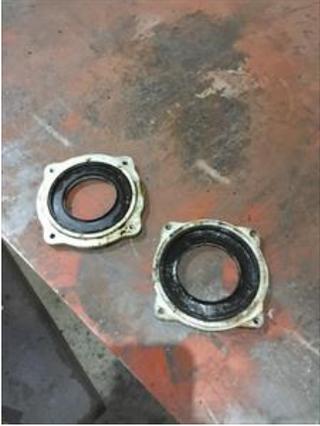
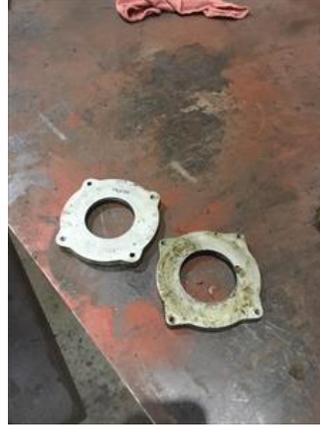
4.7258	4.7258	4.7258
---------------	---------------	---------------

■ *Fail*

● 59. Opposite Drive End - Endbell Bearing Fit Condition **(F) Fail**

■ *Lip worn in*

Ode shaft fit, and end bell housing fit has lip worn in.
