**AC Inspection as Found**  
**ARKANSAS INDUSTRIAL MACHINERY**  
3804 N. NONA ST  
NORTH LITTLE ROCK, AR 72118

**AC Inspection - Rev. 2**

Location: Shop  
Serial Number: UD1604/75681462-001  
Description: 30 HP SIEMENS

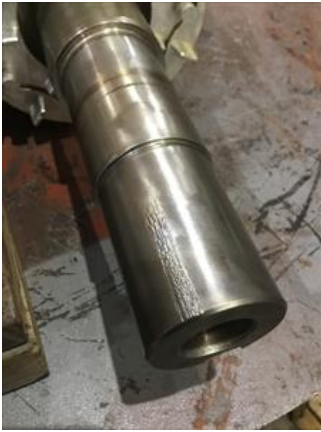
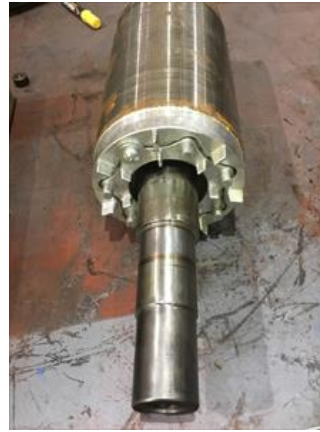
P17

6. Does Shaft Have Visible Damage?

(Yes) Yes

Slight damage. No machine work required

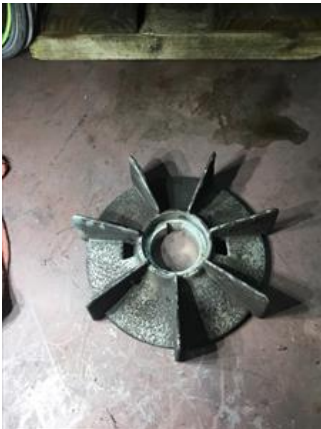
P110

14. Fan Condition (P) Pass

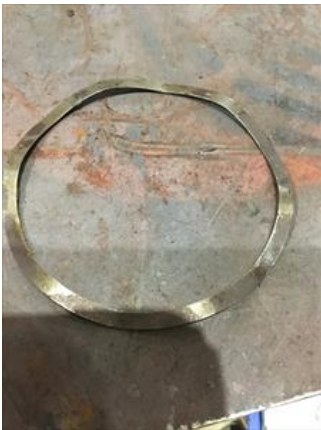
P76

30. Drive End Bearing Condition

replace

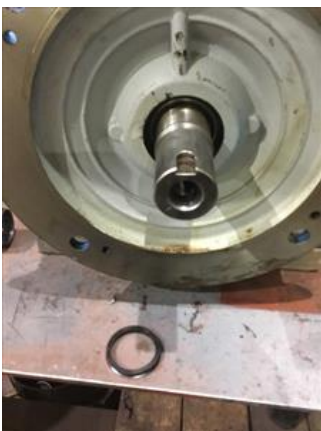
33. Opposite Drive End Bearing Qty.	1	
34. Opposite Drive End Bearing Type	(Ball) Ball Bearing	
35. Opposite Drive End Lubrication Type	(Grease) Grease Lubricated	
36. Opposite Drive End Bearing Insulation or Grounding Device?	none	
37. Opposite Drive End Wavy Washer/Snap-Ring Other Retention Device?	snap ring	
38. Opposite Drive End Bearing Condition	replace	
39. Drive End Seal	VA 045	P120

45.	List the Parts needed for the Repair Below <i>VA 045 dust seal and new seal sleeve.</i>

62.	List Machine Work Needed Below <i>None. Replace seal sleeve.</i>		
63.	Technician		Terrence Holland

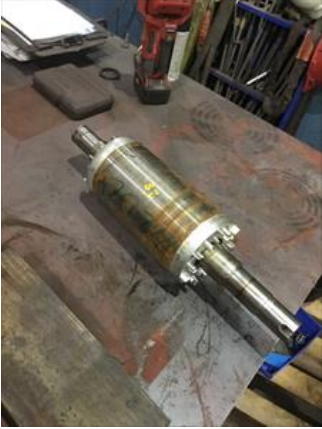
42.	Growler Test	(Pass) Pass	
43.	Number of Rotor Bars	28	
44.	Rotor Condition	pass	P40

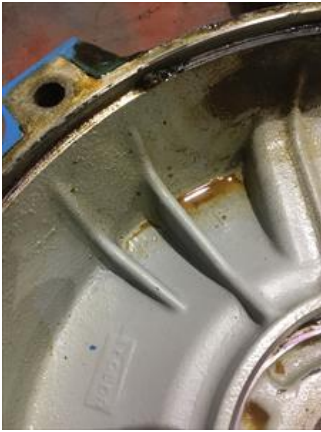
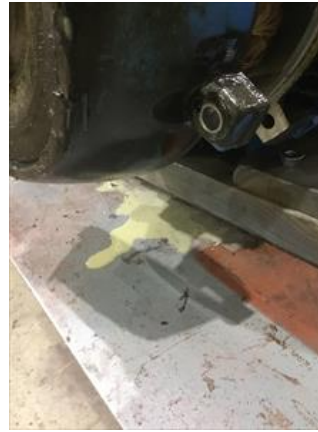
68.	Failure locations

*Excessive moisture found inside stator and housings*
