**AC Inspection as Found**  
**AMERICAN COMPOSTING**  
11911 FAULKNER LAKE ROAD  
NORTH LITTLE ROCK, AR 72217

**AC Inspection - Rev. 2**

**Location:** MOTOR SHOP LR  
**Serial Number:** ES 2016 018914 ZP  
**Description:** 17.3KW ELMOT-SCHAFFER  
1800RPM 160L

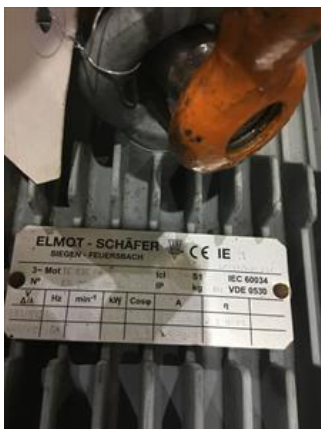
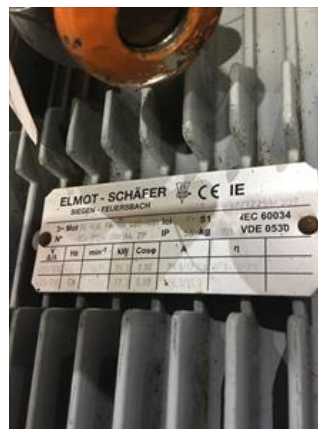
P37

1. Report Date
2. Nameplate Picture

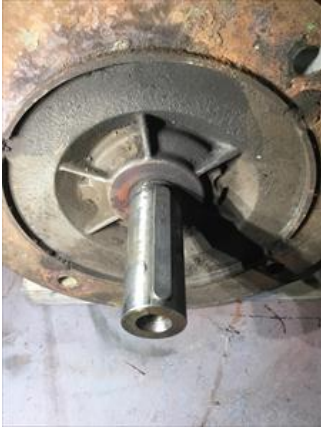
P20

5. Does Shaft Turn Freely?

(Yes) Yes

6. Does Shaft Have Visible Damage?

(No) No

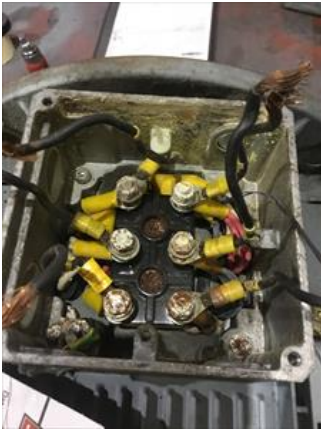
P55

10. Lead Condition

(F) Fail

Excessive amounts of rust and corrosion

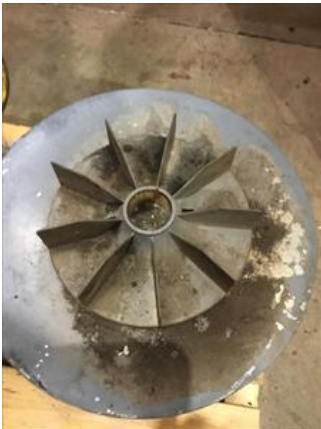
P95

14. Fan Condition

(P) Pass

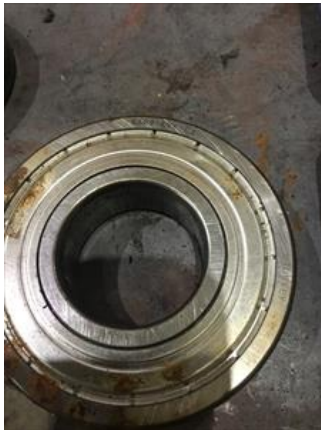
P30

24. Drive End Bearing Number-

6309 EV1 C3

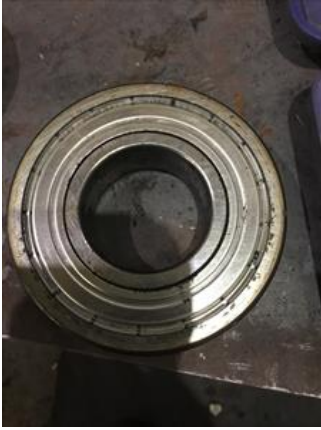
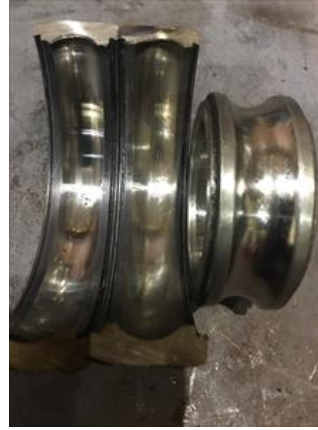
P49

26. Drive End Bearing Type

**(Ball) Ball Bearing**

30. Drive End Bearing Condition

**replace**

| 45. List the Parts needed for the Repair Below<br><i>Replace 4 ea end bell mount bolts. Re-sleeve both housing fits. Replace 6309 &amp; 6209 2Z bearings. Replace both housing lip seals, 45*72*10</i> | |

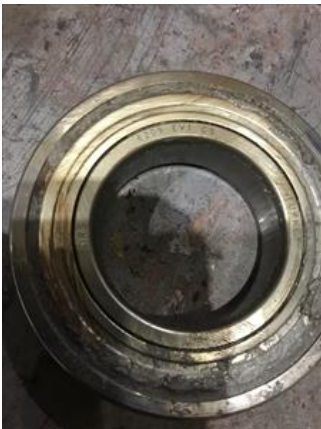
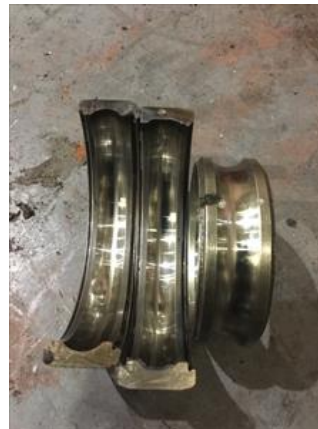
P86

31. Opposite Drive End Bearing Brand

**ORS**

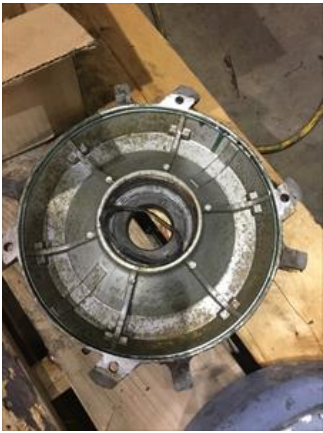
P98

37. Opposite Drive End Wavy Washer/Snap-Ring Other Retention Device?

**wavy washer**

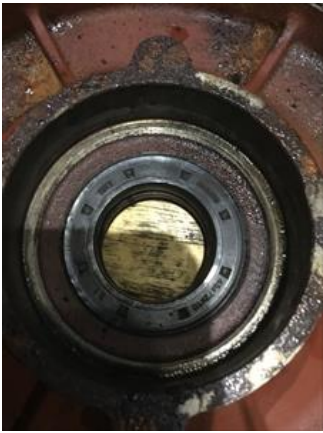
P101

39. Drive End Seal

45\*72\*10

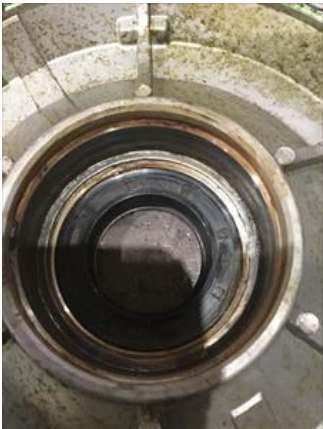
P102

40. Opposite Drive End Seal

45\*72\*10
