AC Inspection as Found

Lexicon (10257)
8900 Fouche Dam Pike
Little Rock, AR

AC Inspection - Rev. 2

Description: NORD GEARMOTOR

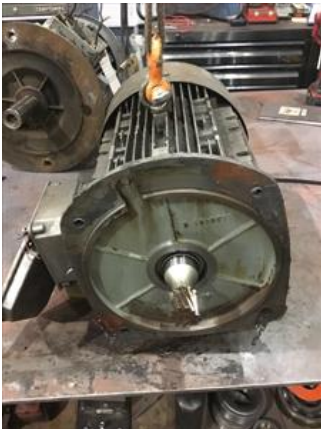
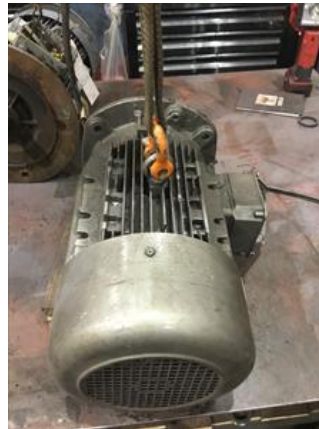
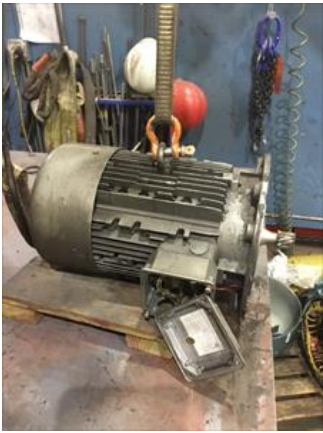
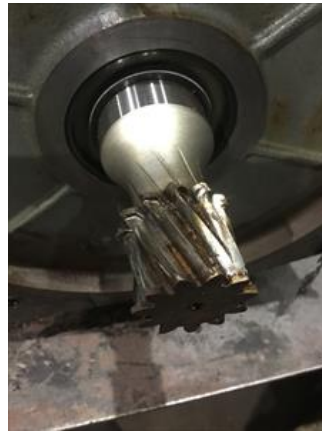
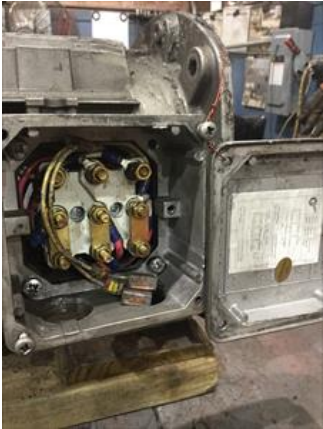
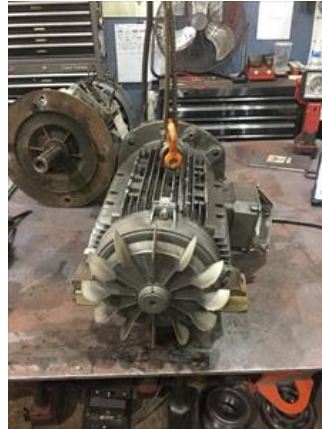
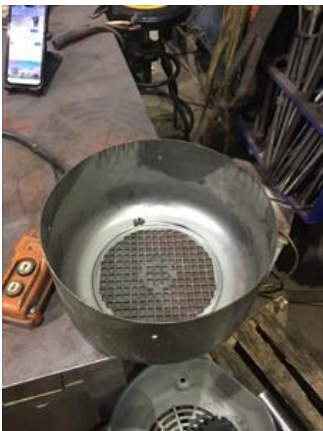
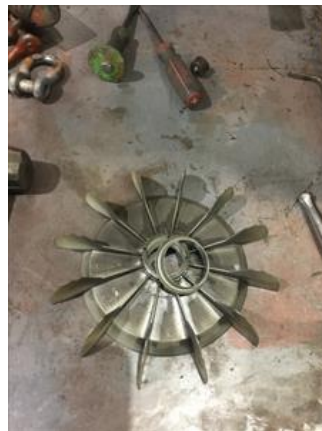
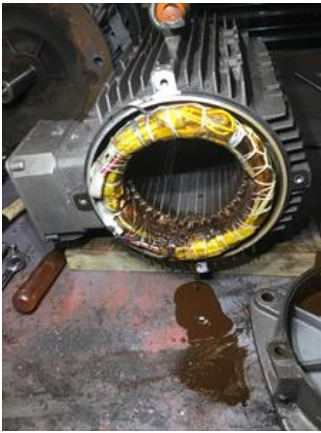
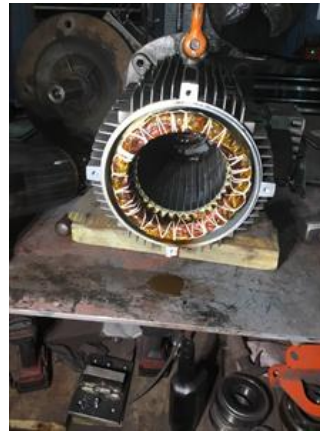
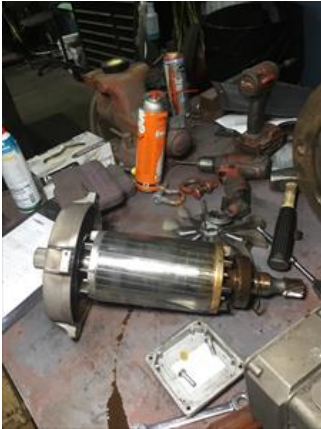
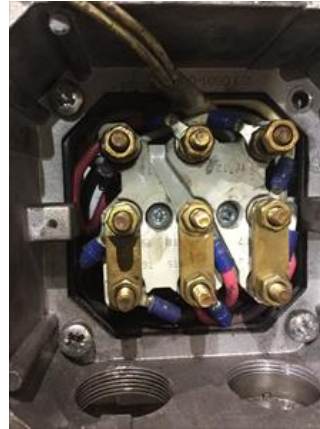
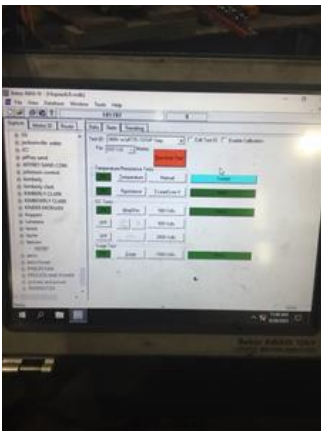
3. Photos of all six sides of the machine.

4. Describe the Overall Condition of the Equipment as Received
Dirty and oily but serviceable.

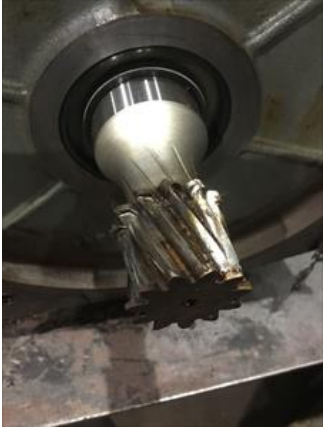
7.	Does Shaft Have Visible Damage?	(Yes) Yes	P20

| <p> Gear is worn beyond acceptable standards. Customer was notified but wanted the motor repaired anyway without fixing the worn gear.</p> | | |

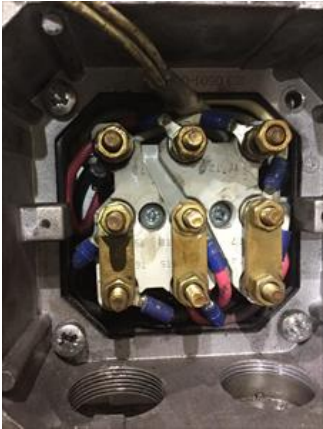
8.	Assembled Shaft Runout		
9.	Assembled Shaft End Play		
10.	Air Gap Variation <10%		
● 11.	Lead Condition	(P) Pass	P55

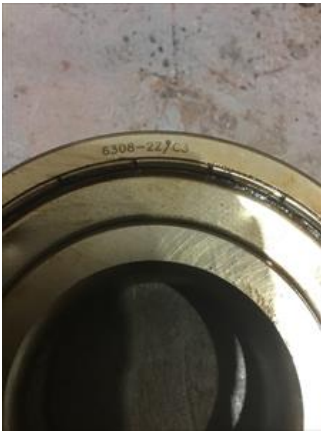
25. Drive End Bearing Number- **6308** P30

29.	Drive End Bearing Insulation or Grounding Device?	none	
30.	Drive End Wavy Washer/Snap-Ring Other Retention Device?	2 wavy washers	
31.	Drive End Bearing Condition	replace	
32.	Opposite Drive End Bearing Brand	skf	
33.	Opposite Drive End Bearing Number-	6308	P90

(2) 6308 2Z C3 bearings. Sleeve both end-bell housings | |

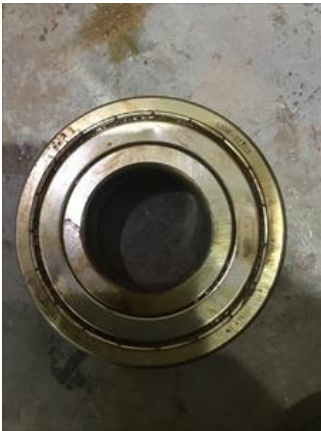
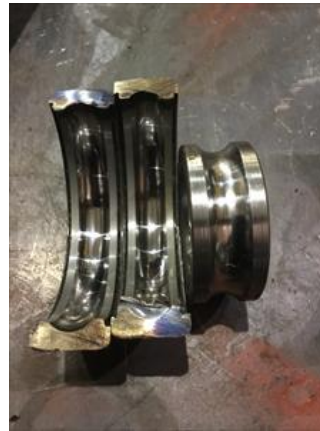
27. Drive End Bearing Type **(Ball) Ball Bearing** P49

56.	Shaft Air Seal Fits		
	Drive End Air Seal	Opposite Drive End Air Seal	
Mechanical Fits- Bearing Housings			
57.	Drive End - Endbell Bearing Fit		
	0 Degrees	60 Degrees	120 Degrees
	<input type="checkbox"/> <i>Bad. Excessive wear and pitting</i>

58.	Drive End - Endbell Bearing Fit Condition		(F) Fail
59.	Opposite Drive End - Endbell Bearing Fit		
	0 Degrees	60 Degrees	120 Degrees
	<input type="checkbox"/> <i>Bad. Excessive wear and pitting</i>

63.	List Machine Work Needed Below <i>Both housing fits check bad.</i>		
64.	Technician		Terrence Holland

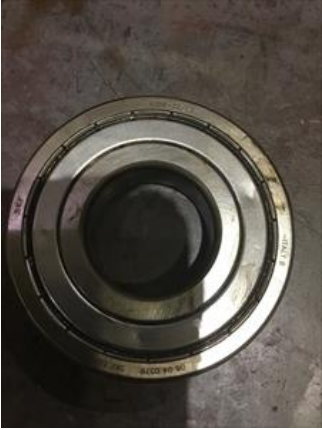
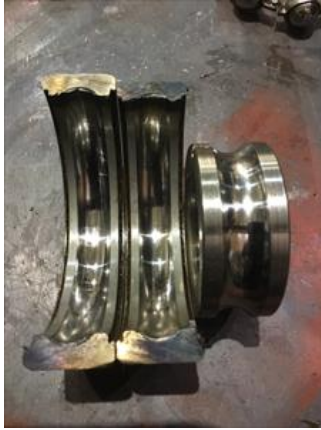
34.	Opposite Drive End Bearing Qty.	1	
35.	Opposite Drive End Bearing Type	(Ball) Ball Bearing	P93

36.	Opposite Drive End Lubrication Type	(Grease) Grease Lubricated	
37.	Opposite Drive End Bearing Insulation or Grounding Device?		
38.	Opposite Drive End Wavy Washer/Snap-Ring Other Retention Device?	2 snap rings, inner and outer	
39.	Opposite Drive End Bearing Condition	replace	
40.	Drive End Seal	40*62*7

60.	Opposite Drive End - Endbell Bearing Fit Condition		(F) Fail
61.	Bearing Cap Condition		
	Drive End Bearing Cap	Opposite Drive End Bearing Cap	
62.	End Bell Air Seal Fits		
	Drive End Air Seal	Opposite Drive End Air Seal
