AC Inspection as Found
North Little Rock Wastewater (10219)
7400 Baucum Pike
N. Little Rock, AR 72117

AC Inspection - Rev. 2

Location: MOTOR SHOP LR
Serial Number: Y 07 17700602-0001 M 0002
Description: 25HP US MOTORS AERATOR
1200RPM 324LPZH

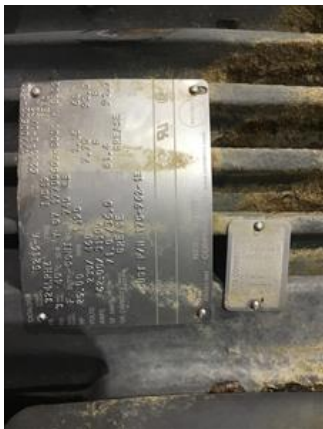
1. Report Date
2. Nameplate Picture

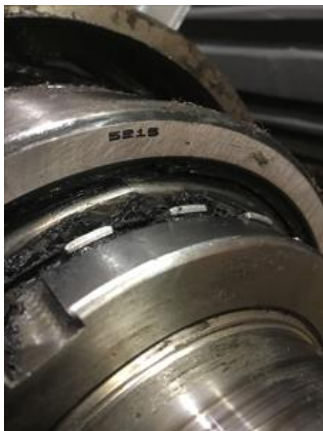
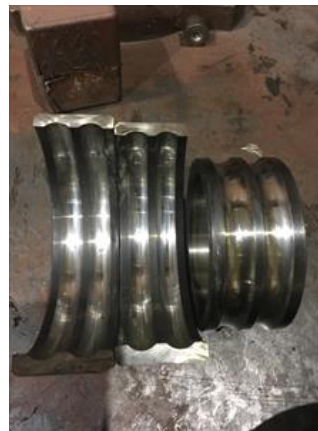
24. Drive End Bearing Brand **NSK**

25. Drive End Bearing Number- **5216**

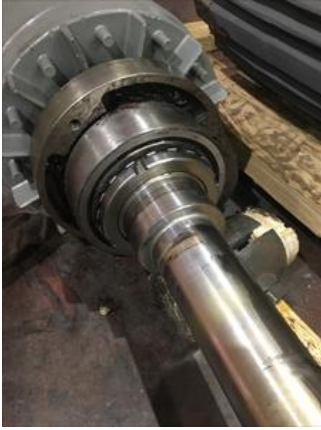
30. Drive End Wavy Washer/Snap-Ring Other Retention Device?

star washer and lock ring

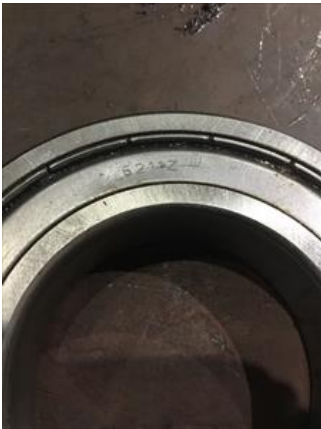
33. Opposite Drive End Bearing Number-

6211 Z

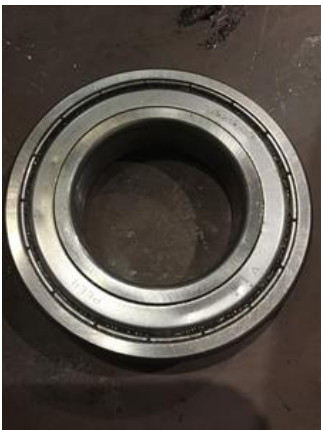
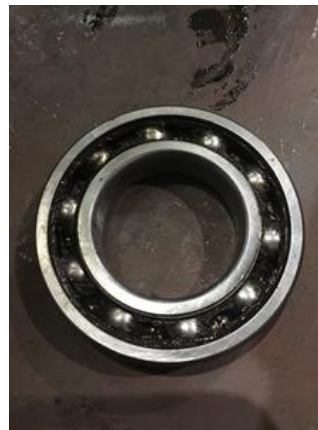
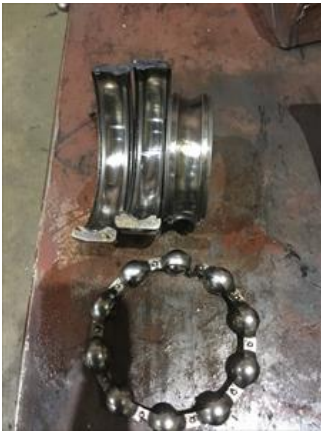
36. Opposite Drive End Lubrication Type	(Grease) Grease Lubricated	
37. Opposite Drive End Bearing Insulation or Grounding Device?	none	
38. Opposite Drive End Wavy Washer/Snap-Ring Other Retention Device?	none	
39. Opposite Drive End Bearing Condition	replace	
40. Drive End Seal	National 416956	P102

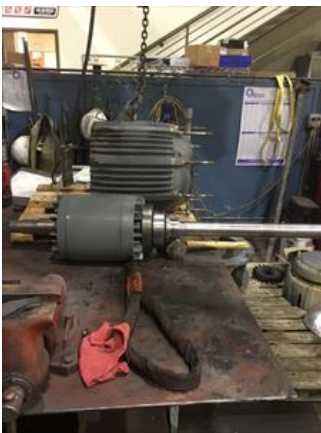
42. Rotor Type/Material	(Squirrel Aluminum) Squirrel Cage Aluminum Die Cast	P3

43. Growler Test	(Pass) Pass	
44. Number of Rotor Bars	66

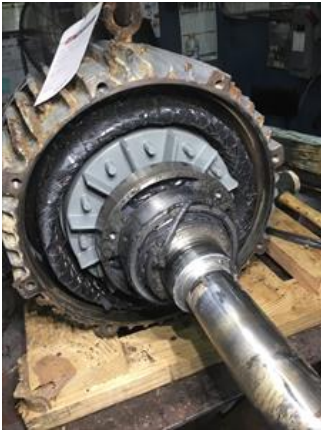
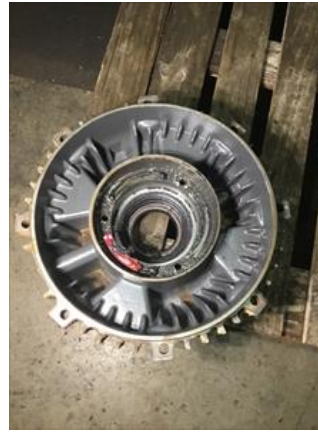
77. Failure locations

Contaminated bearings from grease.
