AC Inspection as Found
ARKANSAS INDUSTRIAL MACHINERY
3804 N. NONA ST
NORTH LITTLE ROCK, AR 72118

AC Inspection - Rev. 2

Location: Shop
Serial Number: E0910/811871 68 003
Description: 37KW SIEMENS 1800RPM 200L

Hi-Speed Job Number:	101876
Manufacturer:	Siemens
Product Number:	1LA5207-4AA99-ZT00
Serial Number:	E0910/811871 68 003
HP/kW:	37 (kW)
RPM:	2700 (RPM)
Frame:	200L
Voltage:	460
Current:	80
Phase:	Three
Hz:	91 (Hz)
Enclosure:	TEFC
J-box Included:	Complete
Coupling/Sheave:	Gear
Bearing RTDs:	No
Stator RTDs:	No
Repair Stage:	Final
Heaters:	No
Winding Type :	Random Wound
Bearing Type:	Rolling Element

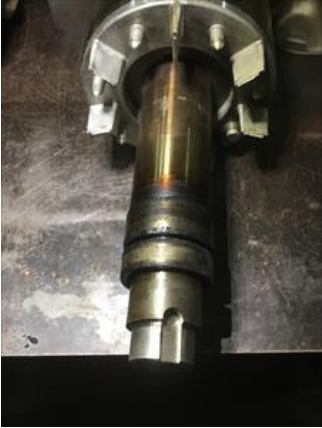
7.	Does Shaft Have Visible Damage?	(No) No	P20

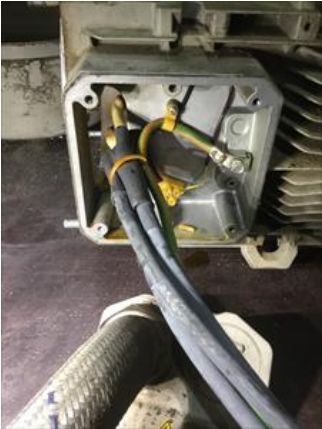
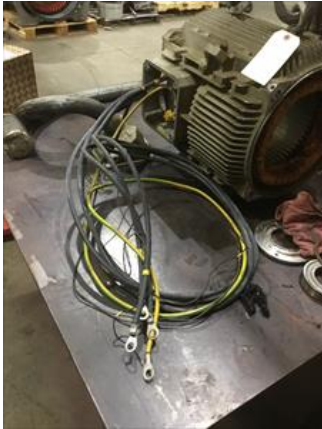
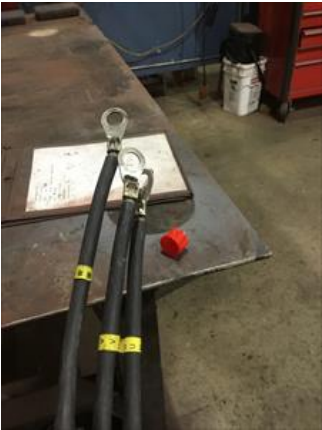
8.	Assembled Shaft Runout		
9.	Assembled Shaft End Play		
10.	Air Gap Variation <10%		
● 11.	Lead Condition	(P) Pass	P55
<div>

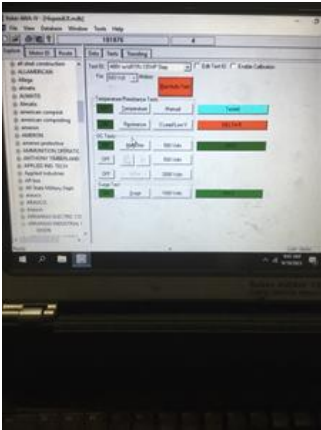
21. Stator Condition

pass

Pulled even amps under voltage

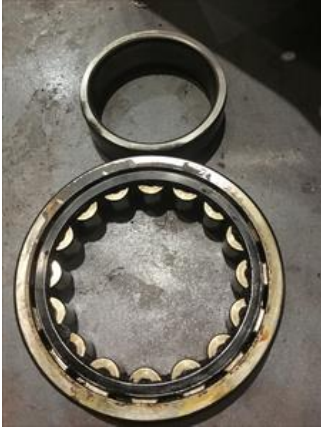
31. Drive End Bearing Condition

replace

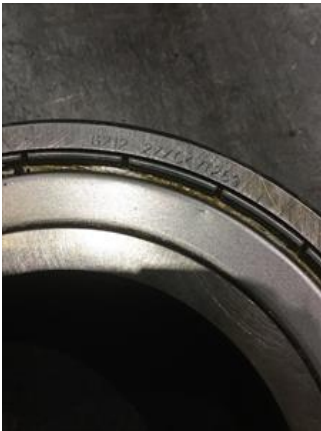
39. Opposite Drive End Bearing Condition

replace

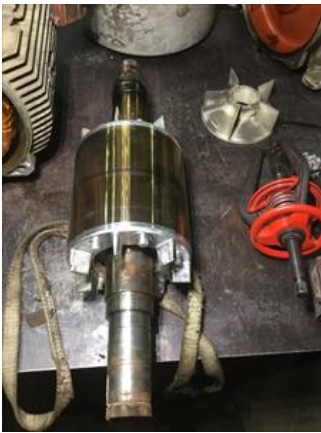
45. Rotor Condition

pass

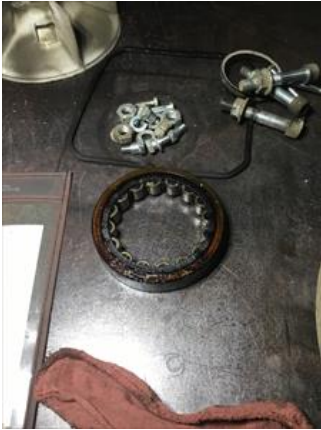
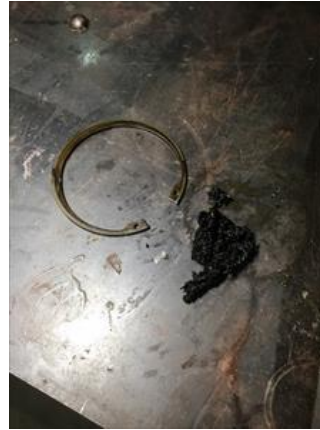
D.E bearing severely contaminated.

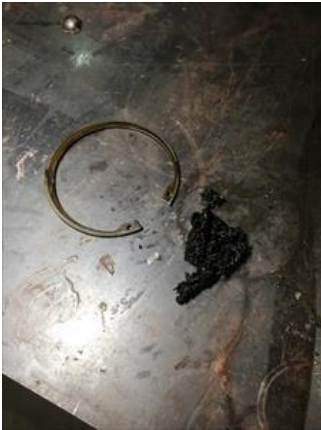
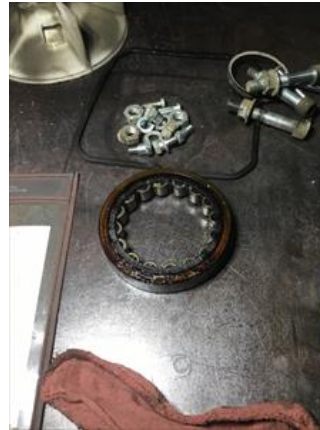
Contamination caused by unknown substances. See pictures below.
