AC Inspection as Found

Georges Inc
1810 S. St. Louis Street
Batesville, AR 72501

AC Inspection - Rev. 2

Description: 75HP BALDOR 1800RPM 365TS

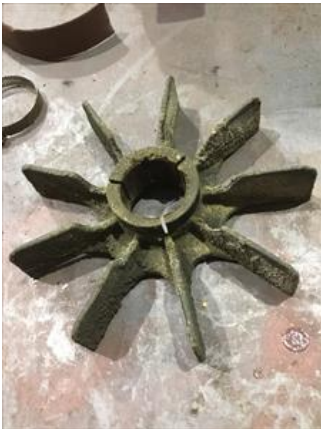
14. Frame Condition	dirty
---------------------	-------

15. Fan Condition	(P) Pass
-------------------	----------

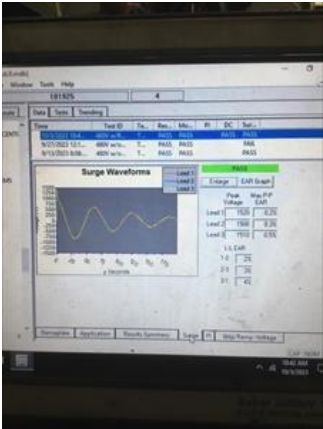
<div><div></div><div>19. Perform Surge Test</div></div>	<div>(P) Pass</div>	<div>P57</div>
<div>

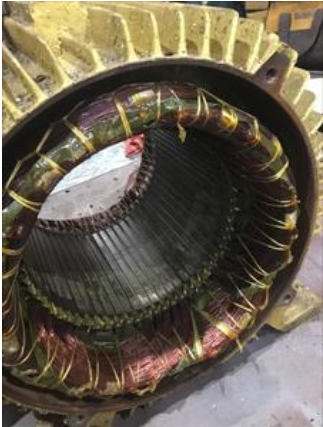
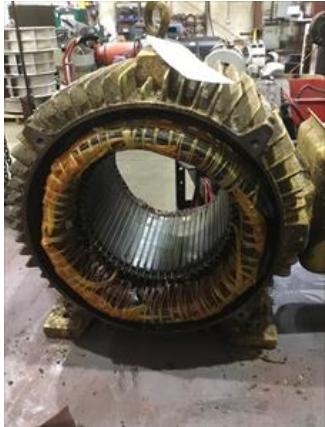
</div>		
<div>20. Number of Stator Slots</div>	<div>60</div>	
<div>21. Stator Condition</div>	<div>wash and bake</div>	<div>P78</div>
<div>

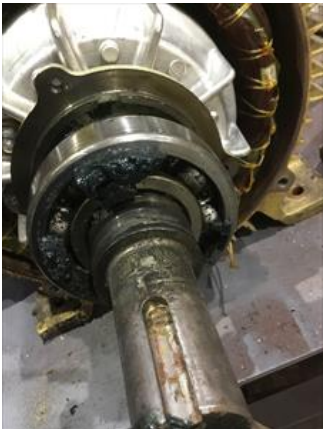
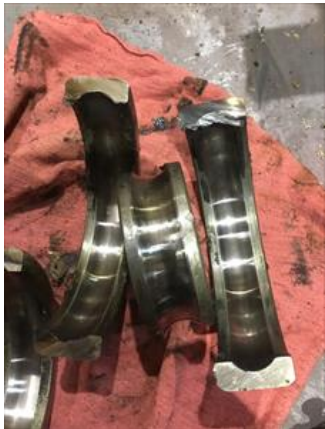
</div>	
<div>22. Stator Thermistors/Ohms</div>	<div>Na</div>	
<div>23. Stator Overloads/Ohms</div>	<div>Na</div>	
<div>Mechanical Inspection<div></div></div>		
<div>24. Drive End Bearing Brand</div>	<div>Nachi</div>	
<div>25. Drive End Bearing Number-</div>	<div>6313</div>	<div>P29</div>
<div>

42.	Rotor Type/Material	(Squirrel Aluminum) Squirrel Cage Aluminum Die Cast
43.	Growler Test	(Pass) Pass
44.	Number of Rotor Bars	47
45.	Rotor Condition	pass
46.	List the Parts needed for the Repair Below <i>2 -6313 Bearings</i>	
47.	Signature of Technician that Disassembled Motor	RW

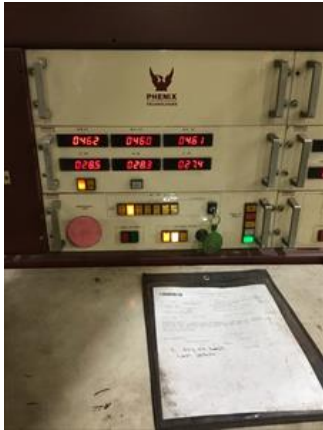
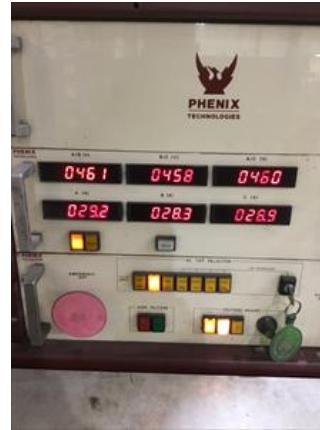
97. Test Run Voltage

462

460

461
