AC Inspection as Found

AC Inspection - Rev. 2

Location: Shop
Serial Number: NO SN
Description: 75HP BALDOR 1800RPM 365TS

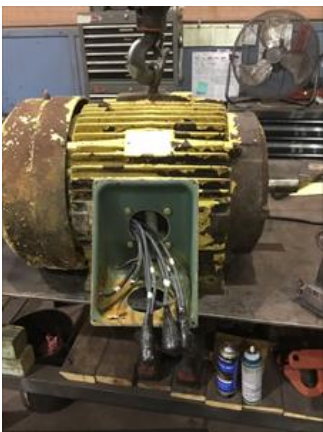
13. Frame Condition

rusty but serviceable

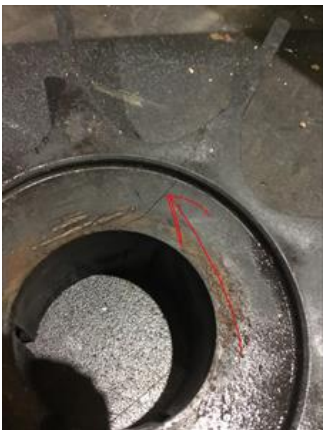
14. Fan Condition

(F) Fail

Cracked

45. List the Parts needed for the Repair Below
Baldor Fan assembly. Part # 70267

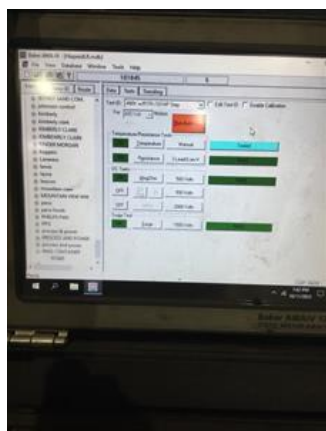
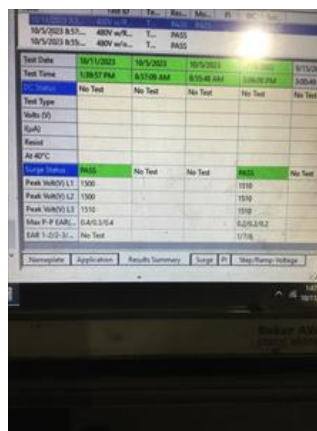
18. Perform Surge Test

(P) Pass

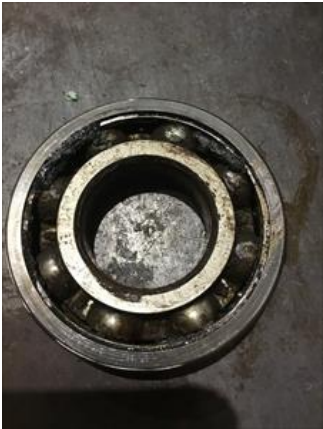
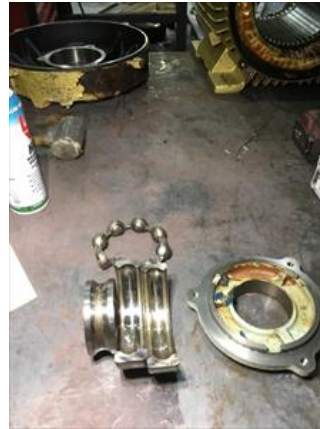
30. Drive End Bearing Condition

replace

Premature bearing failure due to contamination of grease with moisture.

Moisture contaminated grease.

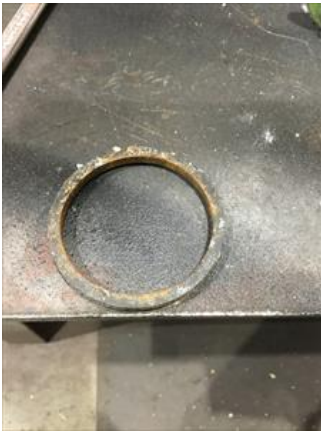
replace
