AC Inspection as Found

Custom Craft Poultry

AC Inspection - Rev. 2

Location: Shop
Serial Number: 870183882.06.06.001
Description: SEW GEARMOTOR 1800RPM
160M

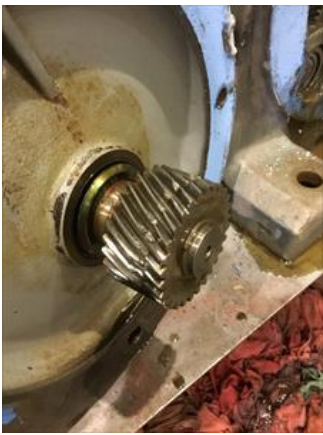
4. Describe the Overall Condition of the Equipment as Received
Rusted and dirty.

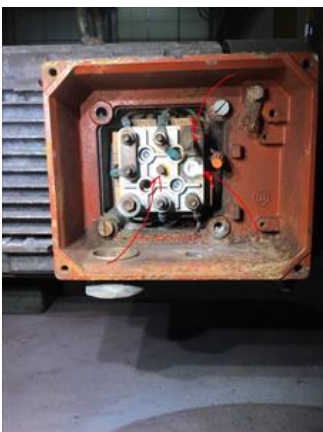
6.	Does Shaft Turn Freely?	(No) No	
7.	Does Shaft Have Visible Damage?	(No) No	
8.	Assembled Shaft Runout	0.002 Inches	
9.	Assembled Shaft End Play		
10.	Air Gap Variation <10%		
11.	Lead Condition	(F) Fail	P55
	<i>Multiple lead connection terminal posts broken.</i>

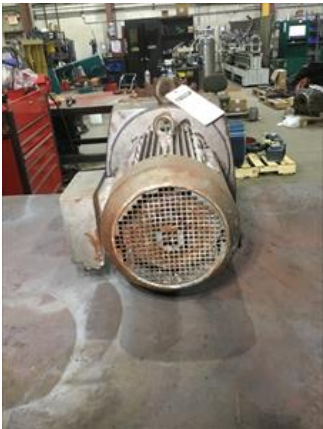
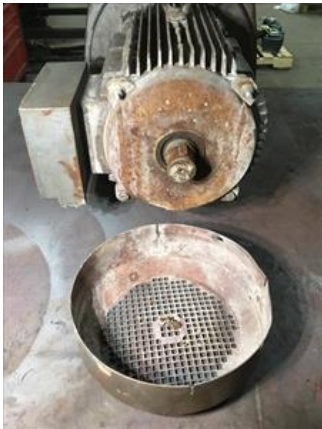
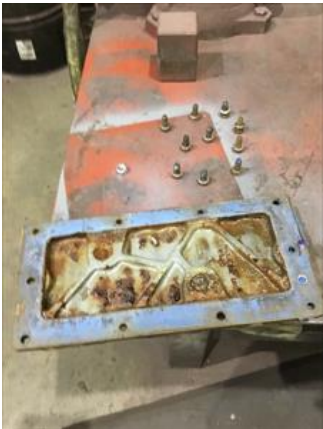
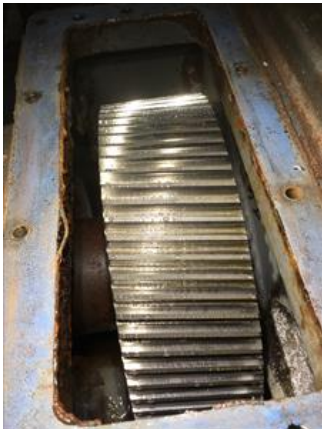
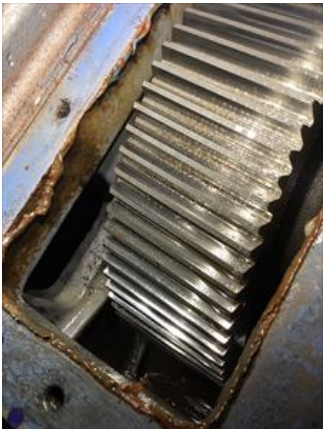
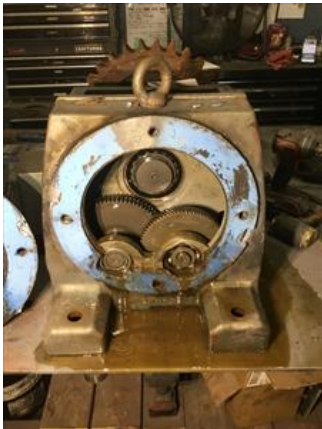
12.	Lead Length	6 Inches	
13.	Lead Numbers	1-9	
14.	Frame Condition	pass	
15.	Fan Condition	(F) Fail	P96
	Missing

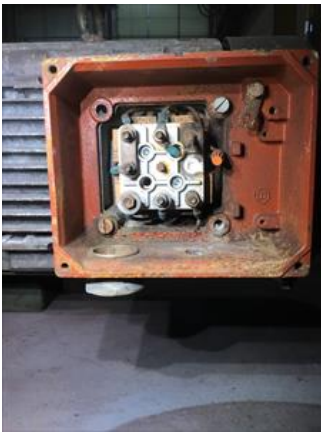
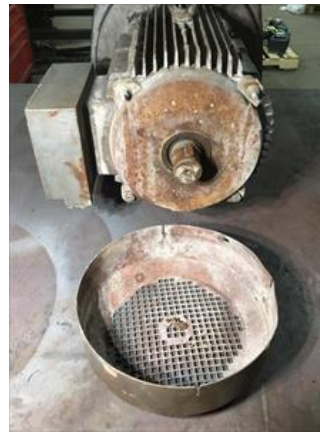
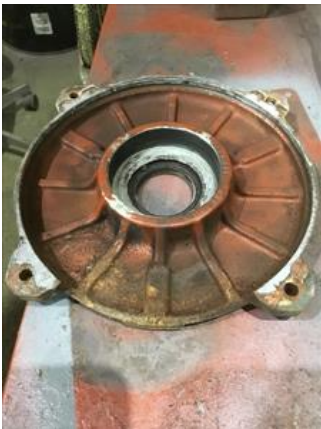
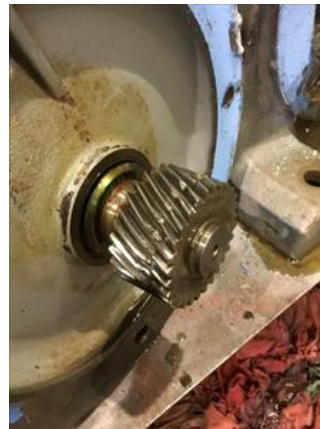
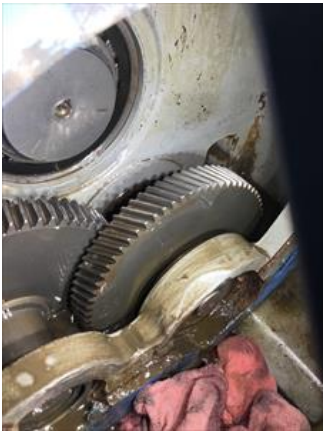
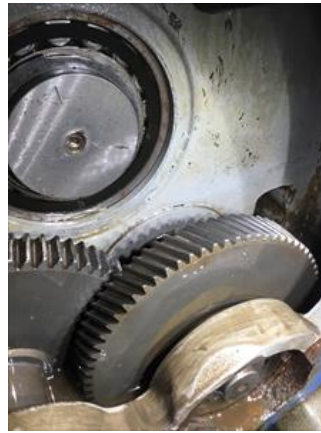
16. Broken or Missing Components

- Connection block terminals broken, fan assembly missing, and ode housing broken and multiple gears stripped from wear.

74.	Post Rewind Surge Test		
75.	Post Rewind Hi-Pot		
76.	Technician		
Root Cause of Failure			
77.	Failure locations <i>Multiple Gearbox gears worn. Motor shaft output gear worn. Connection box mount block needs replacing. Ode housing broken and needs re-sleeved. Fan assembly missing.</i>
