## AC Inspection as Found

### Custom Craft Poultry

#### AC Inspection - Rev. 2

Location: Shop  
Serial Number: 870277766.01.01.001  
Description: SEW GEARMOTOR 73.15 RATIO

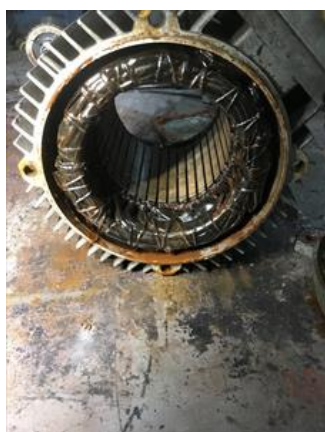
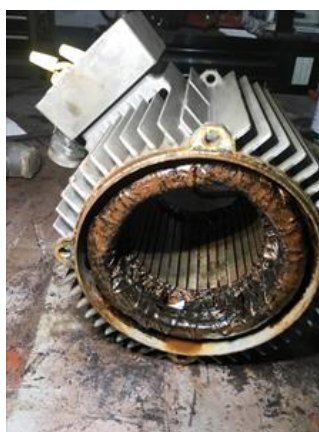
P94

14. Frame Condition

windings saturated with oil.

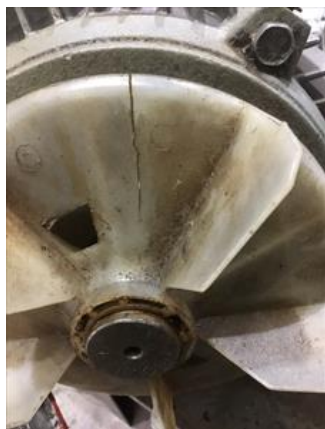
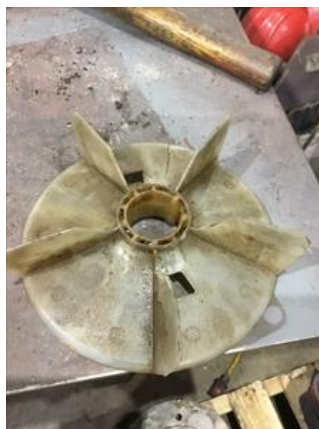
P96

15. Fan Condition

(F) Fail

Cracked

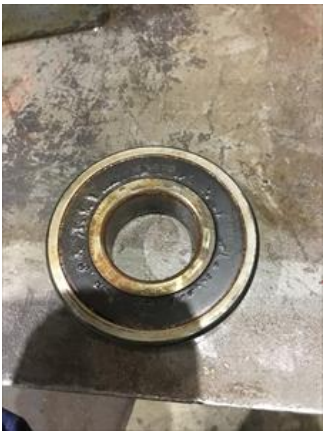
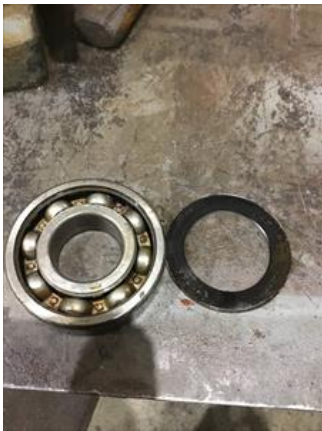
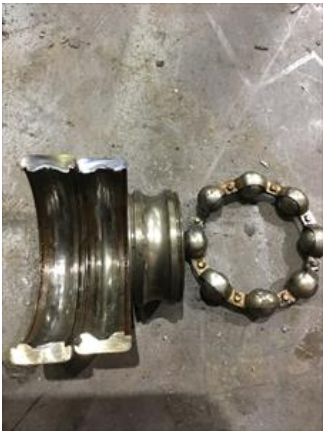
</div>		
31. Drive End Bearing Condition	replace	P78
<div>

Damage due to contaminated lubricant

☐ Replace all seals and bearings. Repair shaft seal surface.

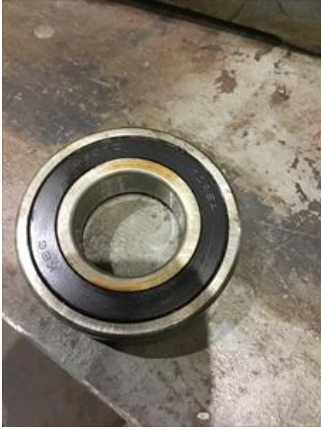
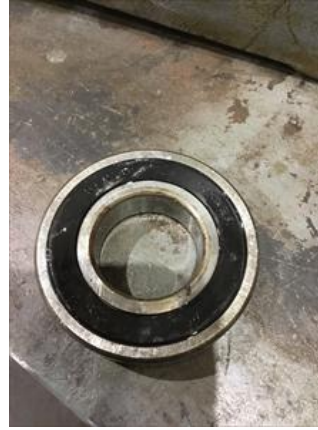
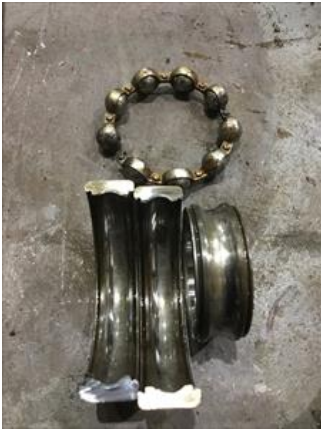
32.	Opposite Drive End Bearing Brand	KBC	
33.	Opposite Drive End Bearing Number-	6207 D	P90

*Damage due to contaminated lubricant*

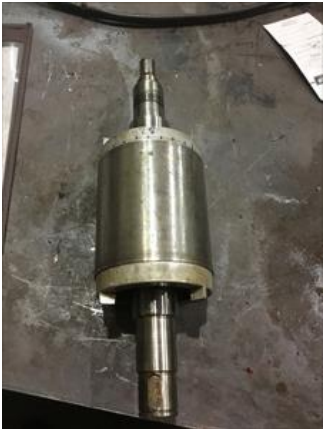
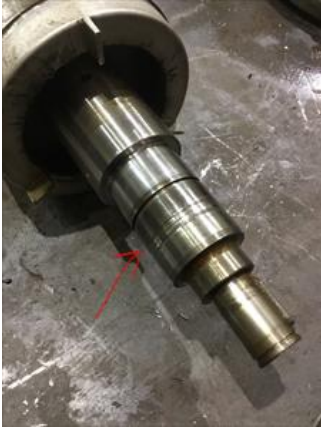
P28

Seal surface worn

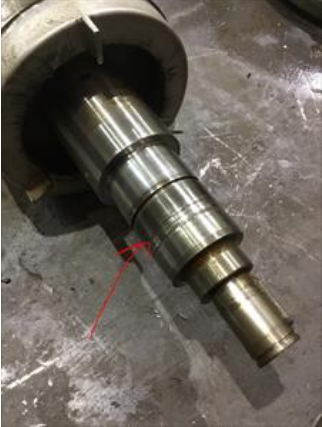
59.	Opposite Drive End - Endbell Bearing Fit		
	0 Degrees	60 Degrees	120 Degrees
	<b>2.8346</b>	<b>2.8347</b>	<b>2.8347</b>
60.	Opposite Drive End - Endbell Bearing Fit Condition		(P) Pass
61.	Bearing Cap Condition		
	Drive End Bearing Cap	Opposite Drive End Bearing Cap	
	na	na	
62.	End Bell Air Seal Fits		
	Drive End Air Seal	Opposite Drive End Air Seal	
63.	List Machine Work Needed Below		P64
	<i>D.E shaft seal surface</i>
