## AC Inspection as Found

Arauco-Malvern MDF (10298)

### AC Inspection - Rev. 2

Description: 75 HP TECO TEFC

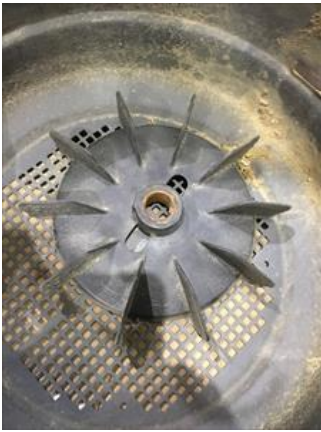
## 14. Fan Condition

(P) Pass

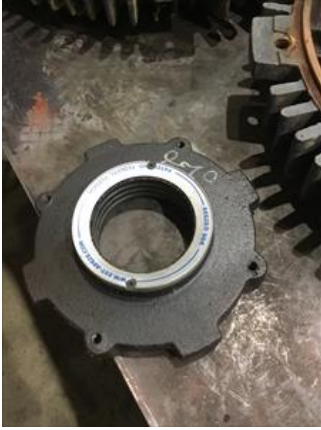
28. Drive End Bearing Insulation or Grounding Device?

Aegis

*Housing fits bad and bearing grease was contaminated in both bearings. Recommend replacing aegis ring on d.e bearing cap. Aegis shaft dia 2.9470*

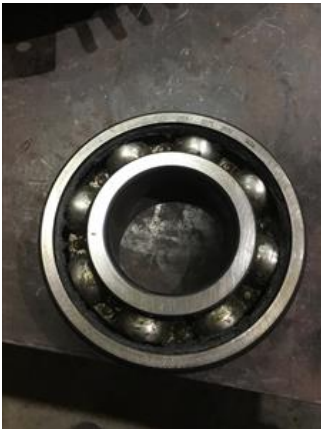
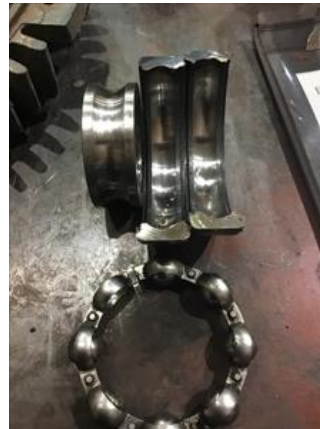
30. Drive End Bearing Condition

replace

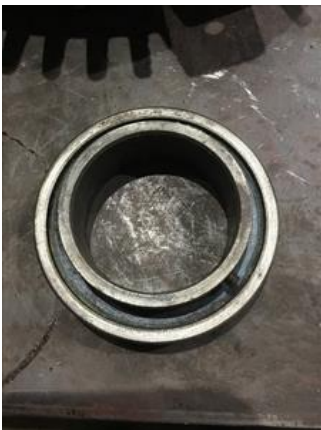
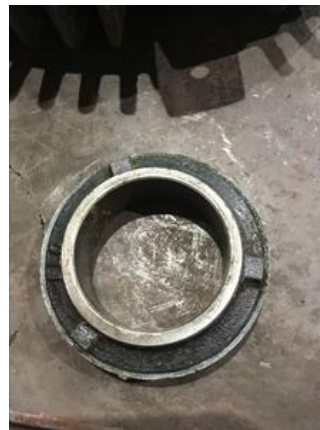
37. Opposite Drive End Wavy Washer/Snap-Ring Other Retention Device?

locking cap

replace

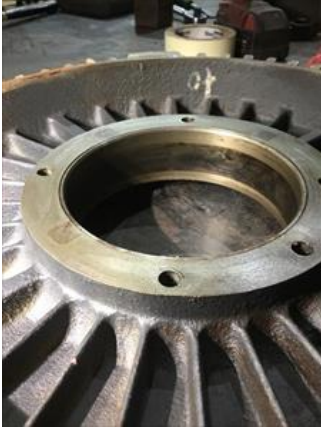
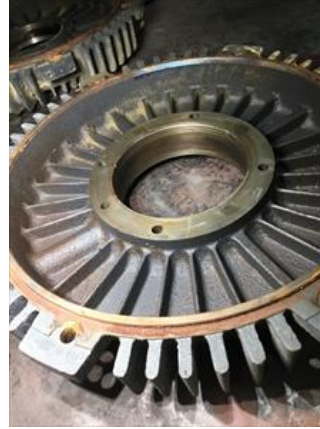
## 56. Drive End - Endbell Bearing Fit

(F) Fail

*Both end bell housing fits pitted and fretted.*

*Housing fits bad and bearing grease contaminated.*

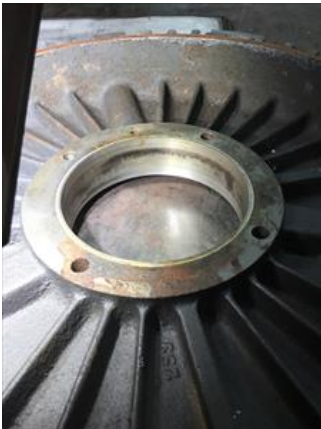
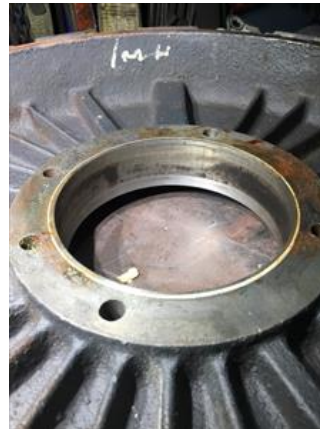
## 59. Opposite Drive End - Endbell Bearing Fit Condition

(F) Fail

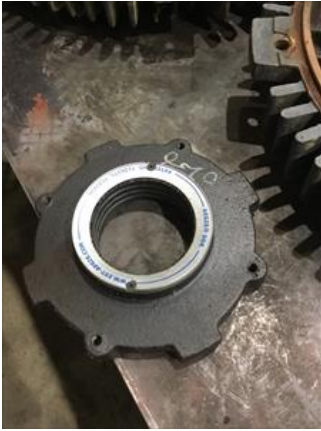
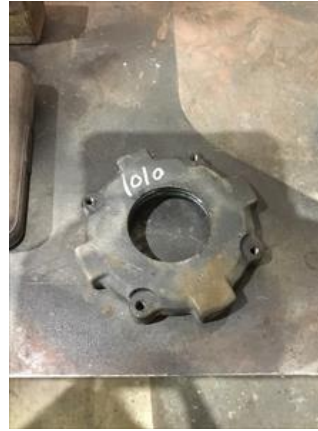
## 60. Bearing Cap Condition

Drive End Bearing Cap  
pass

Opposite Drive End Bearing Cap  
pass
