# AC Inspection as Found Arauco-Malvern MDF (10298) 1275 Willamette Rd

Description:75 HP TECO TEFC

AC Inspection - Rev. 2

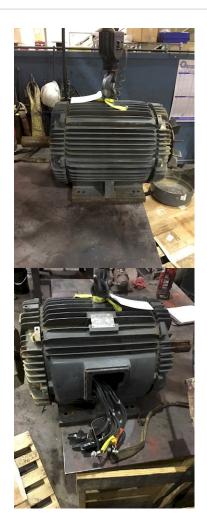
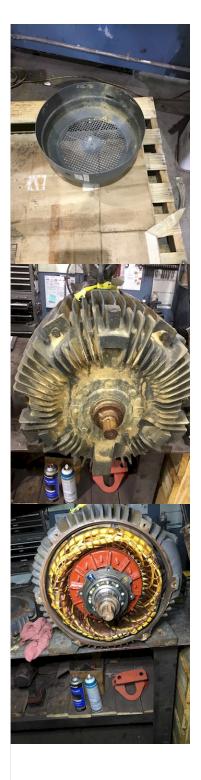
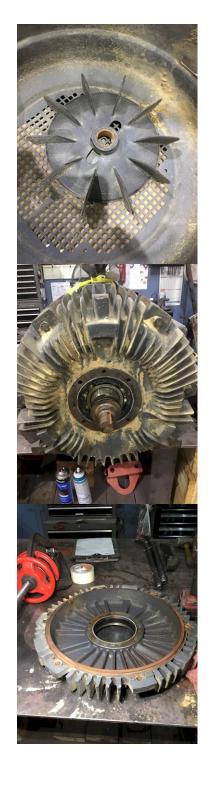
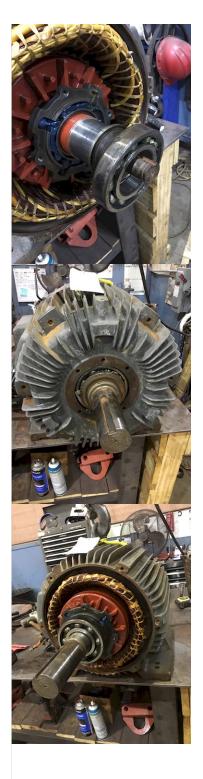
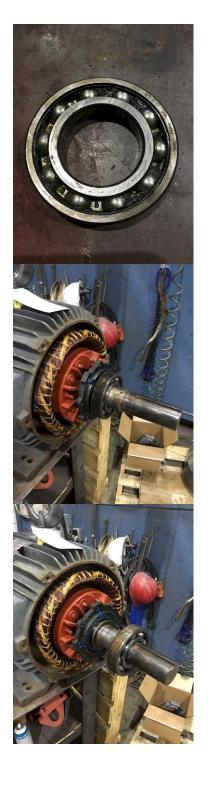
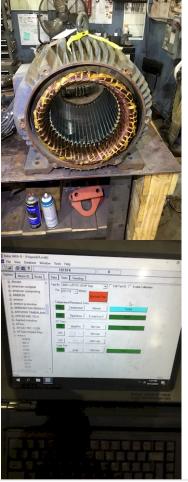
3. Photos of all six sides of the machine.

4.	Describe the Overall Condition of the Equipment as Received
	Serviceable
