AC Inspection as Found

Reynolds Metals company

AC Inspection - Rev. 2

Description: 100 hp

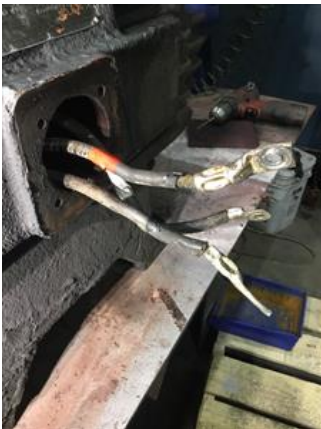
5.	Does Shaft Turn Freely?	(No) No	
6.	Does Shaft Have Visible Damage?	(No) No	
7.	Assembled Shaft Runout	Inches	
	<i>Shaft will not rotate.</i>		
8.	Assembled Shaft End Play	inches	
9.	Air Gap Variation <10%		
10.	Lead Condition	(F) Fail	P56
	<i>Insulation cracked and worn</i>

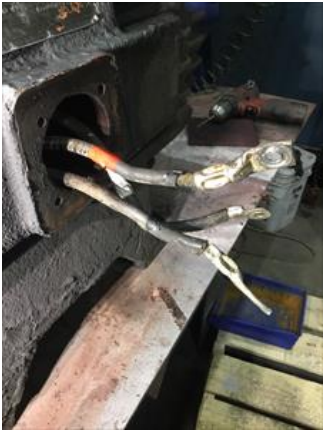
11. Lead Length	7 Inches	P81

Lugged

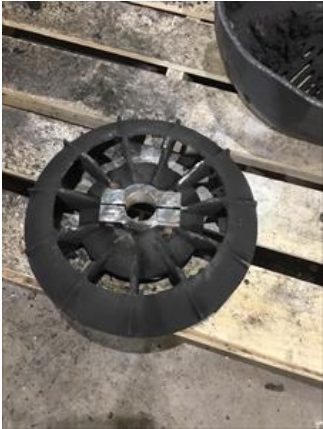
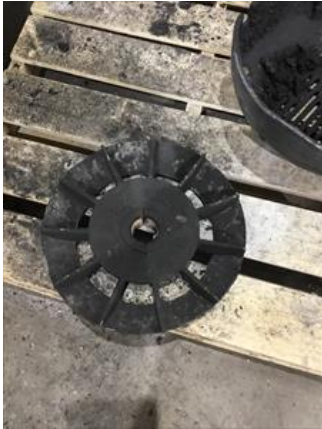
12. Lead Numbers	1-3	
13. Frame Condition	pass	
14. Fan Condition	(P) Pass	P109

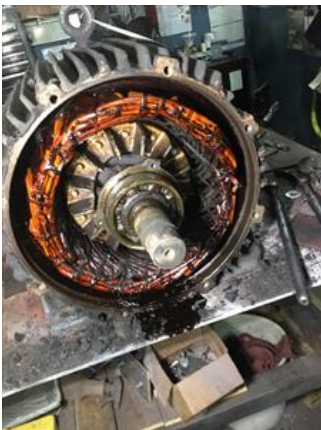
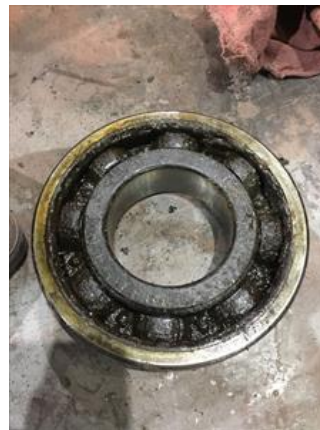
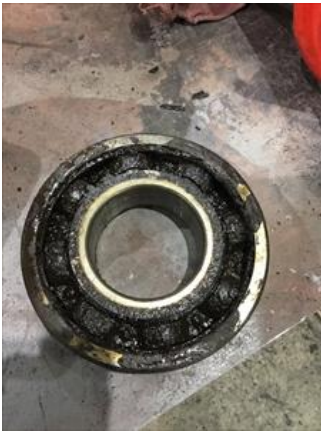
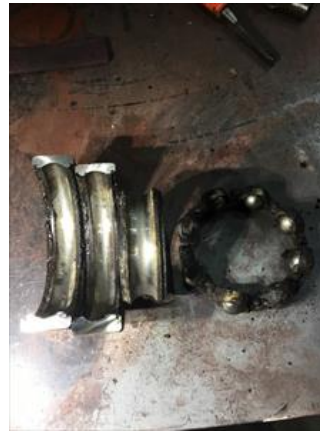
P108

| 38. Opposite Drive End Bearing Condition | replace. |

73.	Post Rewind Surge Test		
74.	Post Rewind Hi-Pot		
75.	Technician		
Root Cause of Failure			
76.	Failure locations		
	D.E bearing cage failed, due to excessive grease contamination on both bearings.

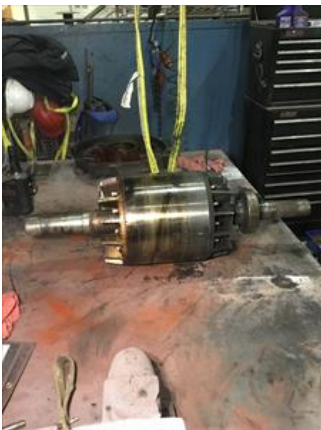
| 41. Rotor Type/Material | (Squirrel Aluminum) Squirrel

Cage Aluminum Die Cast | P3 |

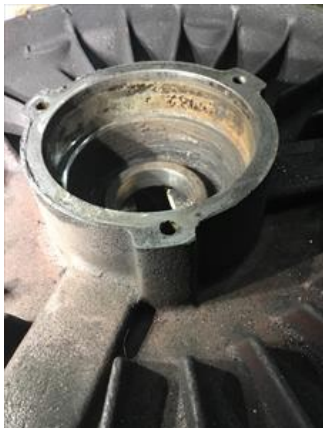
Bad from excessive wear.

57.	Drive End - Endbell Bearing Fit Condition	(F) Fail

Sleeve both end bell housing fits. Repair O.D.E shaft bearing journal. Polish rough shaft seal area on DE.

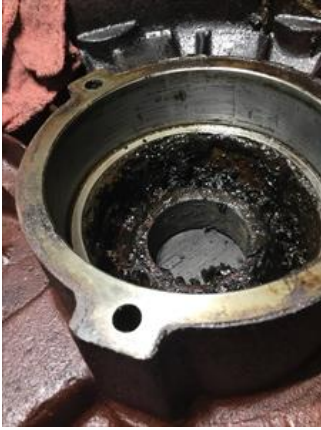
Failed due to excessive wear.

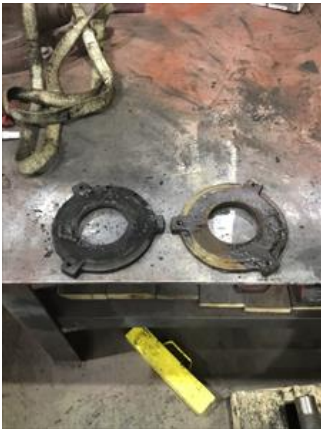
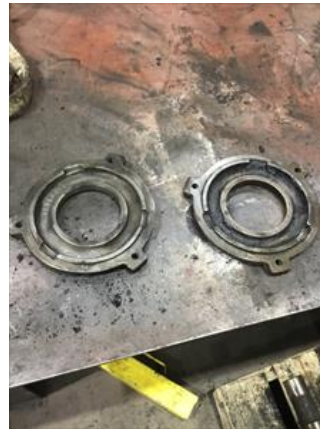
P52

Drive End Bearing Cap
pass

Opposite Drive End Bearing Cap
pass
