## AC Recondition As Found

**MOST INC (00473501)**  
355 JAMES LAWRENCE RD  
JACKSON, TN 38301

Location: Plant  
Serial Number: 1041037915  
Description: HORIZONTAL AC MOTOR

Hi-Speed Job Number:	148585
Manufacturer:	WEG
Spec/ID #:	MODEL MGP80
Serial Number:	1041037915
HP/kW:	1000 (HP)
RPM:	713 (RPM)
Voltage:	4160
Current:	134.1 (Amps)
Phase:	Three
Hz:	60 (Hz)
Service Factor:	1.15
# of Leads:	3
J-box Included:	Complete
Coupling/Sheave:	Coupling
Date Received:	10/18/2022
Bearing RTDs:	Yes
Stator RTDs:	Yes
Repair Stage:	Final
Rewind:	No
Shaft Machined Fit Repairs Required:	No
Bearing Housing Machined Fit Repairs Required:	No
Heaters:	Yes
Winding Type :	Form Coil
Bearing Type:	Rolling Element

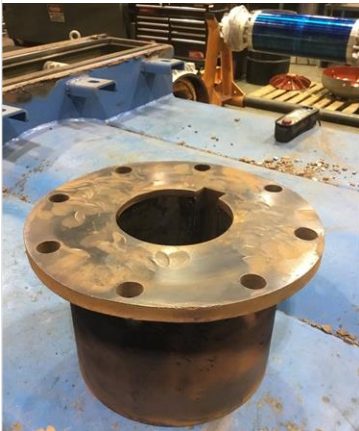
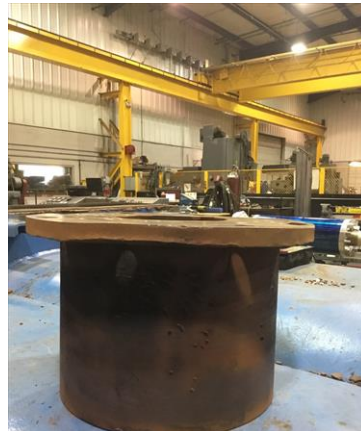
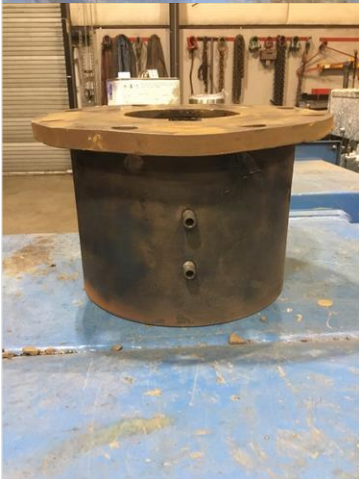
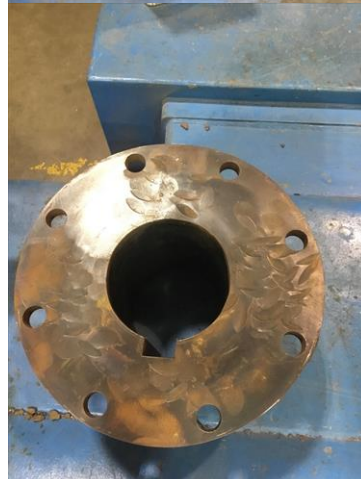
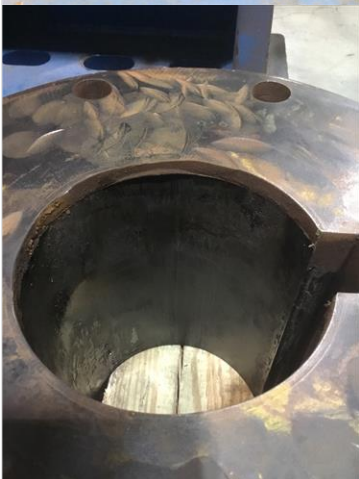
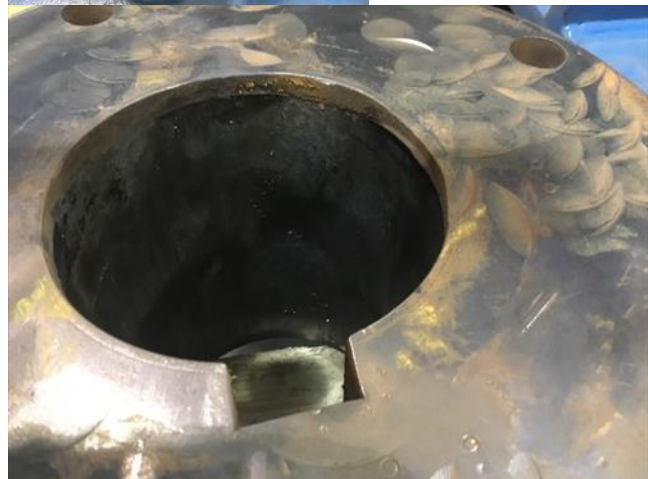
P5

5. Distance from the end of the shaft to the Coupling/Sheave

-0.375 inches

⚠ *Coupling protruding 3/8". Coupling was damaged when received. Coupler was beat on with a big hammer which bent flange and has visible damage on inside diameter. Coupling needs replaced.*

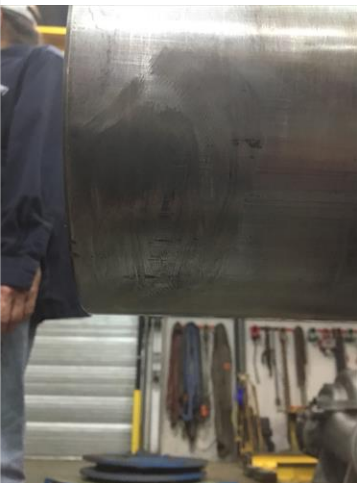
7.	Does Shaft Have Visible Damage?	(Yes) Yes	P7
<div>Does not require any repair.</div> <div>

</div> <div>Slight grinder marks on coupler end of shaft. No repair necessary.</div>			
8.	Assembled Shaft Runout	0.0003 Inches	P8
<div><div>

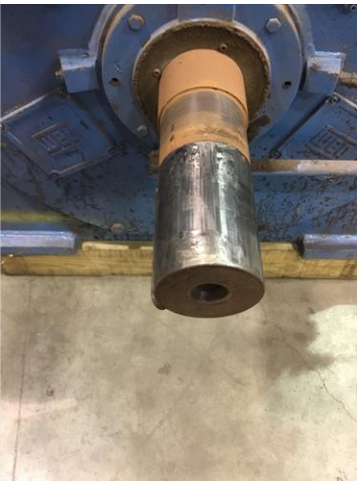
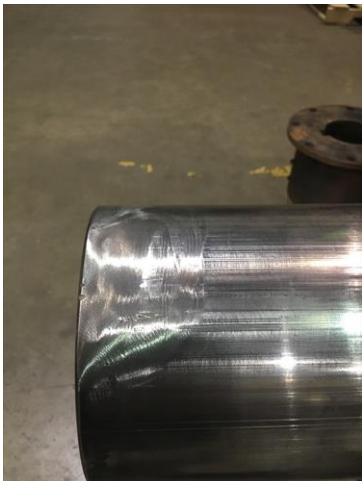
</div></div> <div>Grinder marks on end of shaft.</div>			
9.	Assembled Shaft End Play	0.002 inches	P11
10.	Air Gap Variation <10%	Pass	
11.	Lead Condition	(P) Pass	
<div>

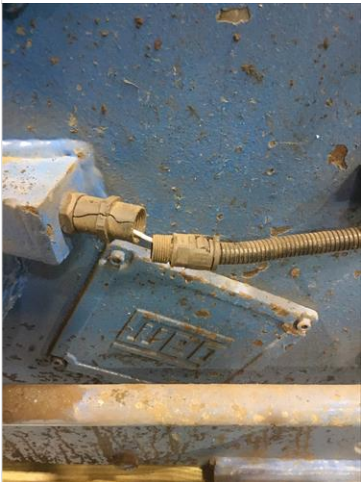
Drive end RTD plastic cracked

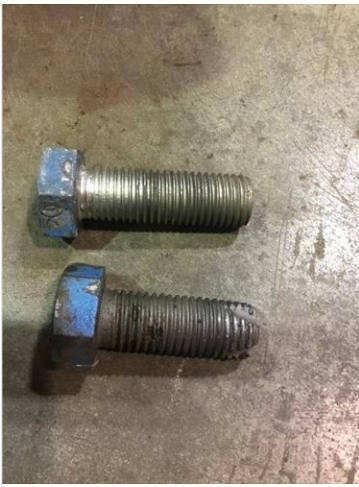
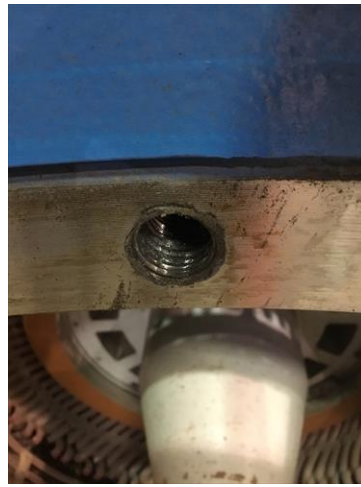
P18

*End bell bolt holes need chased with tap M20x2.5. Two end bell bolts need replaced. M20x2.5 x 75mm. Missing 12 of 16 bolts for electrical panel cover.*

Correct metric bolt on top, wrong standard bold on bottom.

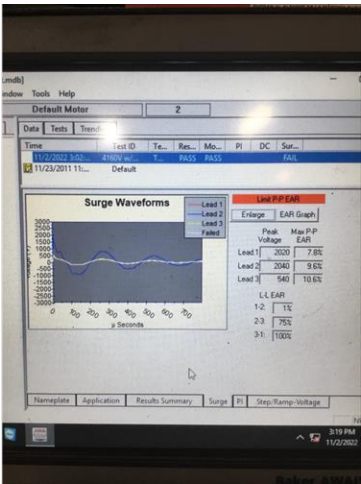
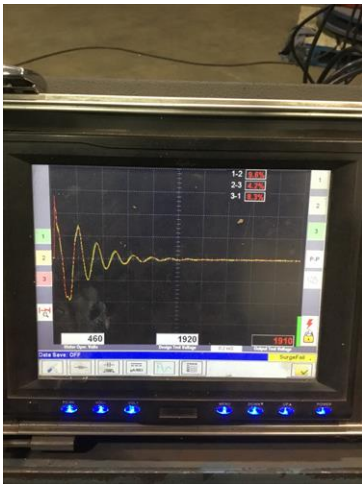
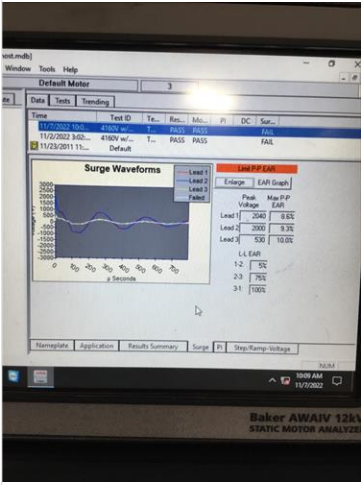
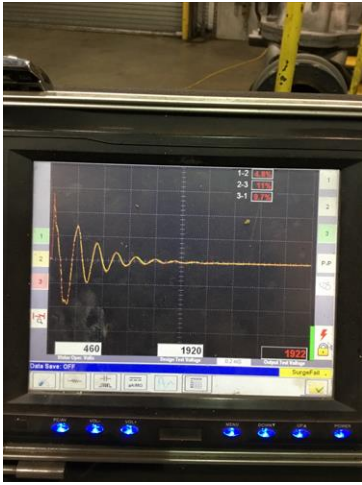
P21

21. Perform Surge Test

(F) Fail

22. Number of Stator Slots	90 Gigohms
23. Stator Condition	fail surge test

**STATOR FAILED SURGE TESTING**

*Coupling failed due to impacting. Winding failure is likely attributable to voltage spikes caused by transient voltage often times attributed to switching of other high voltage devices, and or lightning. Age/Temperature is also a possible factor in the winding degradation.*

*Fair, frame has had tabs welded on it to secure what appears to be the hood in the past. Coupling is in poor condition due to impacting from hammering. We highly suggest replacement of coupling, it is included in the quote. The stator failed the surge test. It is possible for a motor to fail the surge test though running. However, it is a warning sign that a failure will likely occur soon. Stator rewind is highly recommended.*

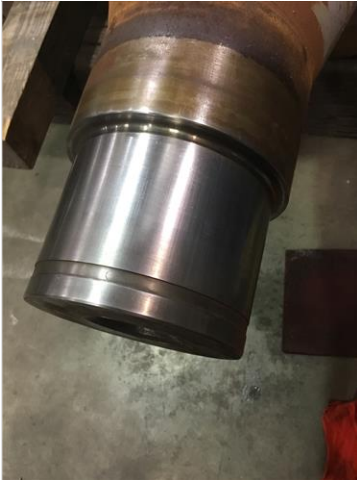
110mm=4.3307. Tolerance is 4.3312-4.3318 .0001 out of tolerance press fit recommend no machine work
