Hi-Speed Industrial Service
7030 Ryburn Dr
Millington, Tn 38053
901-873-5300

AC Recondition As Found

KTG USA (0003468)

Hi-Speed Job Number:	149550
Manufacturer:	Toshiba
Product Number:	02250101-109R00
Serial Number:	991110765
HP/kW:	75 (HP)
RPM:	1775 (RPM)
Frame:	365TSC
Voltage:	230 / 460
Current:	178/89 (Amps)
Phase:	Three
Hz:	60 (Hz)
Service Factor:	1.2
Enclosure:	DP
# of Leads:	12
J-box Included:	Half
Coupling/Sheave:	Coupling
Date Received:	02/13/2023
Bearing RTDs:	No
Stator RTDs:	No
Repair Stage:	Final
Rewind:	No
Shaft Machined Fit Repairs Required:	No
Bearing Housing Machined Fit Repairs Required:	Yes
Heaters:	No
Winding Type :	Random Wound
Bearing Type:	Rolling Element

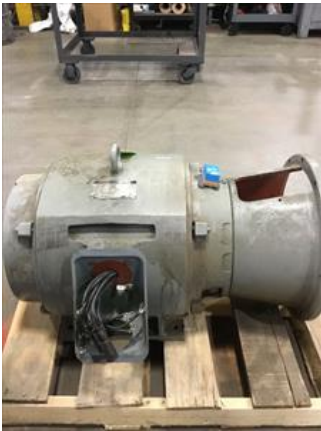
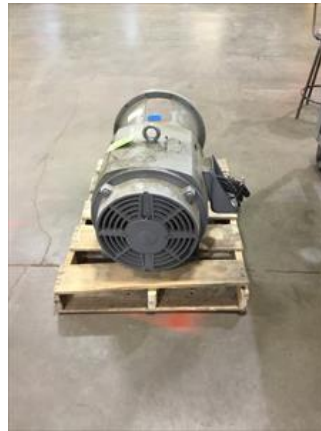
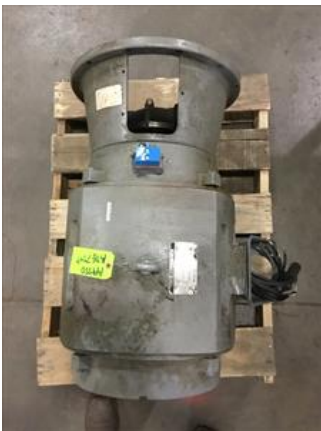
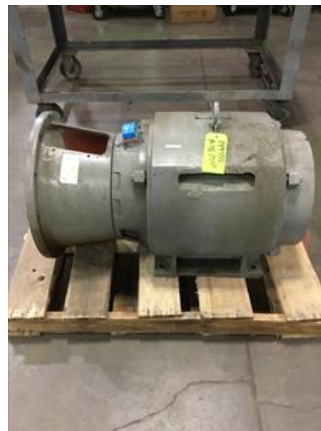
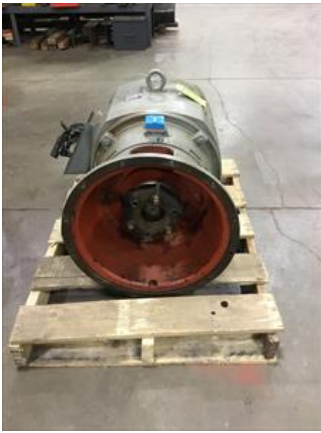
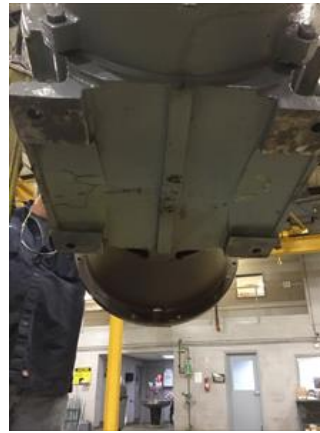
3. Photos of all six sides of the machine.

Good condition needs end bells bore and bush.

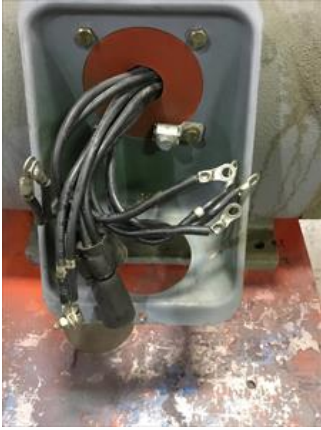
12. Lead Length

6.	Does Shaft Turn Freely?	(Yes) Yes
7.	Does Shaft Have Visible Damage?	(No) No
8.	Assembled Shaft Runout	0.001 Inches
9.	Assembled Shaft End Play	0.098 inches
10.	Air Gap Variation <10%	no Provisions To Measure
11.	Lead Condition	(P) Pass
	Missing lead # tags

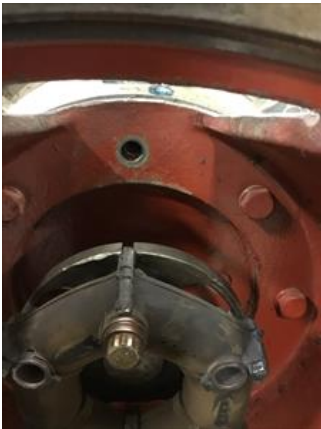
15. Broken or Missing Components

*Missing top bolt of c face***Initial Electrical Inspection**

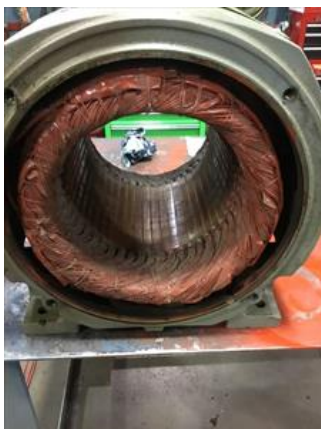
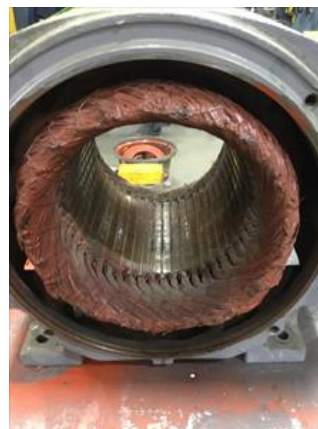
20. Stator Condition

good

Iron needs cleaned

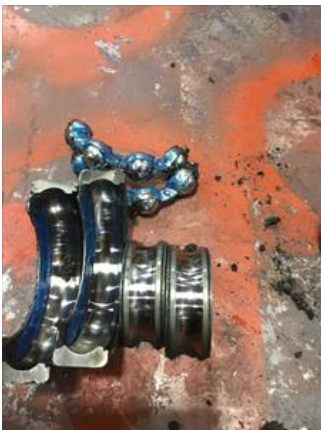
28. Drive End Bearing Condition

normal wear

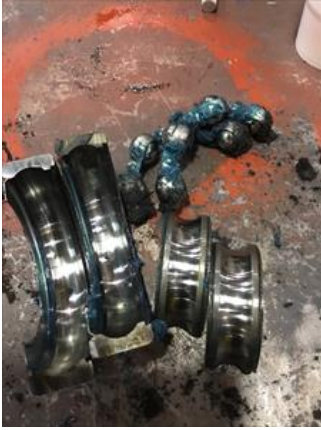
36. Opposite Drive End Bearing Condition

normal wear

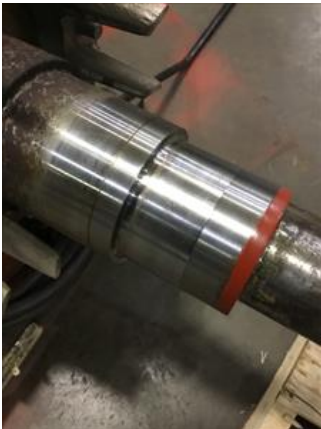
48. Drive End Bearing Shaft Fit

0 Degrees	60 Degrees	120 Degrees
2.5591	2.5591	2.5591

65mm=2.5690. Tolerance is 2.55912-2.5697. .0001 under tolerance recommend no machine work

(F) Fail

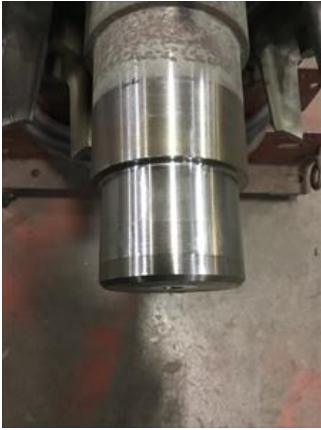
50. Opposite Drive End Bearing Shaft Fit

0 Degrees	60 Degrees	120 Degrees
2.5591	2.559	2.5591

65mm=2.5690. Tolerance is 2.55912-2.5697. .0001 under tolerance recommend no machine work

51. Opposite Drive End Bearing Shaft Fit Condition (F) Fail

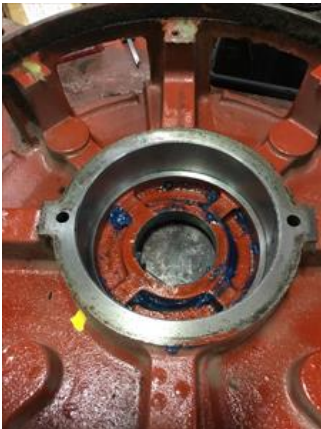
53. Drive End - Endbell Bearing Fit

0 Degrees	60 Degrees	120 Degrees
5.5135	5.5135	5.5135

140mm=5.5118. Tolerance is 5.5118-5.5128. .0007 out of tolerance recommend bore and bush

54. Drive End - Endbell Bearing Fit Condition (F) Fail

Bore and bush both end bells

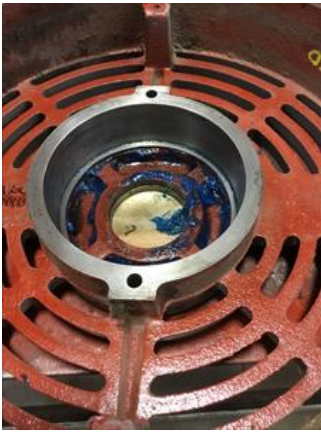
55. Opposite Drive End - Endbell Bearing Fit

140mm=5.5118. Tolerance is 5.5118-5.5128. .0006 out of tolerance recommend bore and bush

56. Opposite Drive End - Endbell Bearing Fit Condition **(F) Fail**
