## AC Recondition As Found

Hi-Speed Industrial Service

### AC Recondition - Rev. 2

Hi-Speed Job Number: 149639

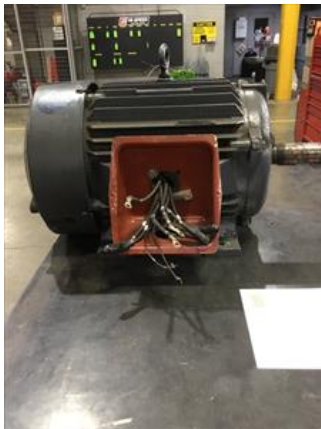
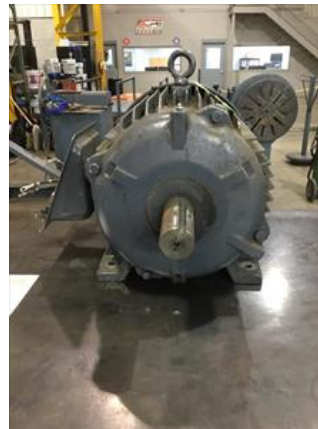
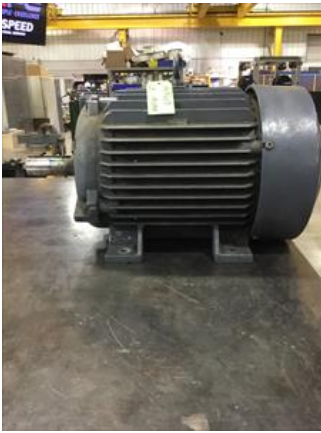
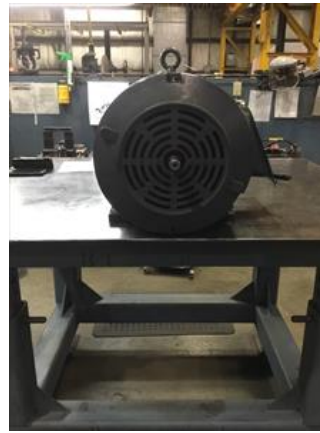
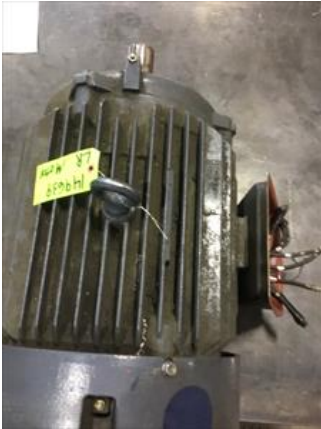
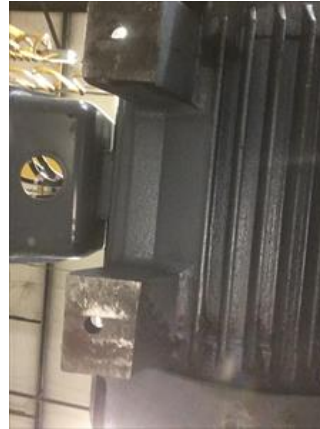
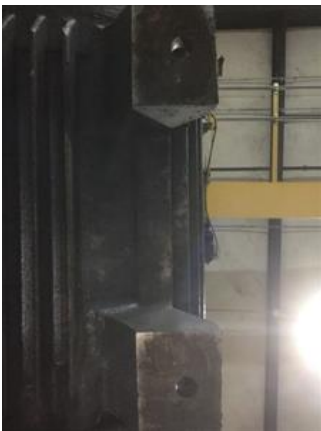
P3

4. Describe the Overall Condition of the Equipment as Received  
*Dirty, needs new lugs , wrong grease in endbells*

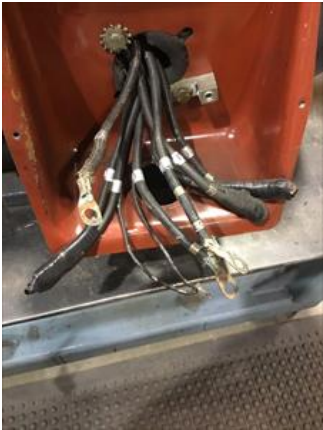
*Lugs need to be cleaned up or re lugged*

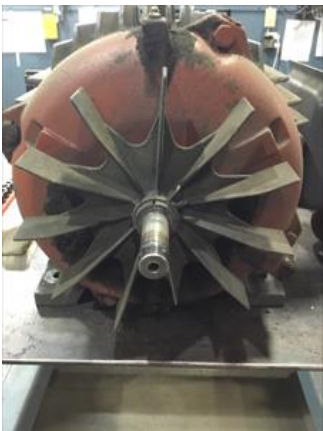
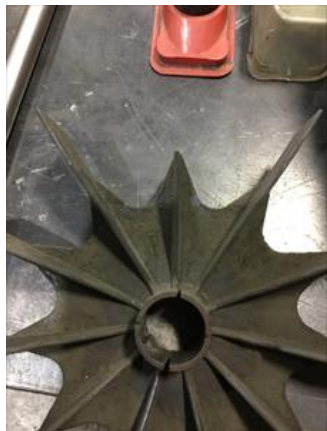
P16

14. Fan Condition

(F) Fail

*Fan broken*

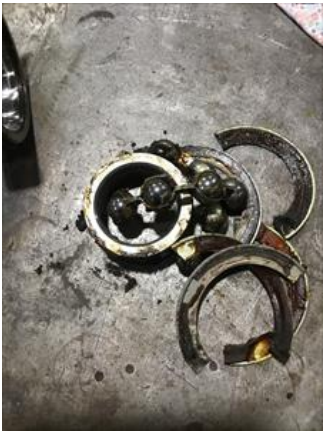
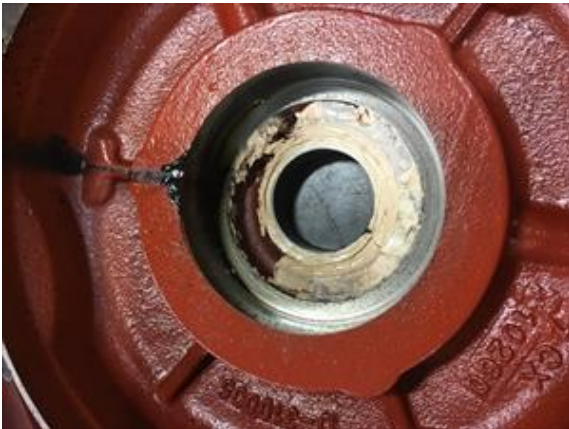
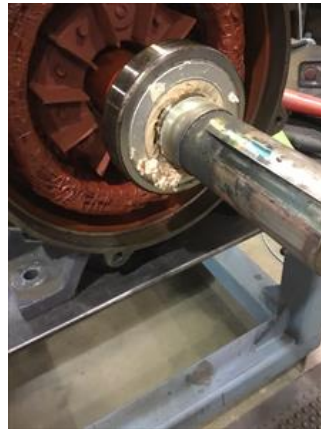
23. Drive End Bearing Qty.	1	
24. Drive End Bearing Type	(Ball) Ball Bearing	
25. Drive End Lubrication Type	(Grease) Grease Lubricated	P28
Wrong grease

Shields on

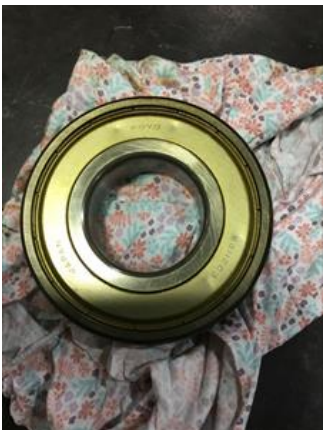
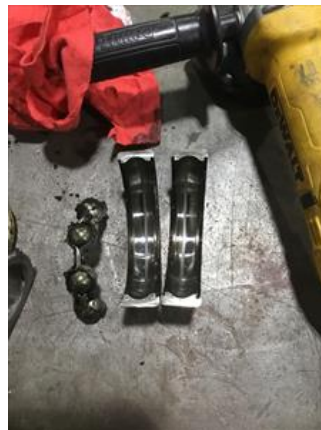
26. Drive End Bearing Insulation or Grounding Device?	none present	
27. Drive End Wavy Washer/Snap-Ring Other Retention Device?	none present	
28. Drive End Bearing Condition	worn wrong grease	
29. Opposite Drive End Bearing Brand	koyo	P32

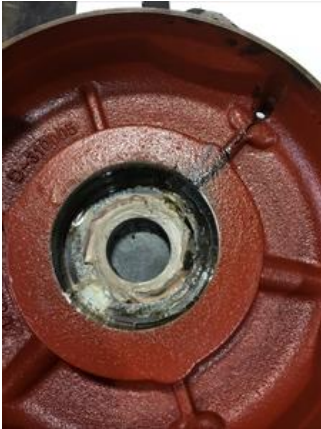
P36

33. Opposite Drive End Lubrication Type

(Grease) Grease Lubricated

Wrong grease

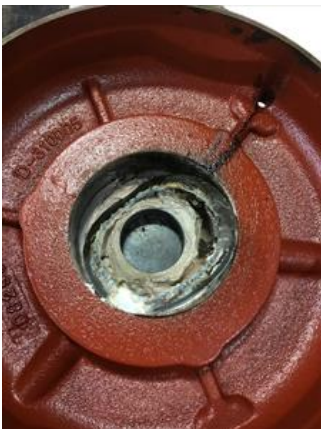
P38

35. Opposite Drive End Wavy Washer/Snap-Ring Other Retention Device?

wavy washer

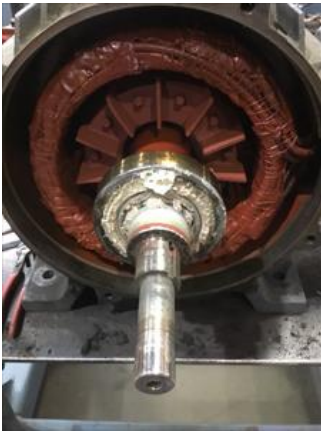
P39

36. Opposite Drive End Bearing Condition

worn

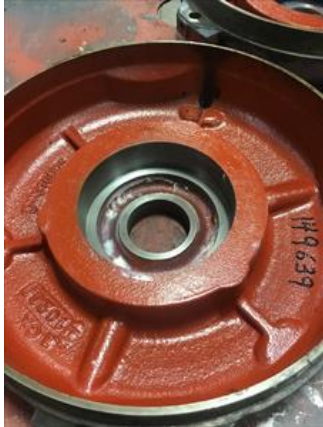
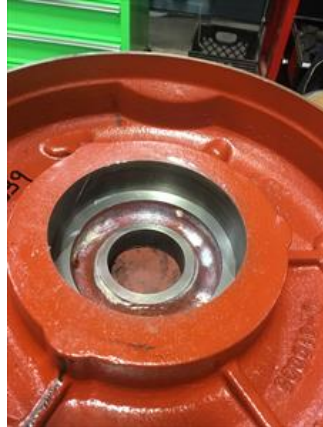
2.1248	2.1248	2.1248	
49.	Drive End Bearing Shaft Fit			P60
	0 Degrees	60 Degrees	120 Degrees	
	2.3631	2.3631	2.3631	
	60mm=2.3622. Tolerance is 2.3623-2.3628. .0003 oversized recommend no machine work			
	<div><div>

50.	Drive End Bearing Shaft Fit Condition			(F) Fail
51.	Opposite Drive End Bearing Shaft Fit			
	0 Degrees	60 Degrees	120 Degrees	
	2.166	2.166	2.166	
	55mm=2.1653. Tolerance is 2.1655-2.1660

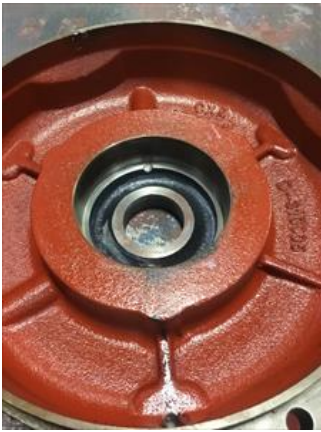
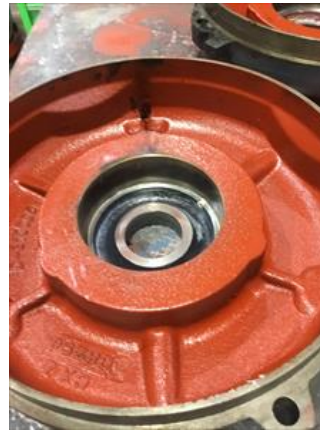
## 56. Opposite Drive End - Endbell Bearing Fit

120mm=4.7244. Tolerance is 4.7244-4.7253

(P) Pass
