Report Title 2023 PDMA Motor MCE Test Report
Submitted By Kevin Maxwell
Create Date 07/19/23 12:44 PM
Asset Name Wet Zone Circ. Fan
Description USG Greenville, MS

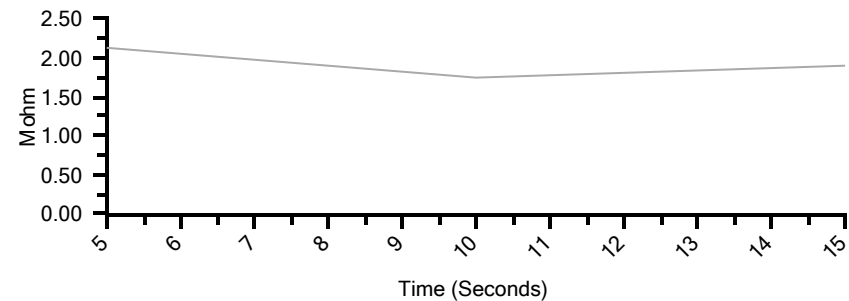
Date: 07/17/23 11:52 AM Test: Polarization Index Test

Remarks: Motor appears to have low megohm reading. This is a major concern and could cause issues especially under start up. PI test kicked out after 20 seconds due to excessive current leakage. Motor was megging around 2 mohms at 2500 volts. The minimum RTG value for this type of motor is 3.3 megohms. This is a good indication of excessive moisture and or contamination. Motor was down for several hours before test was performed. It had also rained heavily one or two days before testing. This may have some influence as this motor is not a true outdoor duty motor. We recommend retesting motor directly after shutting motor down during next availability.
