## American Yeast Memphis Plant 2023 Annual Infrared Survey Report

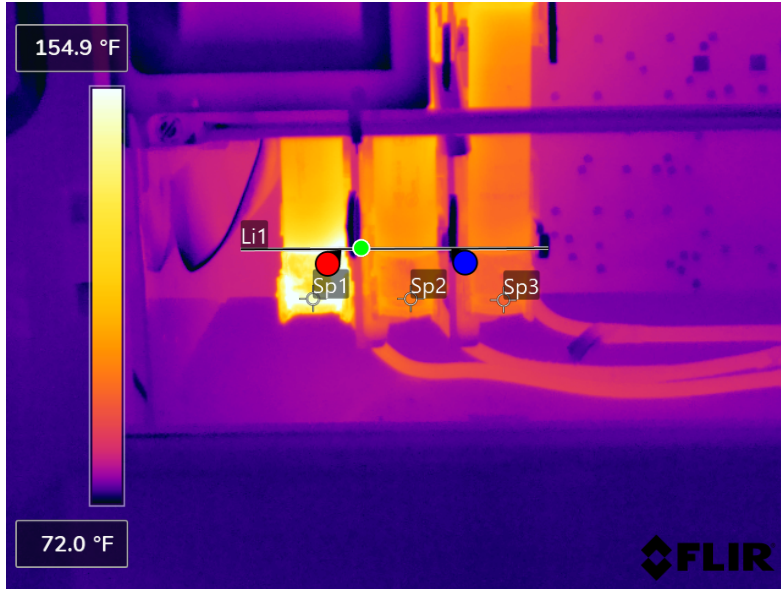
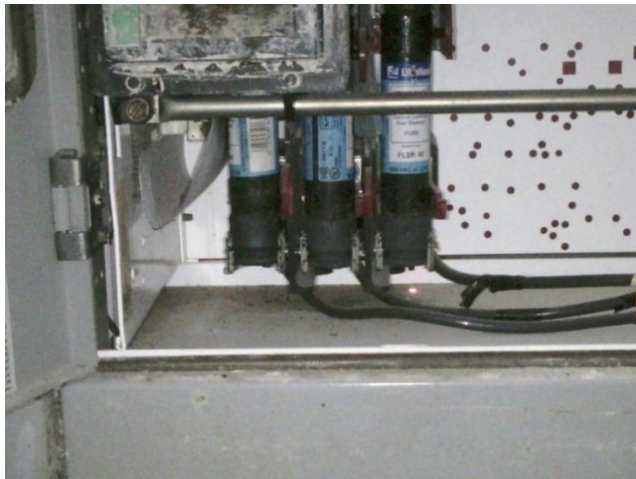
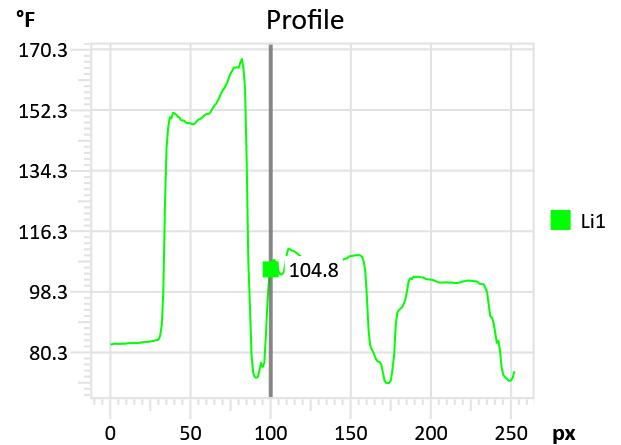
Chiller Room 400 HP Boiler #2

Fuse/Fuse Clip

Sp2	101.3 °F
Sp3	97.1 °F
Li1	
Max	167.5 °F
Avg	106.9 °F
Min	71.3 °F
Sp1	148.3 °F

Possible loose fuse connection/Weak Fuse

CLASS I

IR image shows A phase load side of fuse having an issue. Check fuse clip and fuse ensuring a clean tight connection. Ensure fuse clip/holder is not damaged or worn. If connection is found to be tight, then the fuse itself may be the issue and should be replaced.

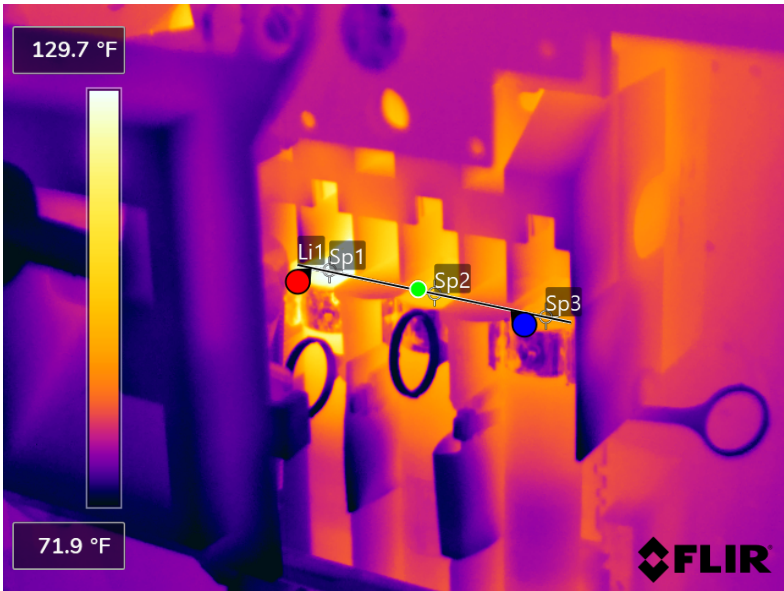
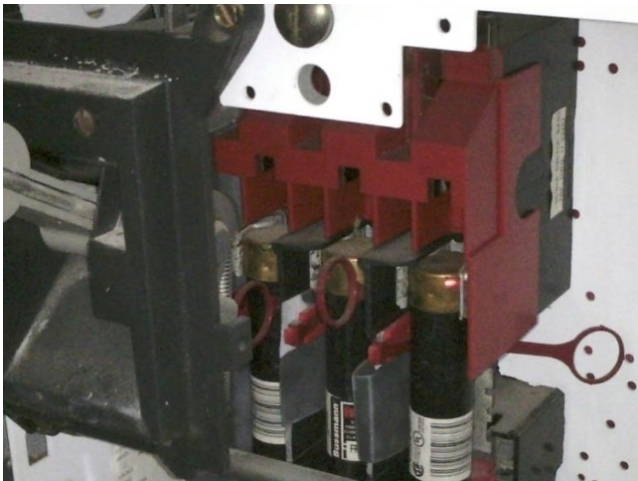
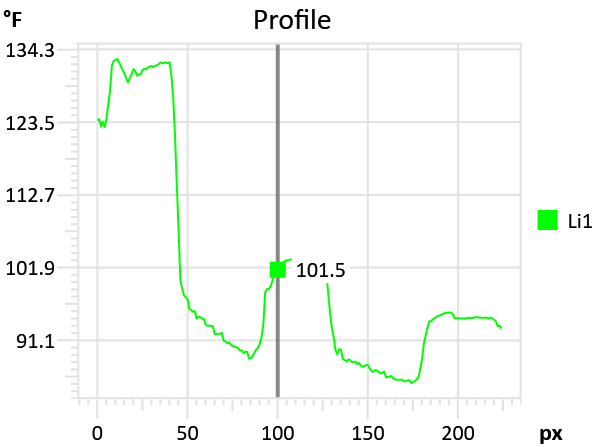
Chiller Room Boiler Feed Water Pump 1 and 2

Fuse Clip

Sp2	103.2 °F
Sp3	94.6 °F
Li1	
Max	132.9 °F
Avg	100.6 °F
Min	84.8 °F
Sp1	132.0 °F

Loose/faulty fuse clip connection

CLASS II

Fuse clip looks to be the issue here but may also be a fuse issue. Inspect fuse clip on A phase ensuring a clean/tight connection to the holder assembly and fuse itself.

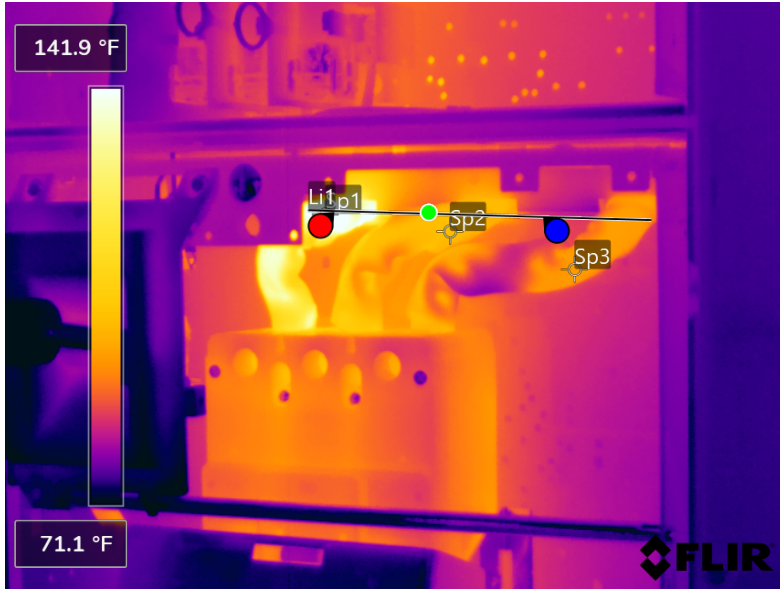
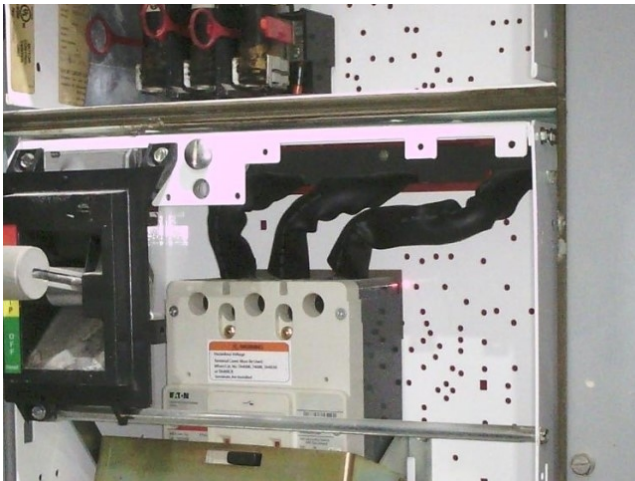
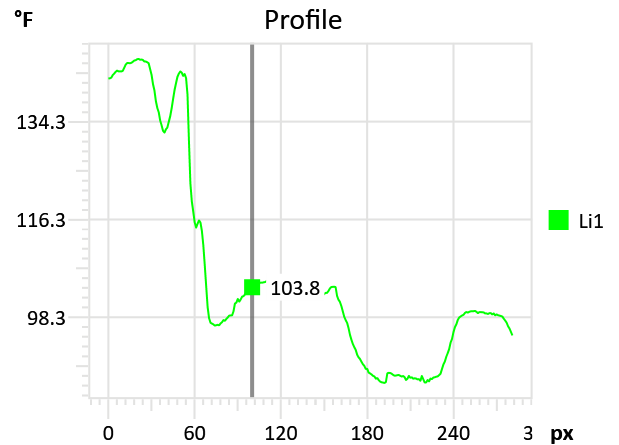
Chiller Room York Chiller #1

A phase power lead

Sp2	105.4 °F
Sp3	99.1 °F
Li1	
Max	145.9 °F
Avg	106.6 °F
Min	86.2 °F
Sp1	145.4 °F

Load imbalance and/or issue with power lead

**CLASS I**

IR image shows the highest temp to be at the back of the power lead. It is hard to tell what is going on here, but the delta-T on A phase is concerning. Measure load on each phase ensuring load is balanced. Also, inspect the A phase lead ensuring lead is not damaged. Trace lead back and inspect connection if possible.

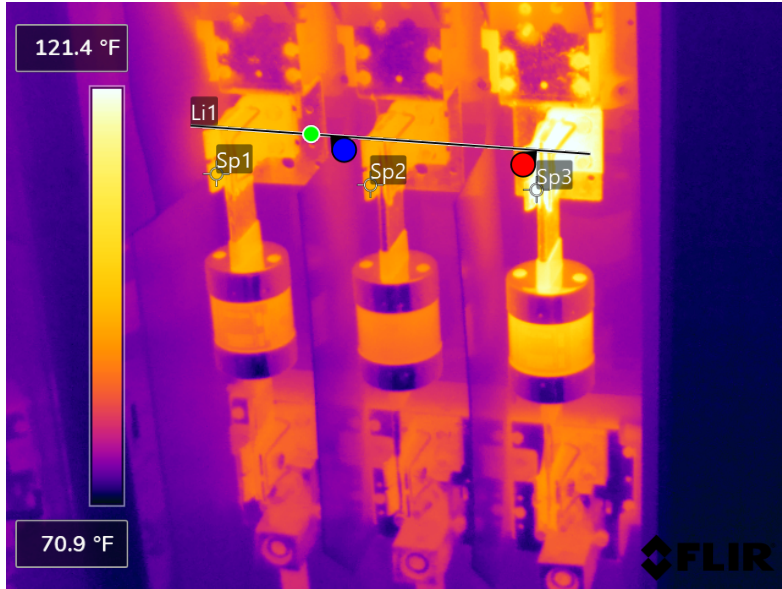
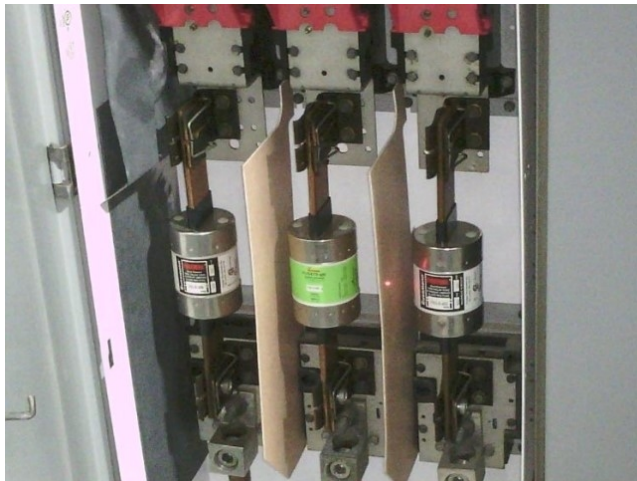
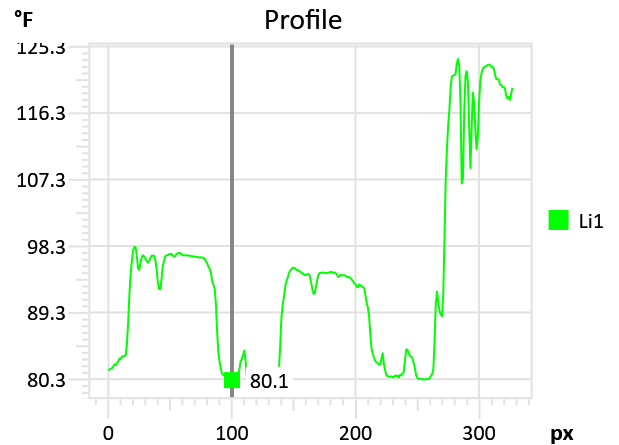
Well Pump #1 VFD

C phase fuse holder

Sp2	94.9 °F
Sp3	124.8 °F
Li1	
Max	123.7 °F
Avg	93.9 °F
Min	79.8 °F
Sp1	98.2 °F

Faulty fuse holder C PHASE

CLASS II

C phase fuse clip/holder has an issue. Ensure connection is tight and clean. Inspect fuse clip/holder for damage and wear.

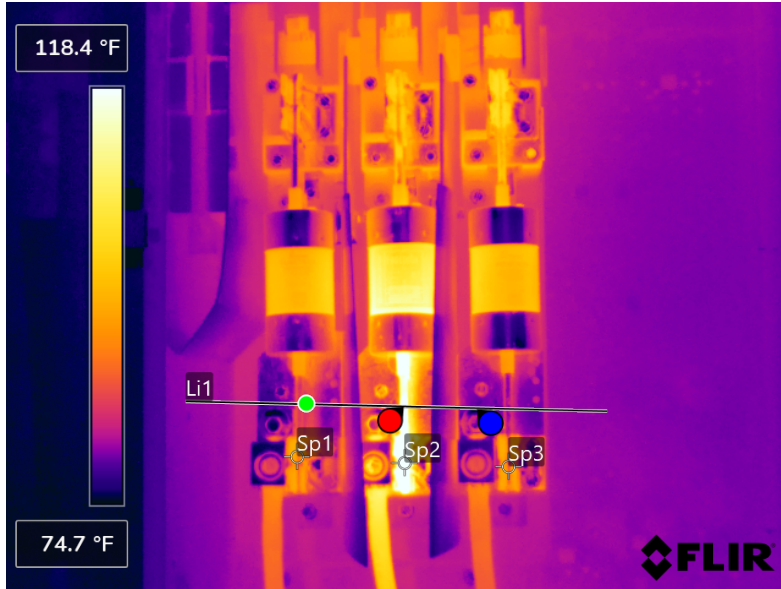
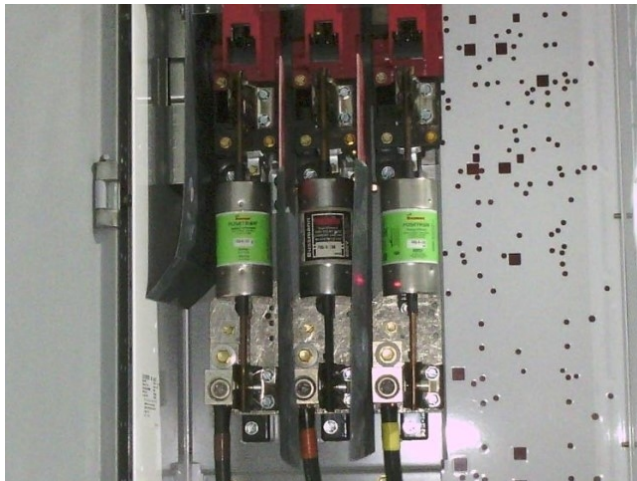
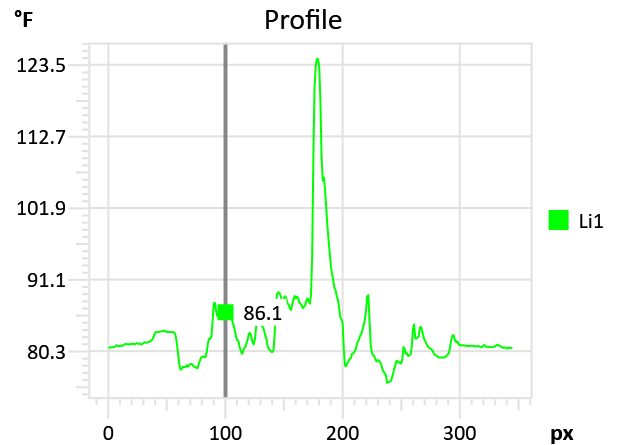
Cooling Tower #2 VFD

B phase fuse connection (Load Side)

Sp2	120.8 °F
Sp3	87.7 °F
Li1	124.4 °F
Max	124.4 °F
Avg	83.4 °F
Min	75.5 °F
Sp1	92.7 °F

Faulty Fuse Connection

CLASS II

B phase fuse and fuse clip are both showing visible signs of heat damage/corrosion. It is recommended to replace fuse, clean fuse holder/clips, and ensure new fuse has tight clean connection. Also measure current on each phase on load side ensuring motor has a balanced load.

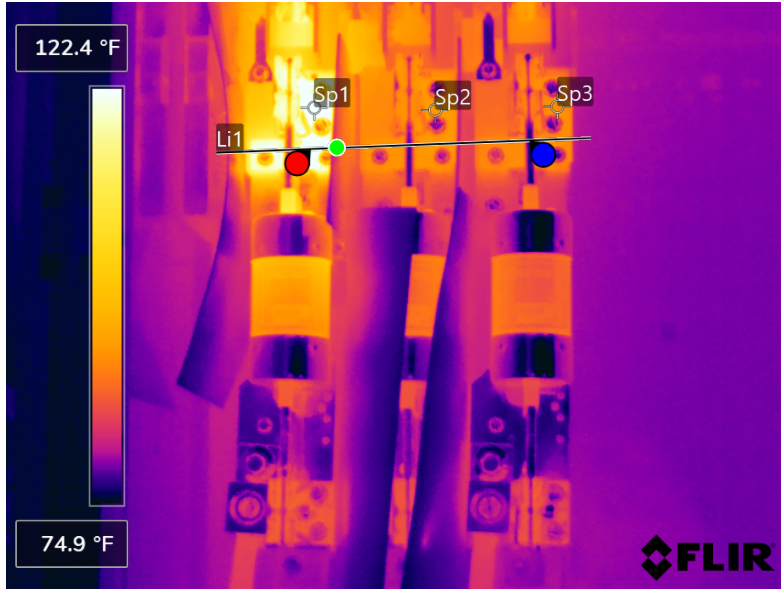
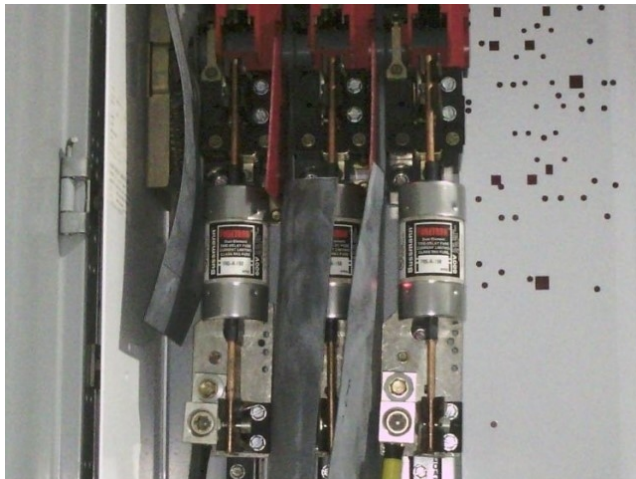
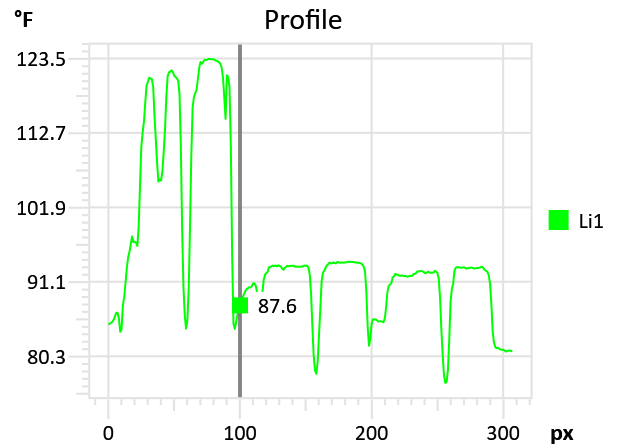
Cooling Tower Water Pump #2 VFD

A phase fuse connection

Sp2	94.0 °F
Sp3	92.8 °F
Li1	
Max	123.5 °F
Avg	95.9 °F
Min	76.4 °F
Sp1	124.5 °F

Faulty fuse connection

**CLASS II**

A phase fuse clip/holder has an issue on line side of fuse. Ensure connection is tight and clean. Inspect fuse clip/holder for damage and wear.

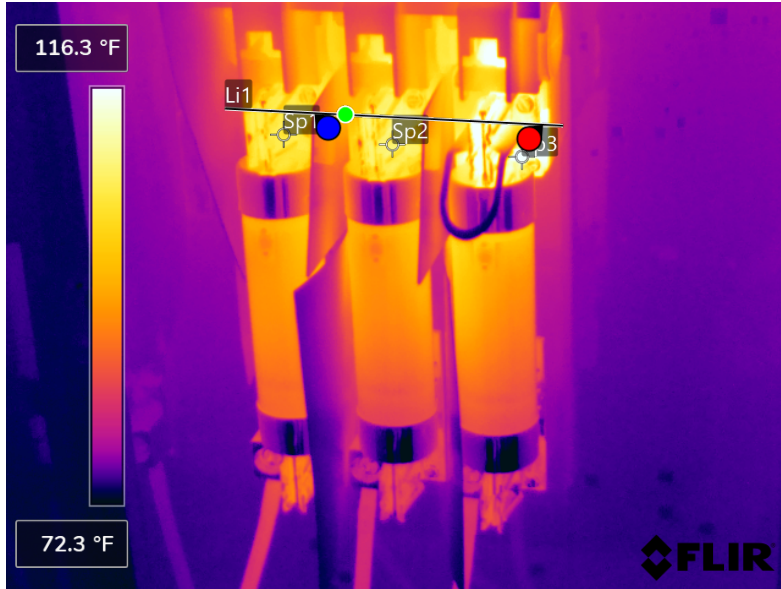
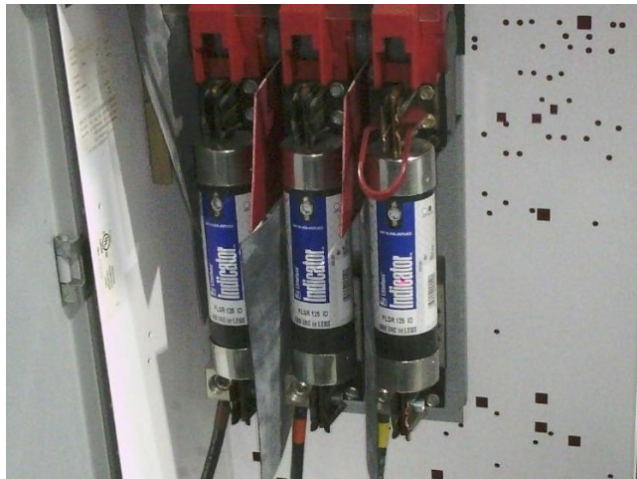
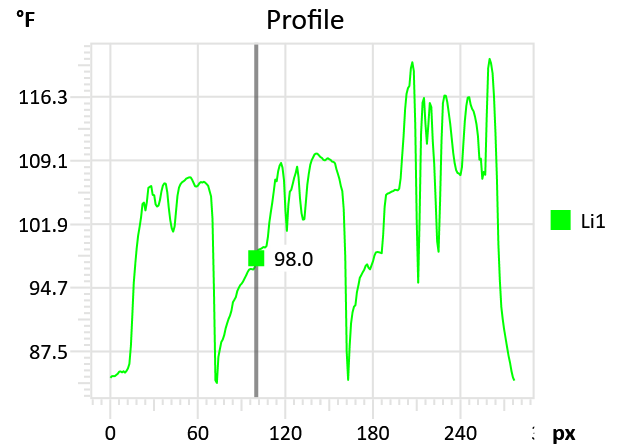
Chiller Evaporator Water Pump P2 VFD

C phase fuse connection (Line Side)

Sp2	108.3 °F
Sp3	121.1 °F
Li1	120.6 °F
Max	120.6 °F
Avg	102.9 °F
Min	84.0 °F
Sp1	104.5 °F

Fuse connection

CLASS I

C phase fuse clip/holder has an issue on line side of fuse. Ensure connection is tight and clean. Inspect fuse clip/holder for damage and wear.
