The following is a summary of findings from the Air Compressor vibration survey that was performed at MS Silicone on November 3, 2023.

### **Defect Summary**

## South Air Compressor CLASS II

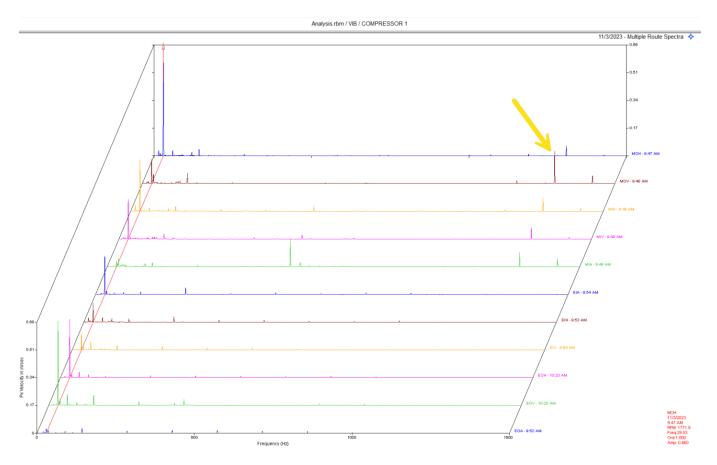
Multipoint spectra above is the motor and the compressor. Notice the large peak in the lower end of the motor spectra. This is 1 x motor rpm. The other large peak in the MOV spectrum is marked with the arrow. This peak is likely rotor bar pass frequency. Compressor spectra also shows a high 1 x input shaft rpm vibration.

A few issues were found during our assessment of this unit. The first issue found was a soft base condition that may be contributing to the high 1 x rpm vibration. The skid is not mounted very well to the concrete. While taking data in monitor mode, we stood on the skid and the vibration dropped from .5 to .4 ips-pk. This may be the effect and not the cause. We locked the unit out and performed a shaft run out check of the compressor section. Shaft was found to be within tolerance at .002" run-out. We then performed a lift check of the compressor shaft and found around .008" lift. This seems excessive as typical clearance should be around .0025-.0035". This could cause some high 1 x rpm vibration. We also checked the alignment with the unit hot and found .010" offset and angularity misalignment. Our spec is .002-.003" for 1800 rpm machines. We also found some wear of the coupling element that is causing some slack in the coupling hubs.

The rotor bar pass frequency peak in the motor data along with a high 1 x rpm vibration can sometimes be caused by rotor bar issues in the rotor. This is not as common as the other issues we found, but still could be suspect. For now, we recommend determining what the max shaft clearance is on the input compressor shaft. Air end may need to be

replaced due to excessive shaft movement. We also recommend to anchor the base down better, replacing the coupling element, and performing a hot alignment of the unit. If vibration persists, then the rotor could be the issue. Further vibration/electrical testing can be performed to help determine the rotor condition.
