QualiTest® Diagnostics

The following is a summary report from the initial vibration survey of the City Flood Pumps throughout the city of West Memphis, AR.

Defect Summary

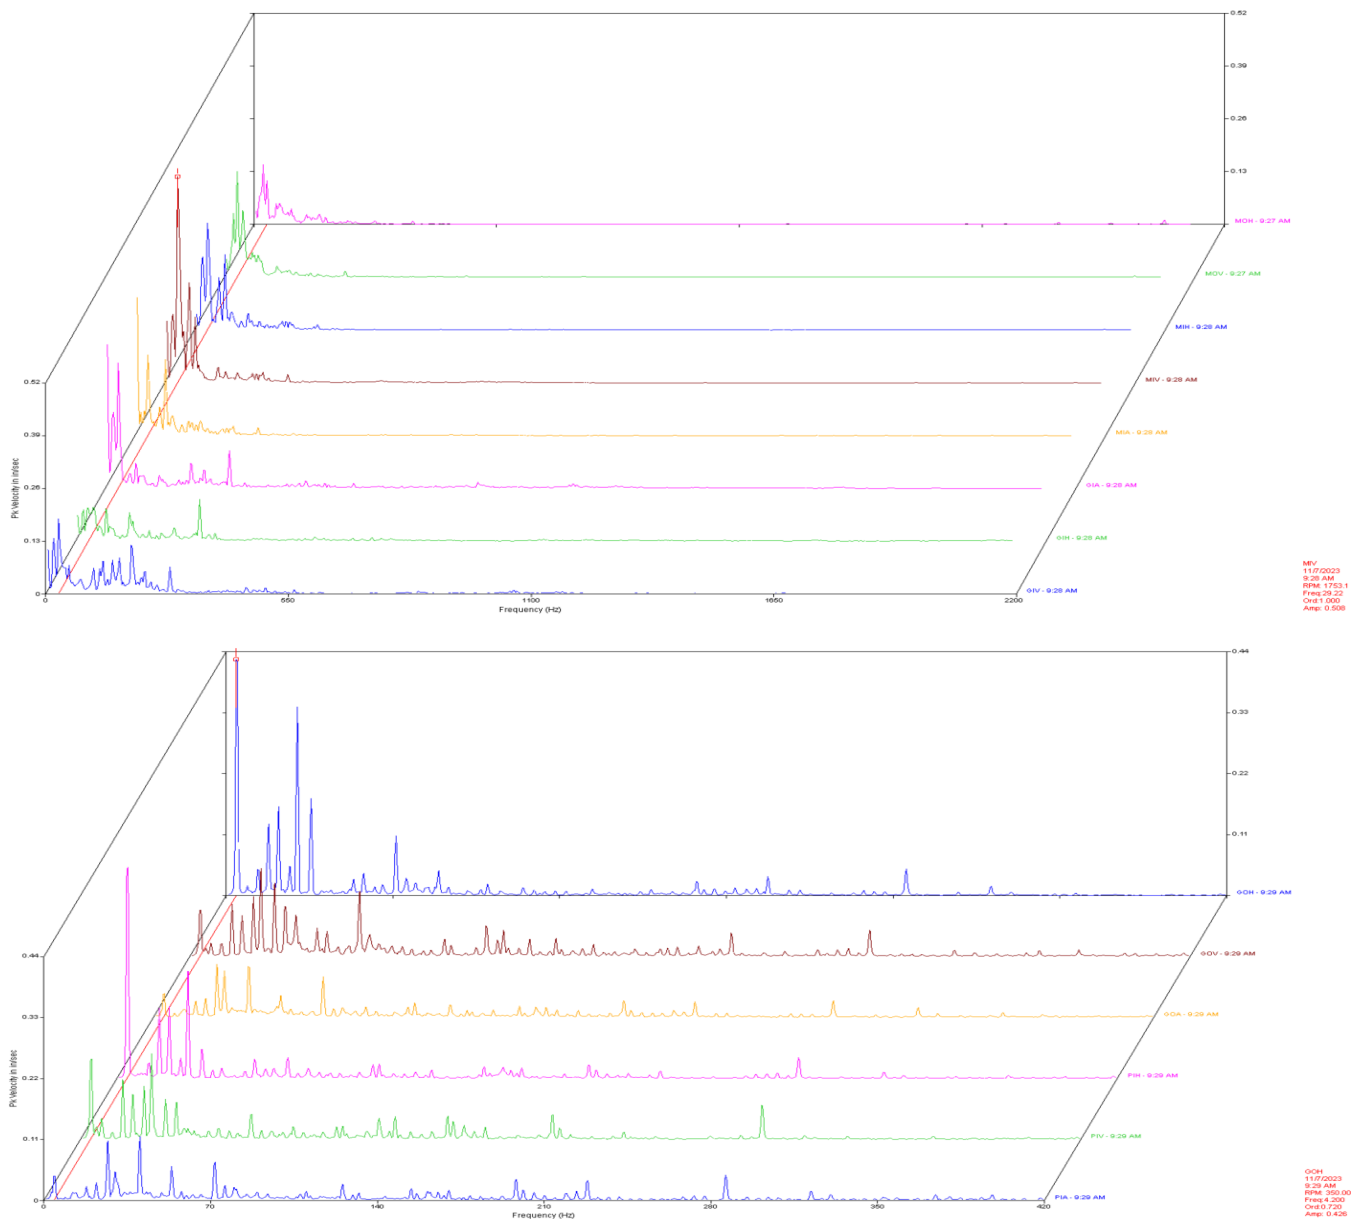
Airport Road Pump **CLASS II**

Data above is a multipoint spectral waterfall. The first plot is the motor and input of the gearbox. Second plot is the output of gearbox and inboard pump. The first plot shows some 1 x motor rpm vibration while the second plot shows some output speed vibration with some harmonics of pump speed.

For now, check sheaves for wear and misalignment and check belts for wear also. Gearbox appears to have some slight wear of the output end.

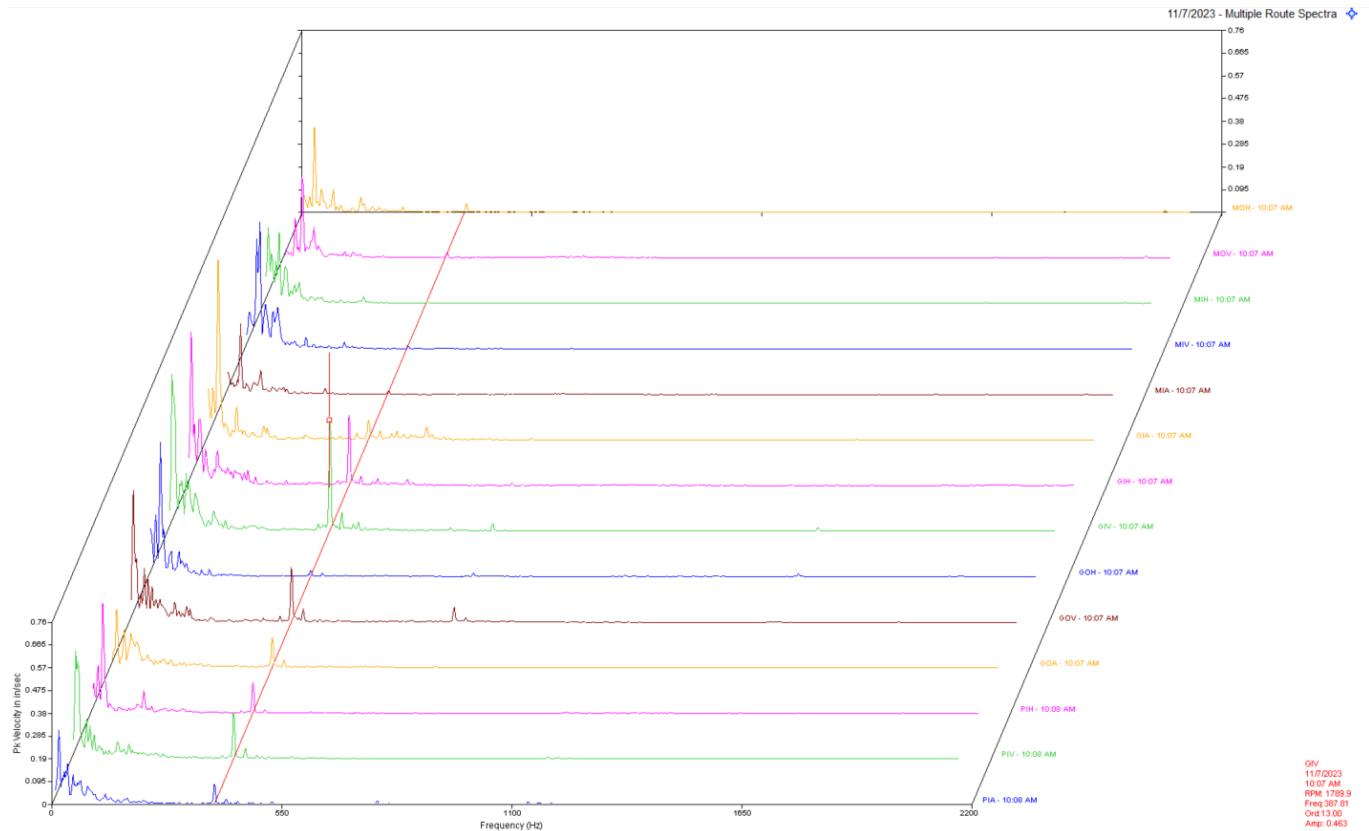
Ingram Road North Pump **CLASS II**

Data above is a multi-point spectral waterfall for the motor, geardrive, and pump. Data shows a low frequency vibration that is likely pump related. There is also a peak at 13 orders which may be gear related.

The pump shaft may be bent or some other shaft issue with pump may be present. Geardrive may also have some slight gear wear.

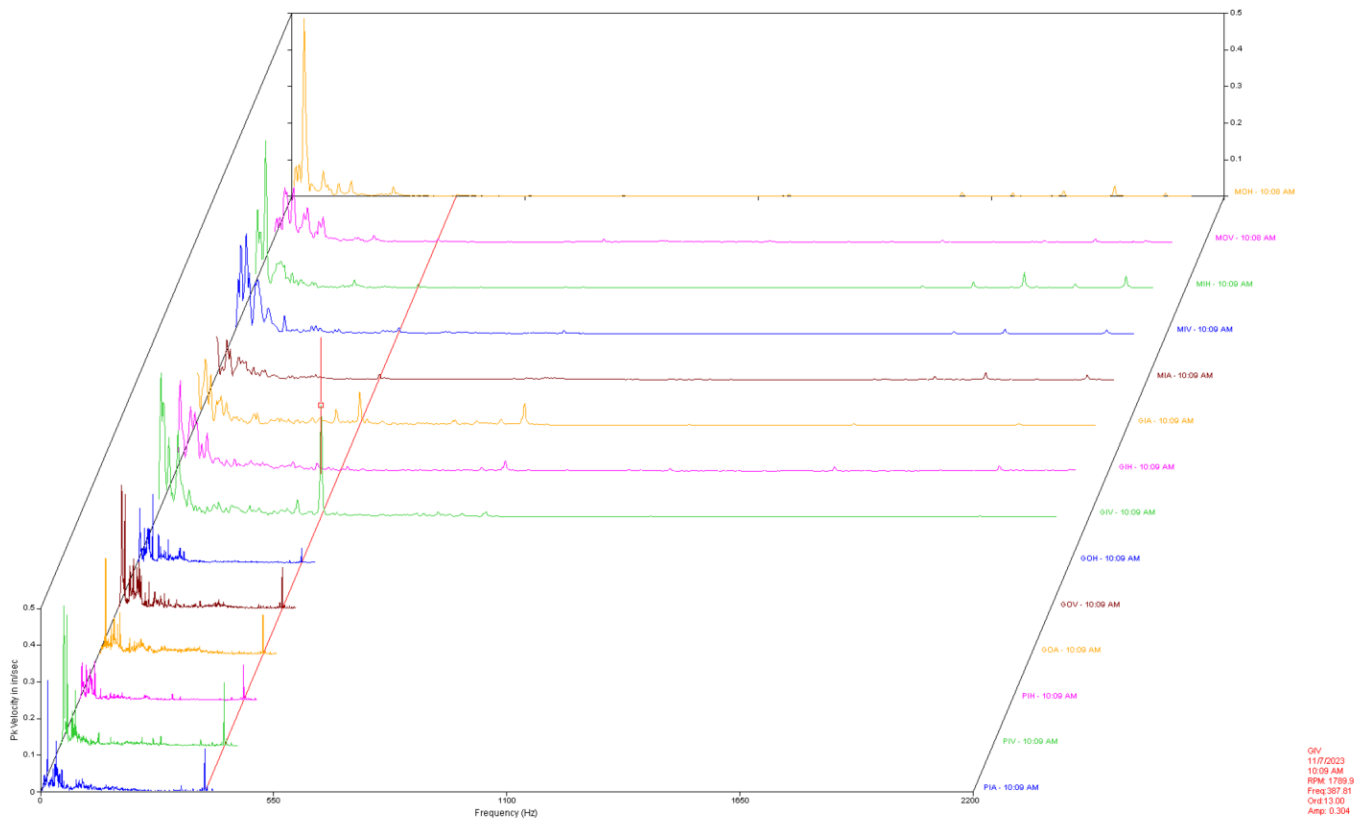
Ingram Road South Pump CLASS I

Data above is a multi-point spectral waterfall for the motor, gear drive, and pump. Motor data shows a high 1 x motor rpm vibration. There is also a peak at 13 orders which may be gear related.

For now, check sheaves for wear and misalignment and check belts for wear also. Gearbox appears to have some slight wear of the input gear.

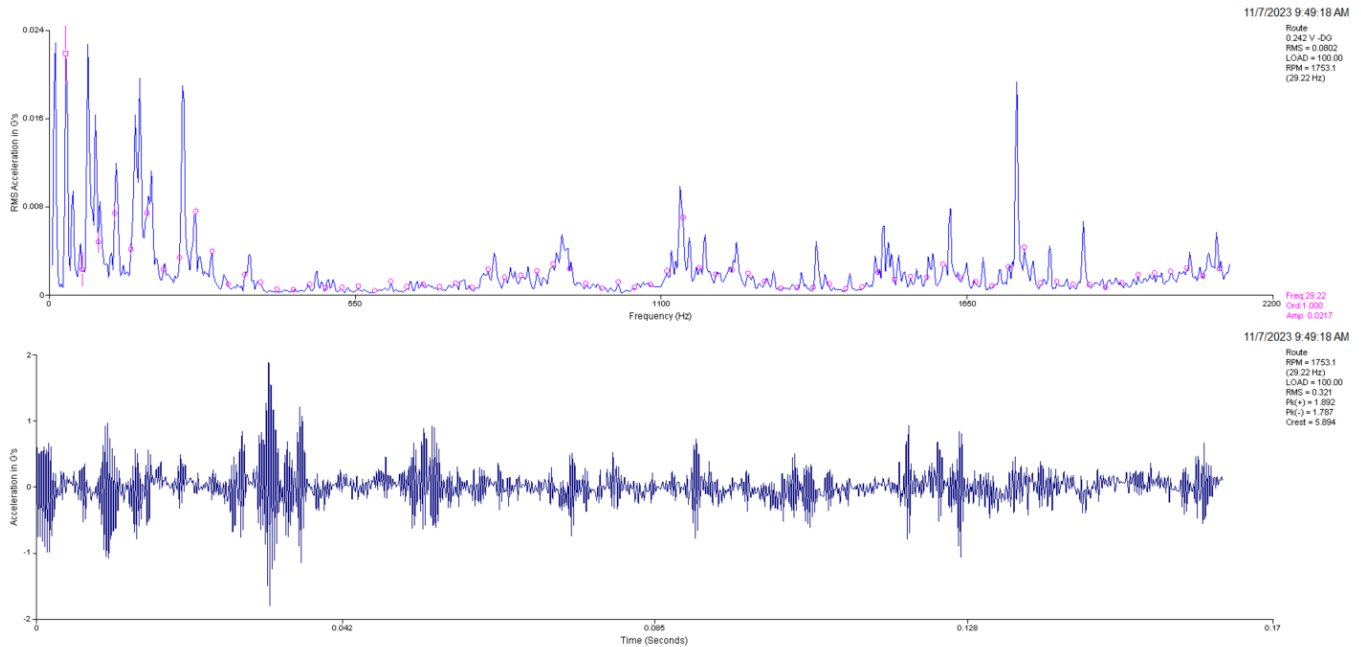
Rice Road Pump CLASS I

Data above is the drive end of the motor. Data shows some non-synchronous peaks and waveform data below spectrum shows some impacting.

Motor bearings appear to be noisy. Data suggests bearings need to be lubricated. Ensure that Mobil Polyrex EM grease is used.
