**USG
Greenville, MS
December 2023
Infrared Survey Report**

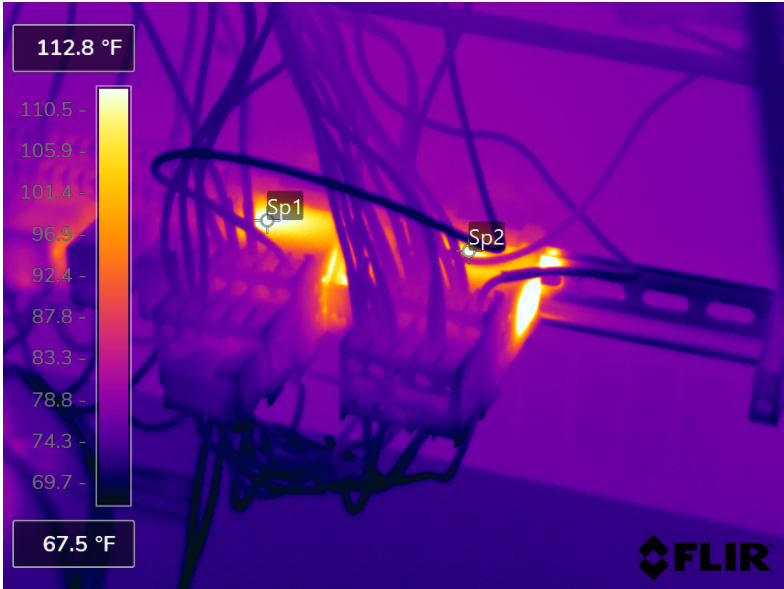
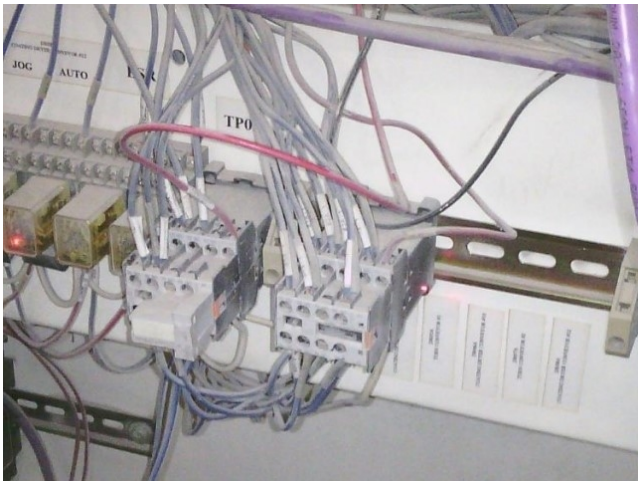
VFD FN4

Sp2	112.9 °F
Sp1	115.2 °F

None

This is a recheck. IR image shows this to be normal. No further action is needed at this time.

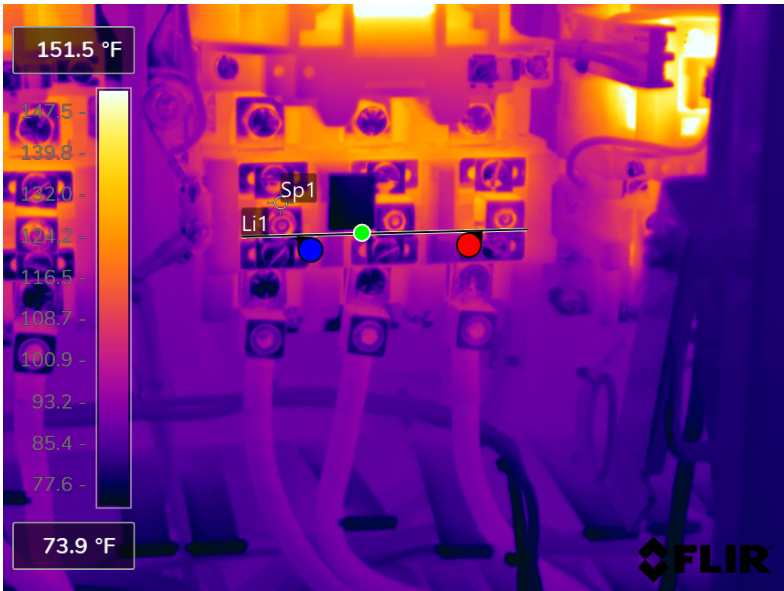
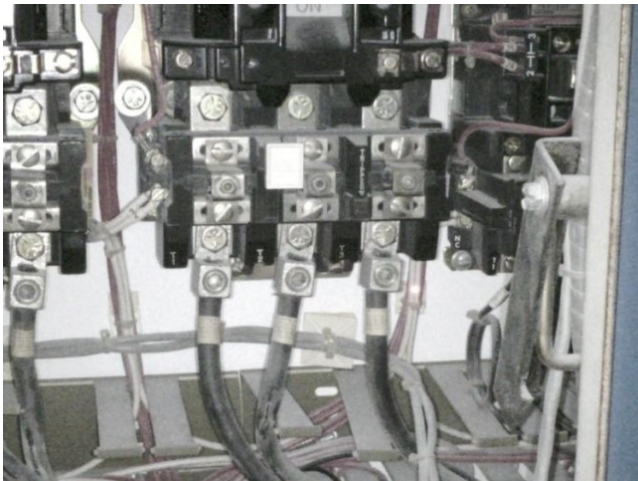
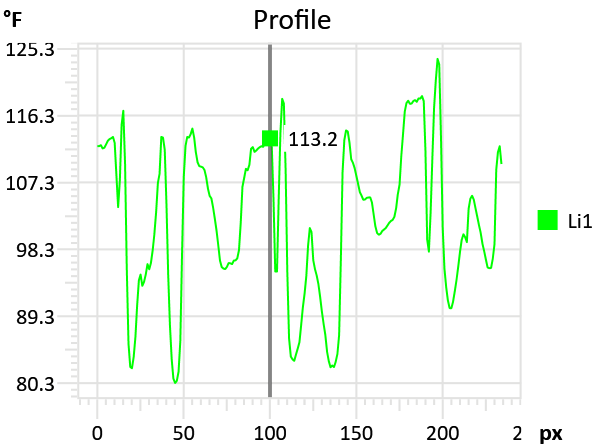
#2 Wisconsin Oven

Recheck A Phase lead connection

Li1	
Max	123.9 °F
Avg	102.5 °F
Min	80.4 °F
Sp1	126.5 °F

None

Recheck image shows no issues present.

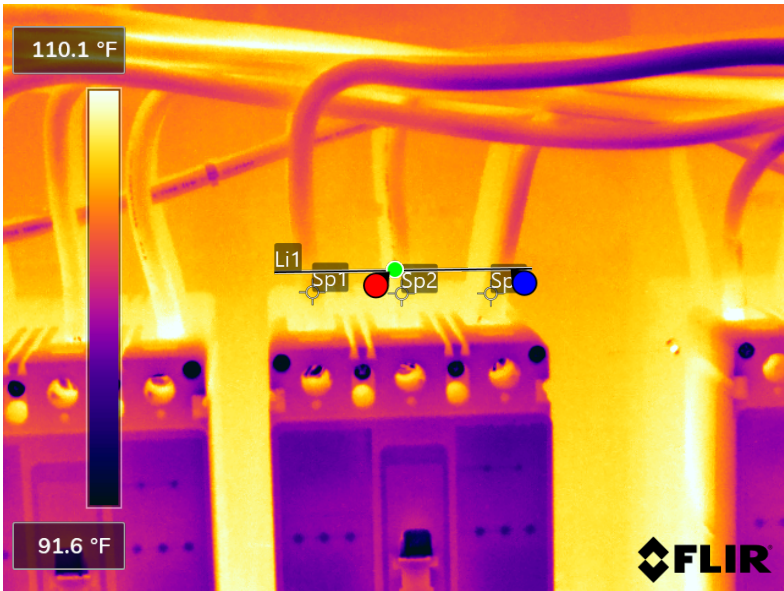
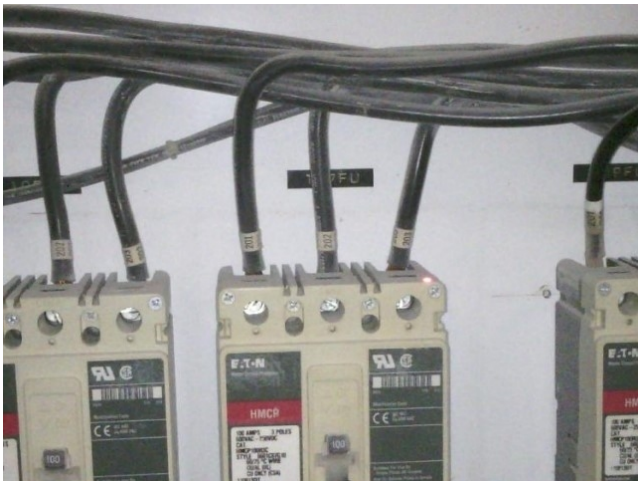
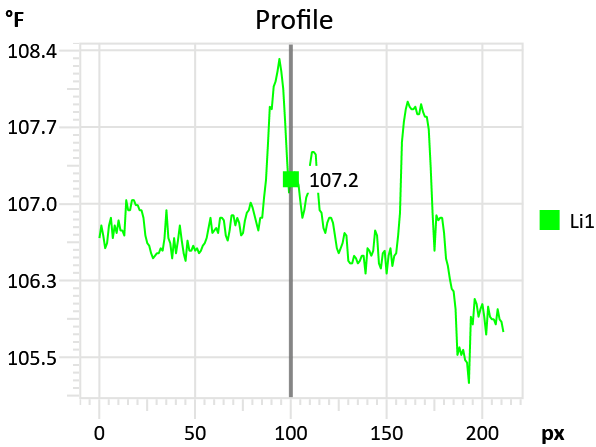
#1 Wisconsin Oven

Recheck Breaker 107FU A phase connection

Sp2	107.9 °F
Sp3	107.1 °F
Li1	
Max	108.3 °F
Avg	106.7 °F
Min	105.3 °F
Sp1	106.7 °F

None

Recheck image shows issue to be resolved. No issue to report.

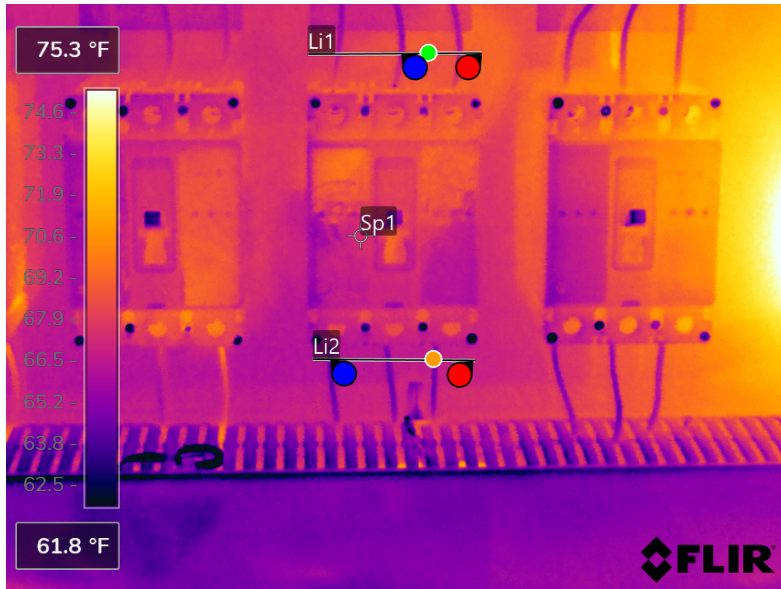
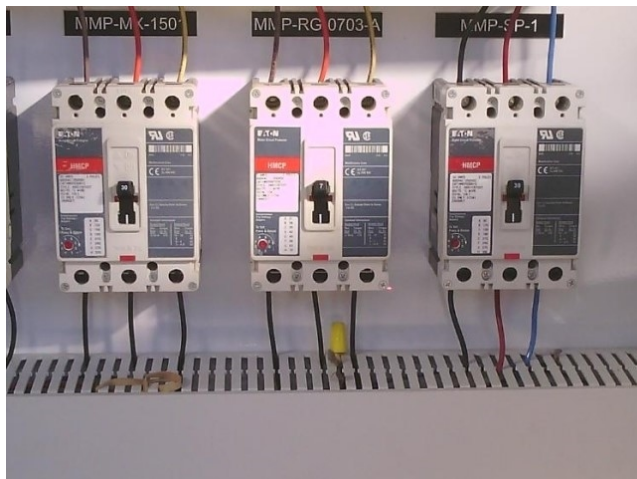
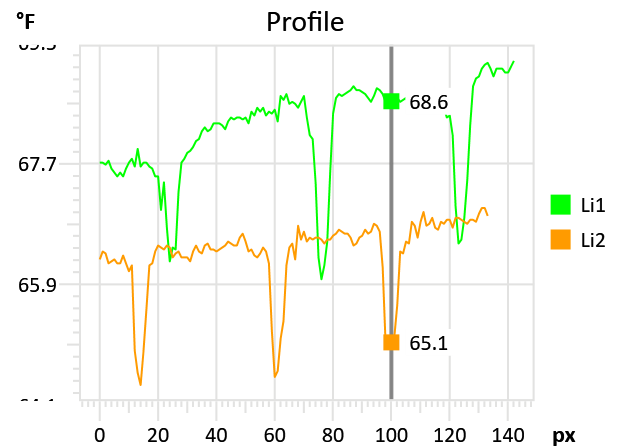
World Water Works DAF Control Panel MMP-RG-0703

RECHECK A phase connection

Li1	
Max	69.3 °F
Avg	68.2 °F
Min	66.0 °F
Li2	
Max	67.1 °F
Avg	66.4 °F
Min	64.4 °F
Sp1	67.3 °F

None

IR recheck shows no issues.

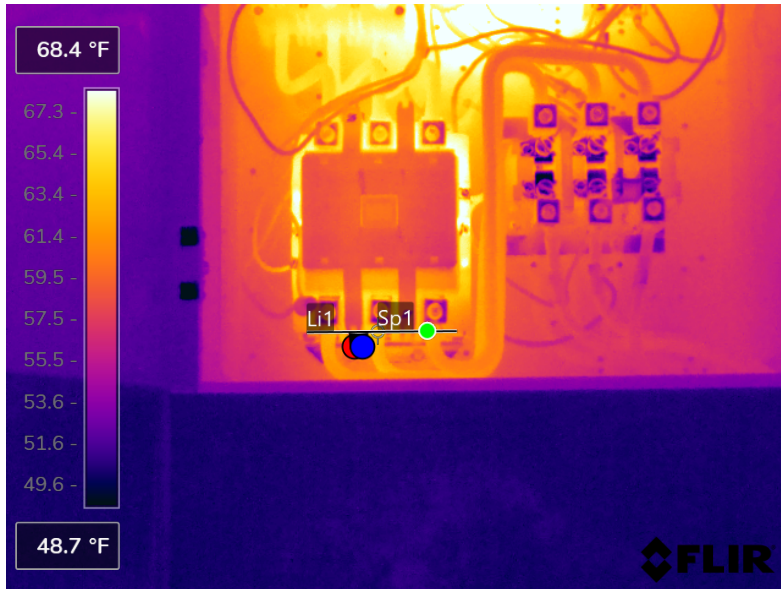
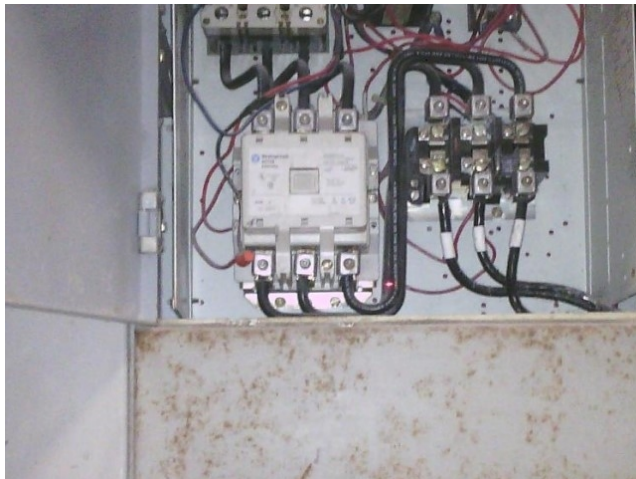
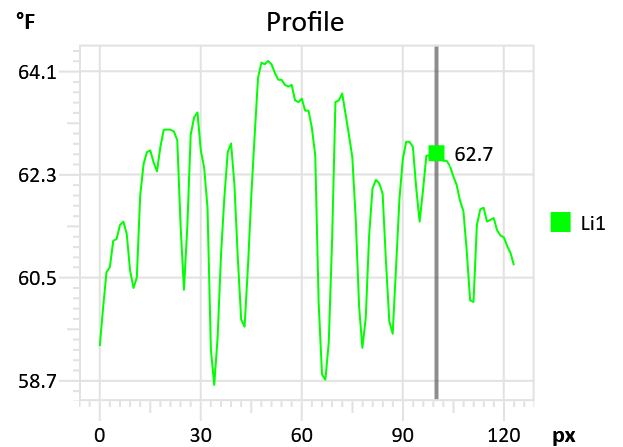
MCC 1CB2 Hydrapulper Ultra Sorter Screen

Li1	
Max	64.3 °F
Avg	61.9 °F
Min	58.7 °F
Sp1	63.7 °F

None

IR recheck shows no issues found.

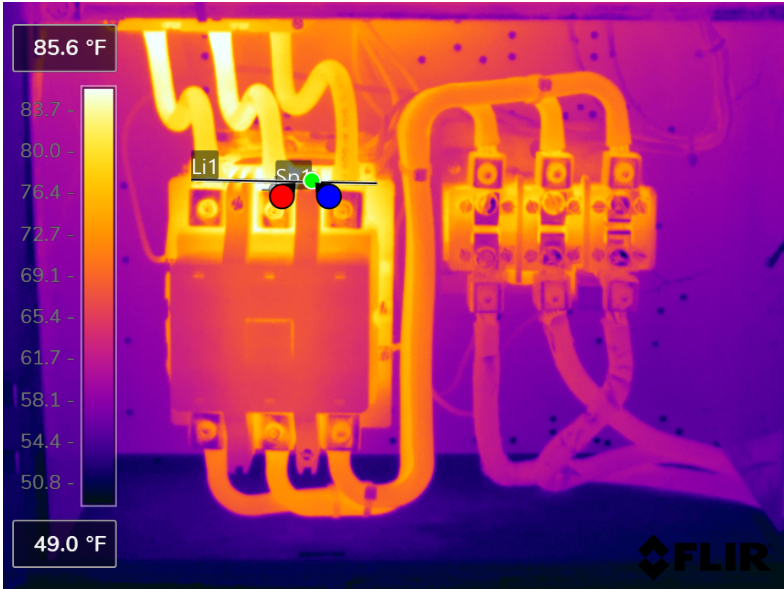
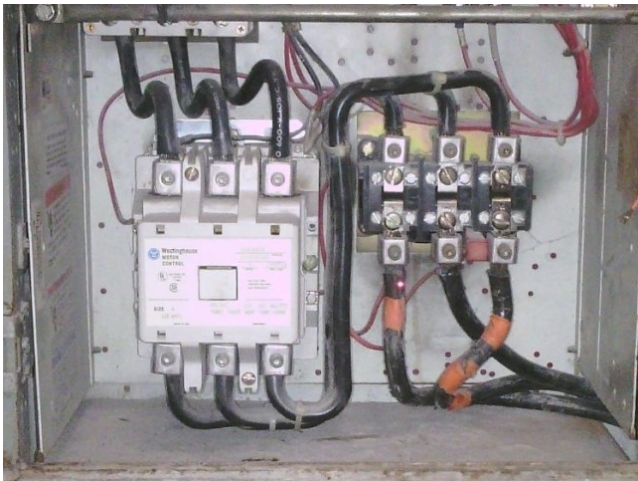
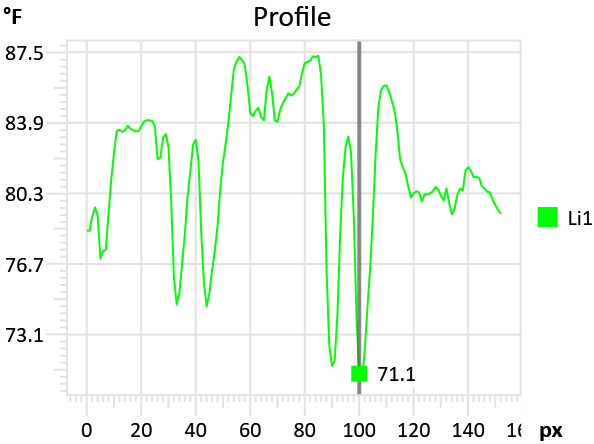
MCC 1CB2 Pressure Screen

Li1	
Max	87.3 °F
Avg	81.5 °F
Min	70.8 °F
Sp1	82.0 °F

None

Recheck shows no issues.

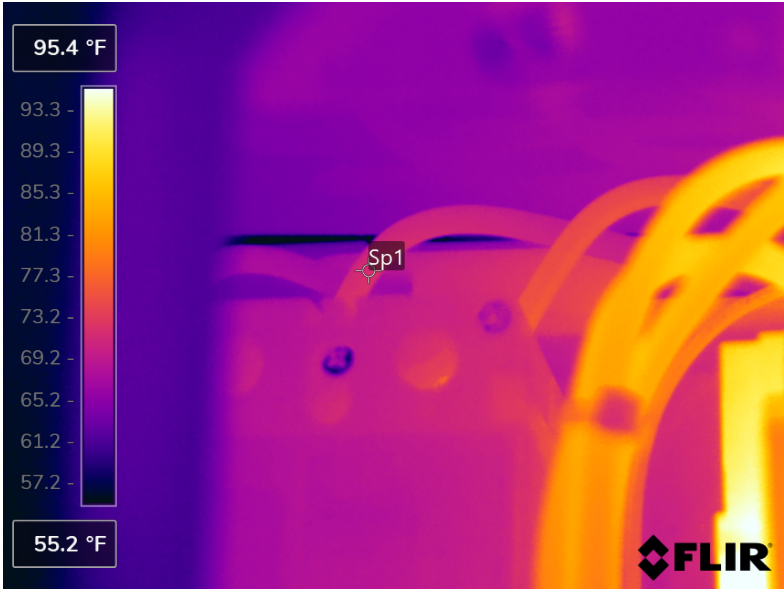
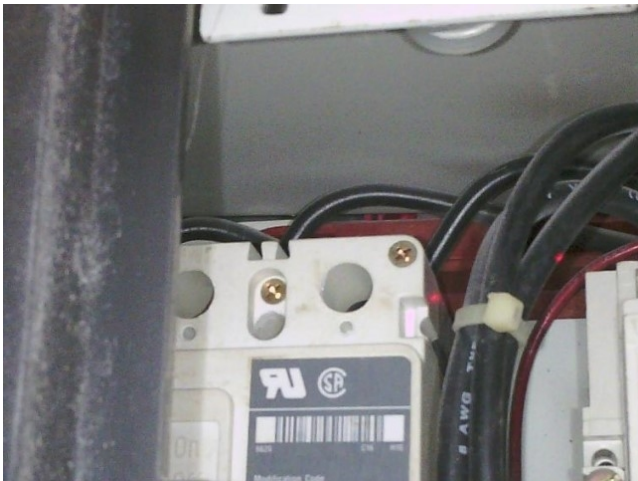
MCC 10C1 M2202 8 exp comb blower

Sp1	72.6 °F
-----	---------

None

Recheck image shows no issues.

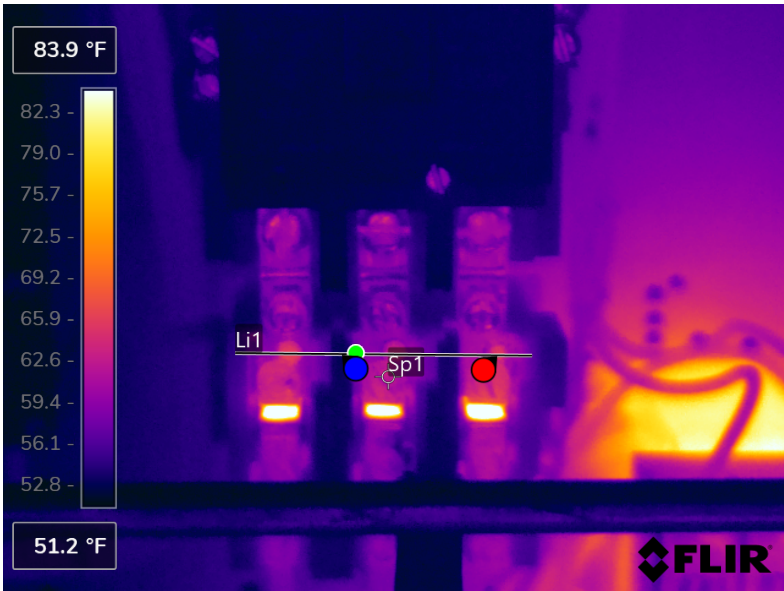
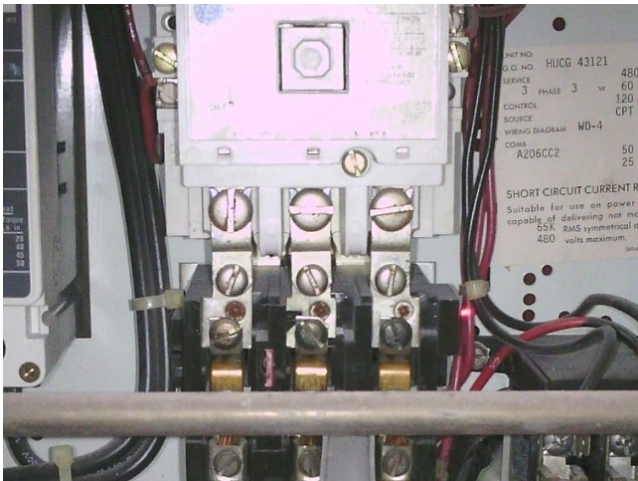
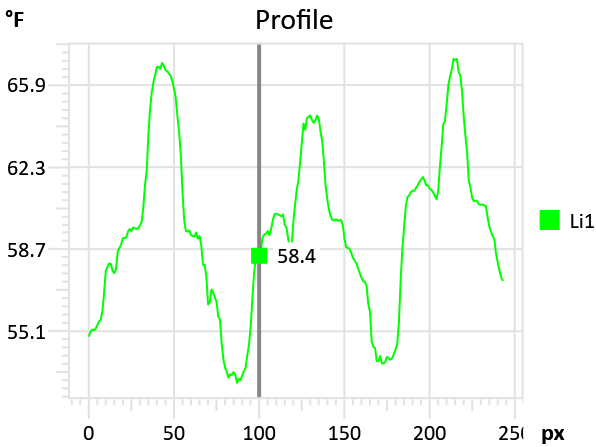
MCC 10A1 M0168 Perlite Exp Exh Fan 1

Li1	
Max	67.1 °F
Avg	59.7 °F
Min	52.9 °F
Sp1	62.9 °F

None

IR recheck shows no issues found.

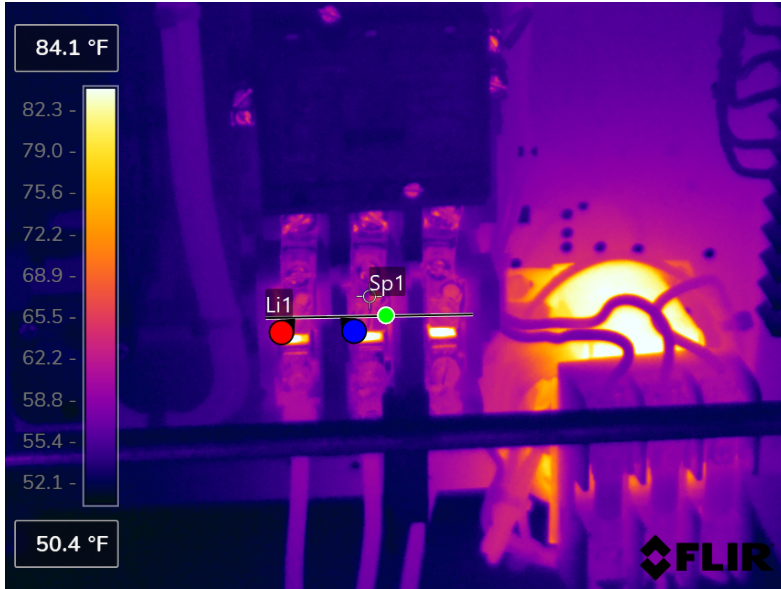
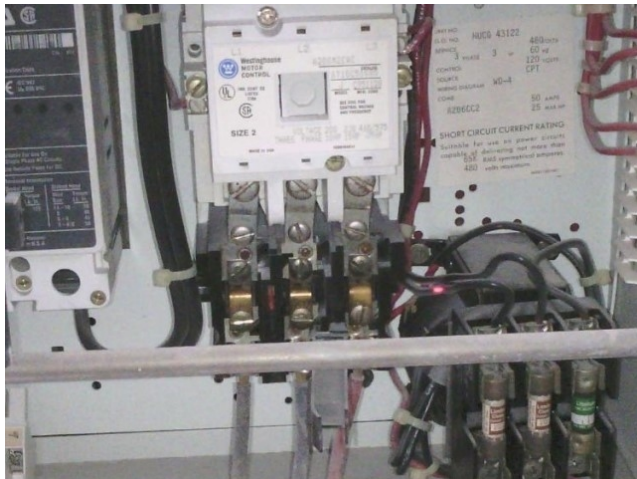
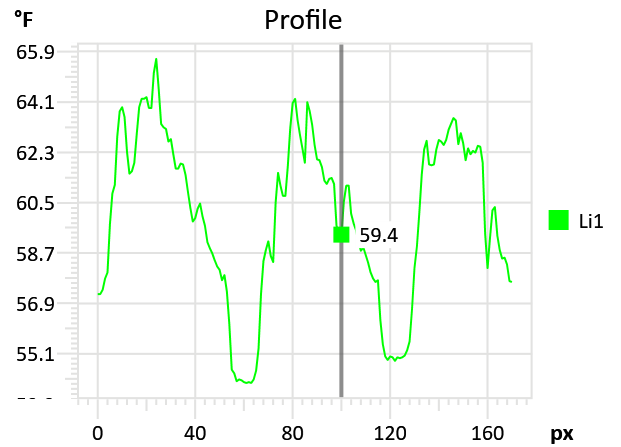
MCC10A1 M0174 Perlite Exp Exh Fan 2

RECHECK Thermal Heaters

Li1	
Max	65.7 °F
Avg	60.1 °F
Min	54.1 °F
Sp1	62.8 °F

None

IR recheck image shows no issues found.
