**INCA Presswood Sardis, MS**  
**2023 Electrical Infrared Survey Report**

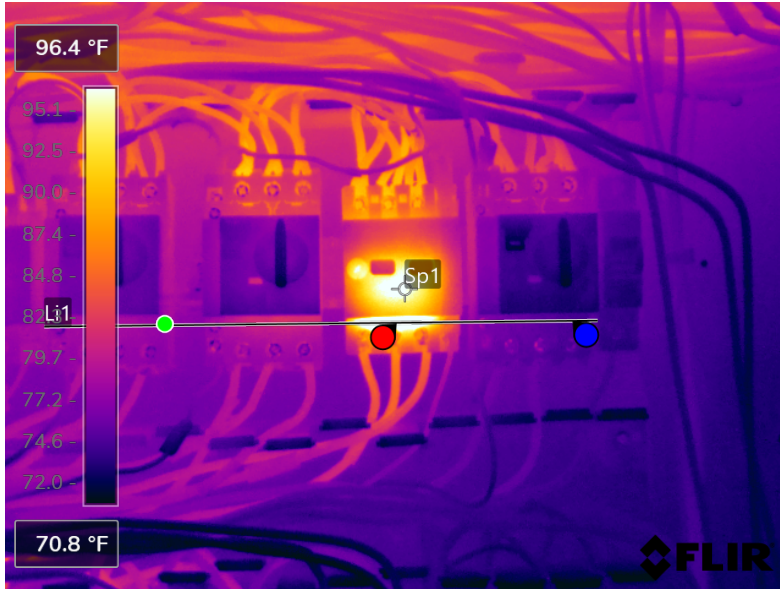
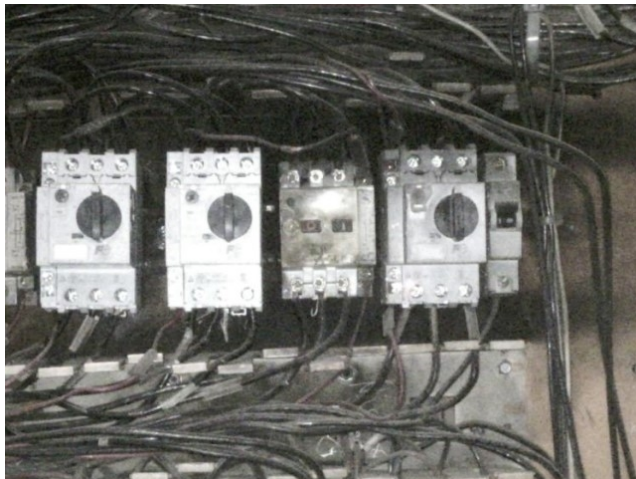
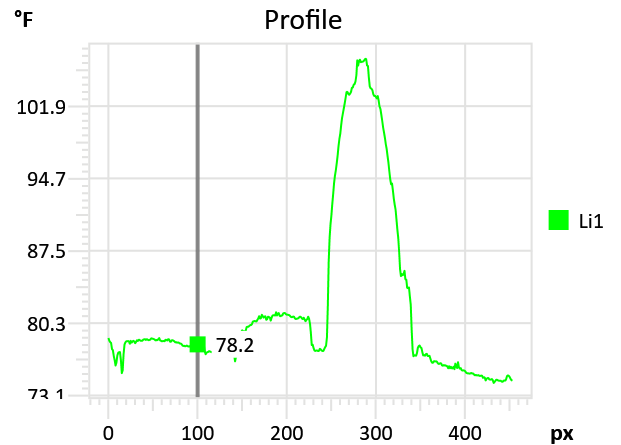
Glue Kitchen 04 PNL 01

Contactor/Breaker

<b>Li1</b>	
Max	106.6 °F
Avg	82.0 °F
Min	74.4 °F
Sp1	96.5 °F

Weak contactor/breaker

CLASS I

IR image shows this component to likely have internal issues. Replace as time allows.

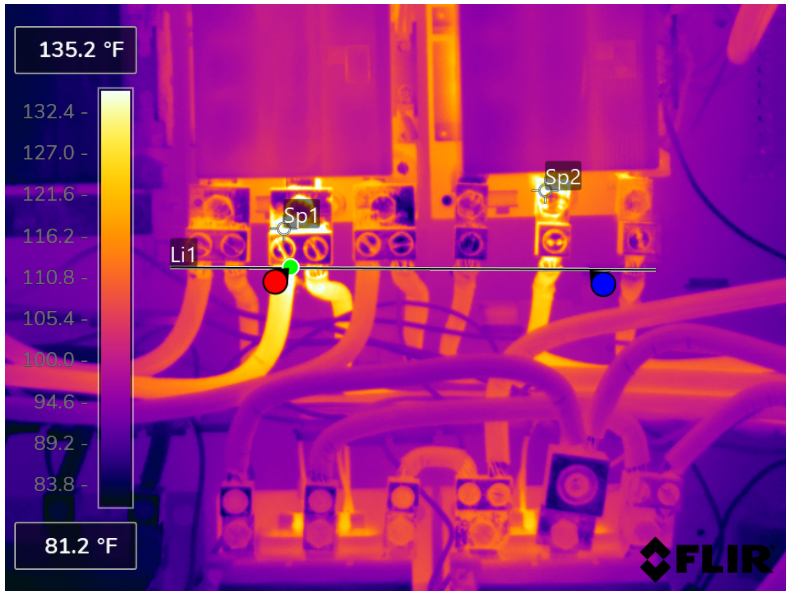
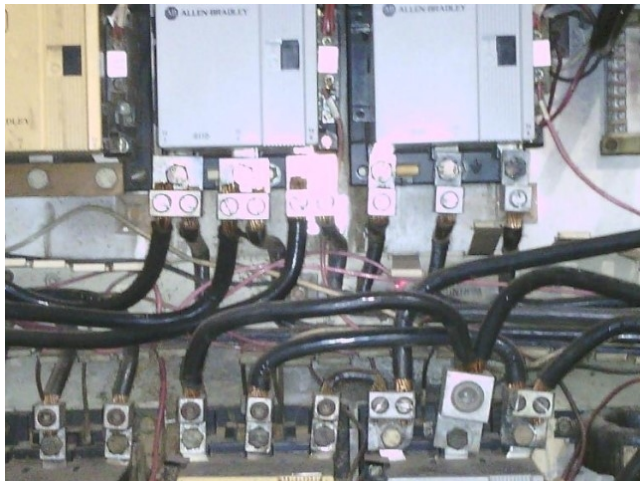
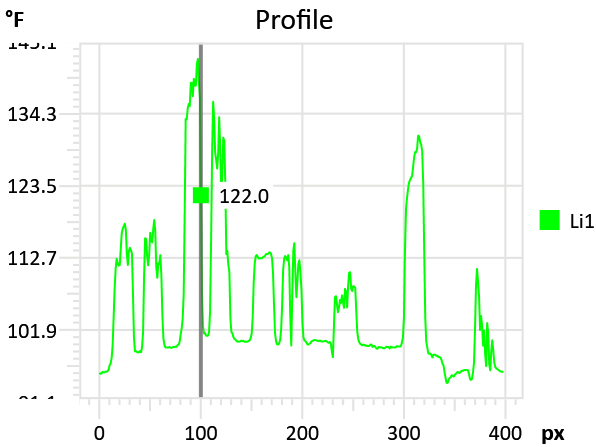
Hydraulic Pump Panel 1-3

Connections

<b>Sp2</b>	143.0 °F
<b>Li1</b>	
Max	142.5 °F
Avg	106.3 °F
Min	94.0 °F
<b>Sp1</b>	136.4 °F

Faulty connections

**CLASS I**

Load side connections appear to have some issues. Check connections, ensuring a clean/tight connection.

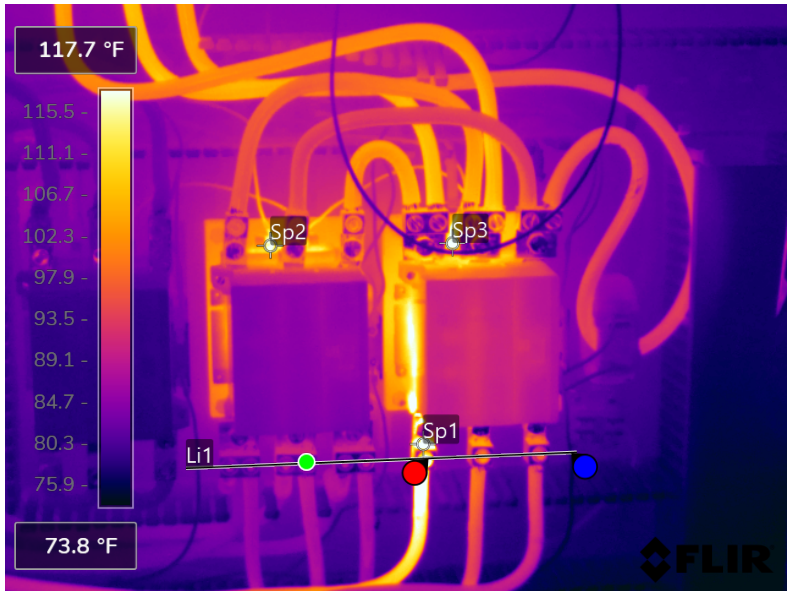
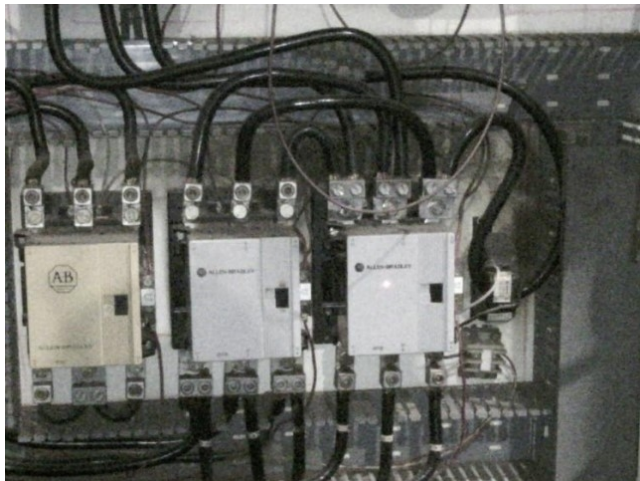
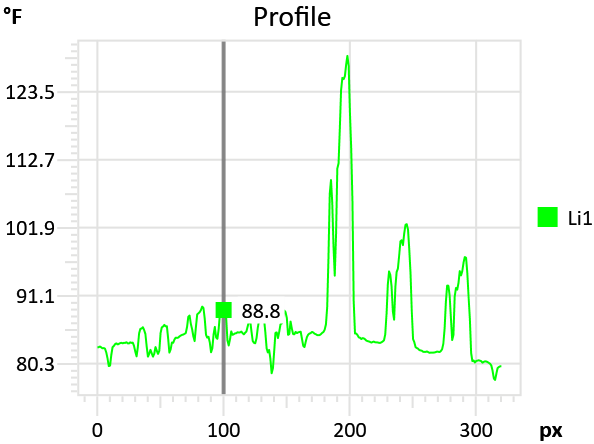
Hydraulic Pump 4 Panel

Lead connection

Sp2	119.1 °F
Sp3	123.1 °F
Li1	
Max	129.2 °F
Avg	87.2 °F
Min	77.7 °F
Sp1	132.1 °F

Faulty connections

**CLASS I**

Load side has connection issue (Sp1). Load side (top side) also has a small lead wire that appears to have a connection issue (Sp2). Inspect connections, ensuring a tight, clean connection.

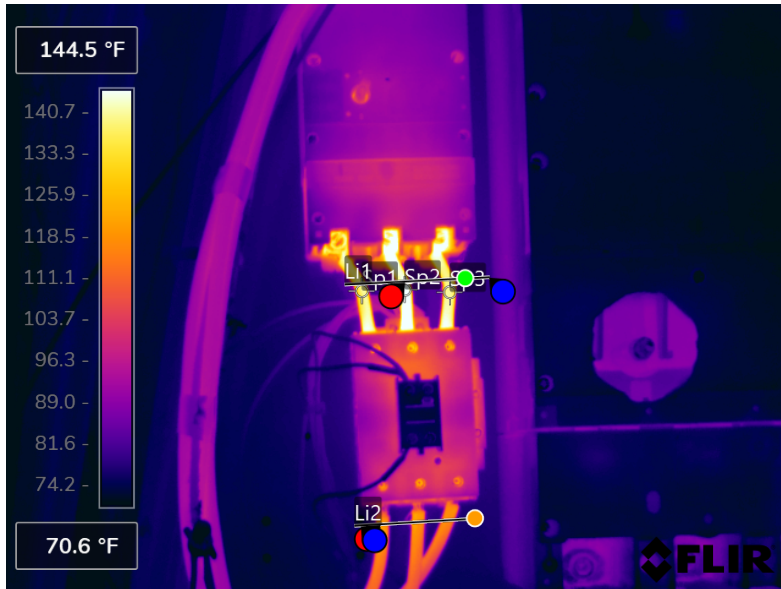
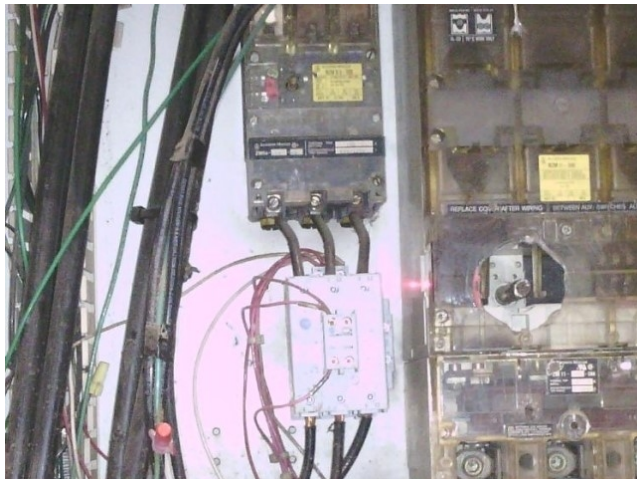
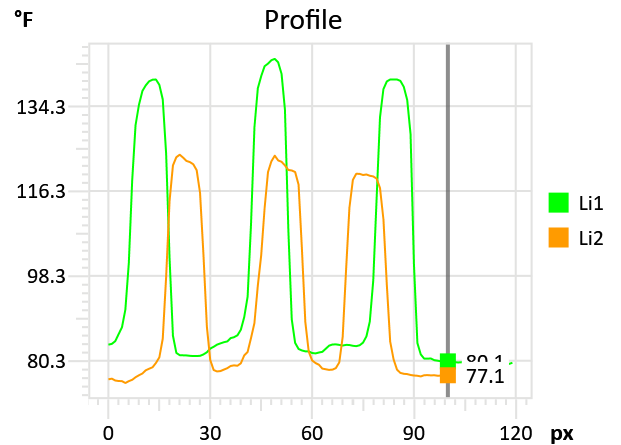
Hammer Mill Control Panel

Jumper leads

Sp2	144.6 °F
Sp3	140.8 °F
Li1	
Max	144.3 °F
Avg	98.1 °F
Min	79.7 °F
Li2	
Max	124.0 °F
Avg	93.5 °F
Min	75.6 °F
Sp1	140.2 °F

Overloaded circuit

CLASS I

The jumper leads going from contactor to breaker appear to be undersized for the operating current. It is recommended to replace these leads with the proper sized wire. Ensure all connections are clean and tight.
