USG June 2023 Infrared Survey Report

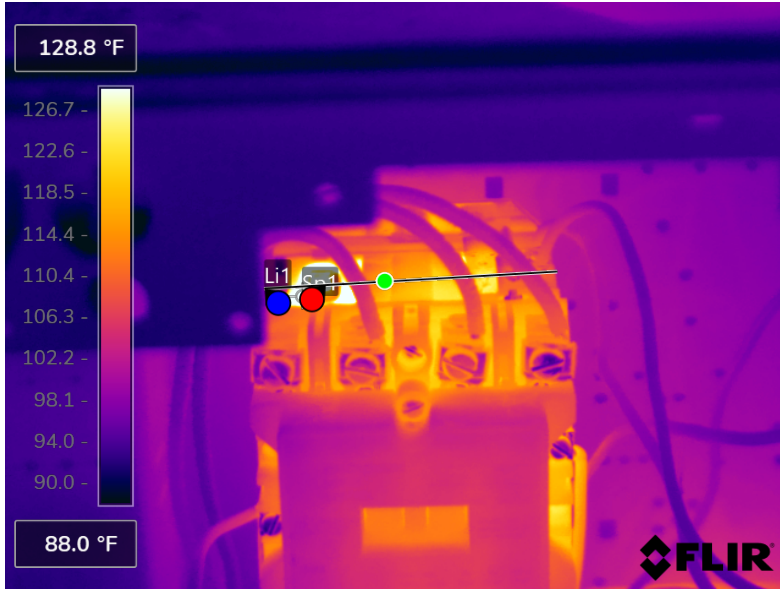
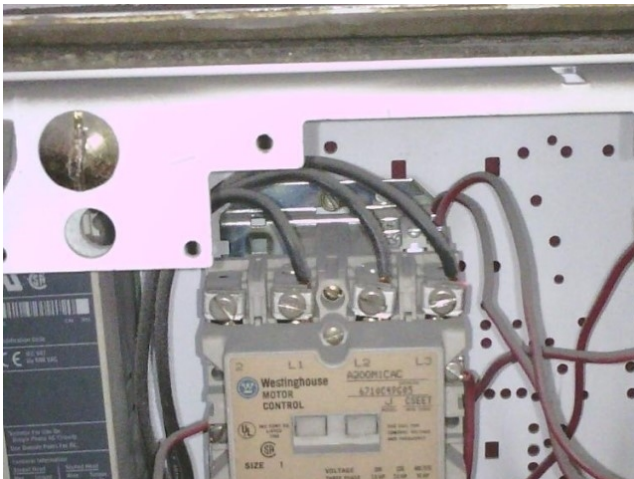
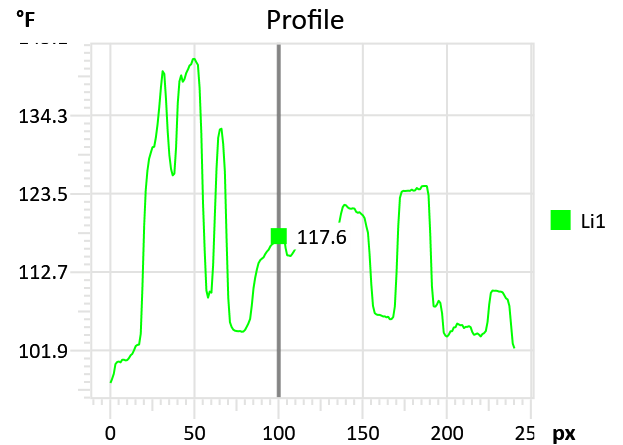
MCC FG2 M5378 #2 oven exhaust fan

Motor contactor

Li1	
Max	142.1 °F
Avg	115.6 °F
Min	97.4 °F
Sp1	135.4 °F

possible connection issue

CLASS I

IR image shows heat on the back side of the contactor. Also seems to be some discoloration from heat Inspect soon.

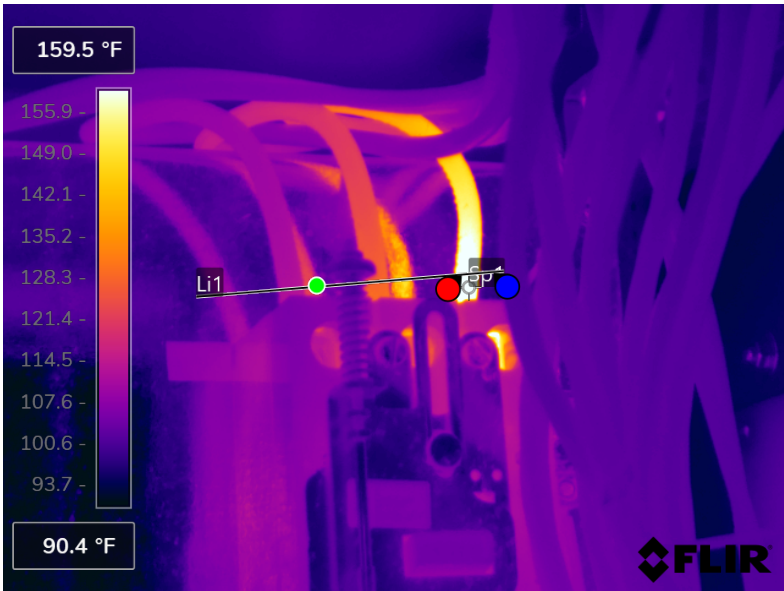
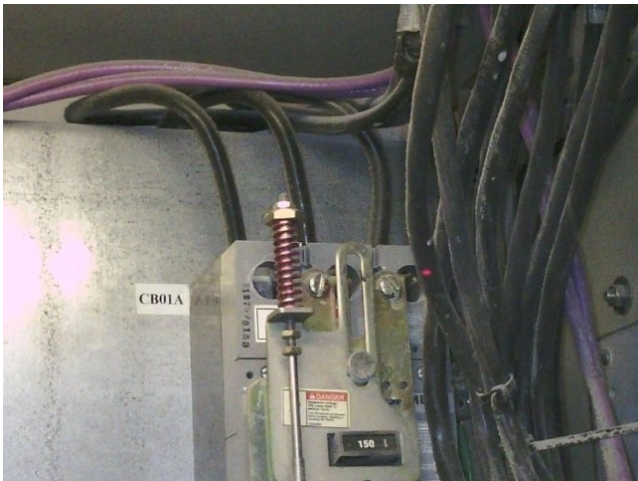
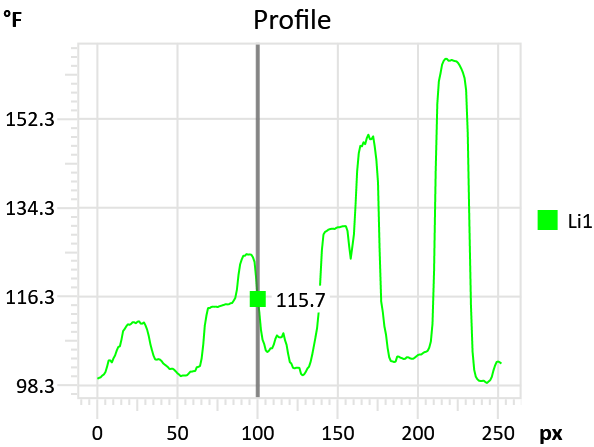
VFD Panel D Fiberglass Line Drive

C Phase connection

Li1	
Max	164.5 °F
Avg	115.8 °F
Min	98.8 °F
Sp1	165.6 °F

connection issue

CLASS II

Line side c phase connection appears to have an issue. Check connection ensuring a clean and tight connection.

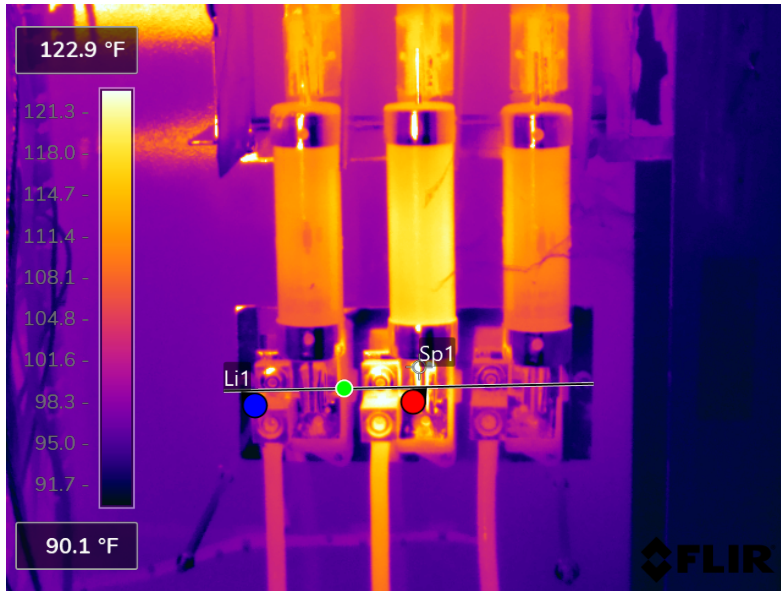
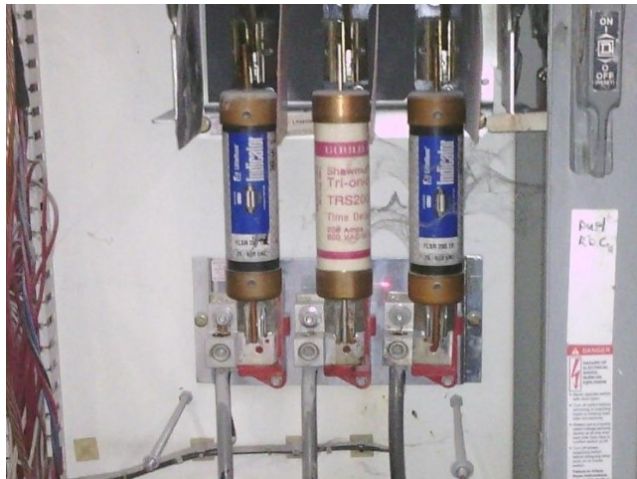
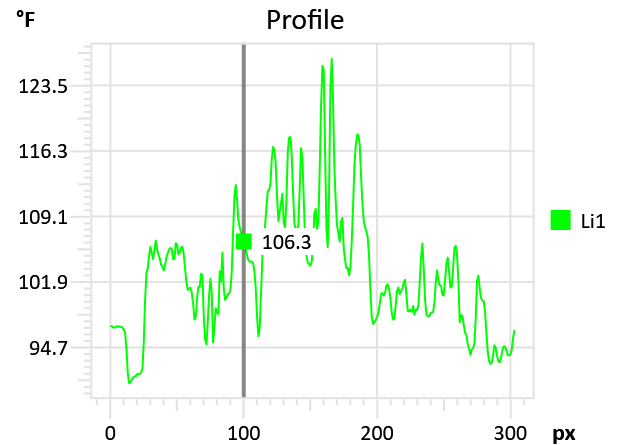
Fiberglass Dust Collector Control Panel

B phase fuse

Li1	
Max	126.4 °F
Avg	102.9 °F
Min	90.8 °F
Sp1	125.1 °F

Faulty fuse connections

CLASS I

B phase fuse holder appears to have 25 degree delta from A and C phase. Check fuse ensuring a tight and clean connection.
