December 1, 2023

Derreck Smith Louis Dreyfus Co. West Memphis, AR

The following is a summary of findings from the Annual Vibration Analysis that was performed on November 30, 2023 on BE-705 and Take Up Gear Drives.

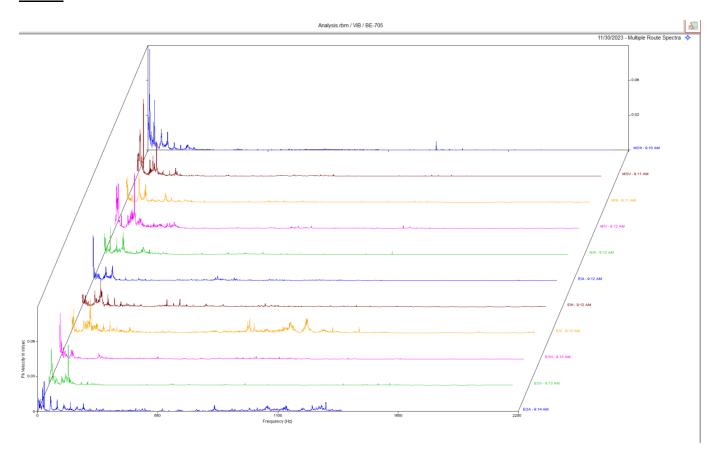
BE-705

Data above is a multipoint spectral waterfall of the motor and gearbox. Vibration levels appear to be within normal limits.

None at this time. Continue to monitor as normal.

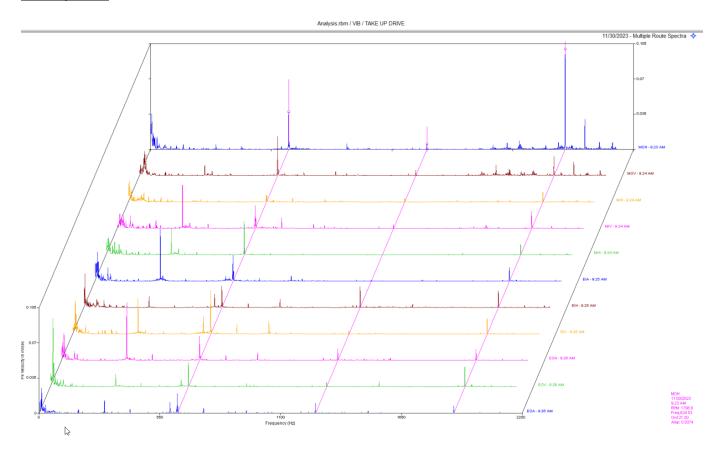
Take Up Drive

Data above is a multi-point waterfall of the motor and gearbox. Motor data shows some harmonics of 21 orders of rpm present while gearbox data shows some gear mesh frequencies present. Amplitudes are not very high according to the baseline data.

There appears to be some electrically related vibrations in the motor. Amplitudes are low and this is baseline data, so severity is unclear here. Gearbox also has some low-level gear mesh vibration. No actions are recommended at this time. Continue to monitor as normal.
