March 2023 Infrared Survey Report

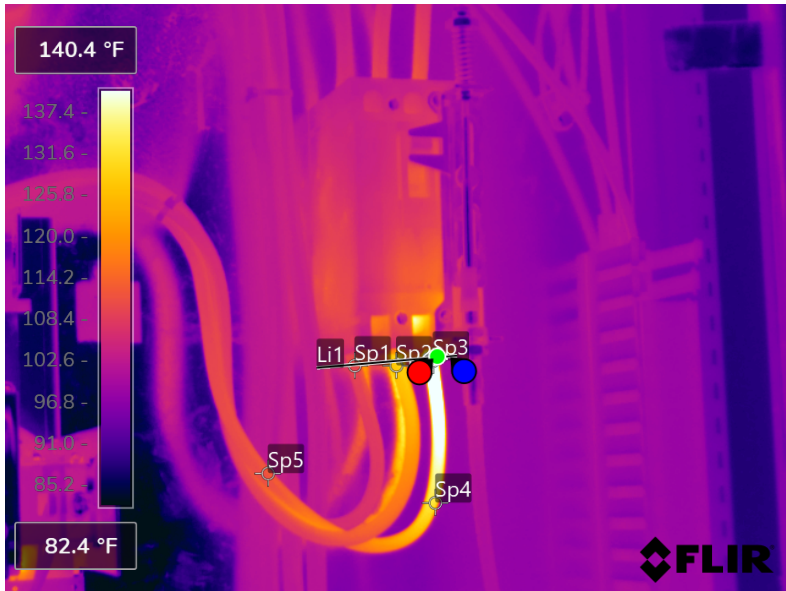
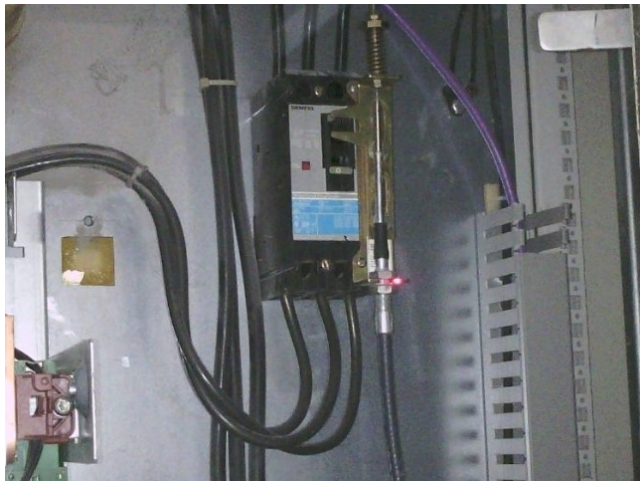
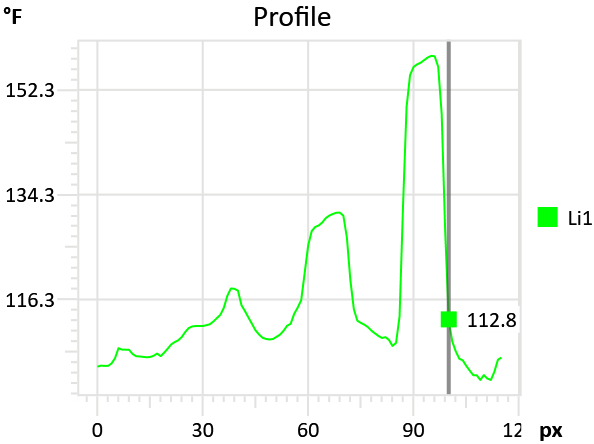
VFD-MCP1 Machine Chest Pump 3A

C Phase Load Side Lead Connection

Sp2	129.2 °F
Sp3	157.2 °F
Sp4	131.8 °F
Sp5	114.0 °F
Li1	
Max	158.2 °F
Avg	116.5 °F
Min	102.5 °F
Sp1	111.7 °F

Faulty Connection

CLASS I

IR image shows C phase load side connection to have issue. Inspect lead wire, lug connection ensuring a clean and tight connection.

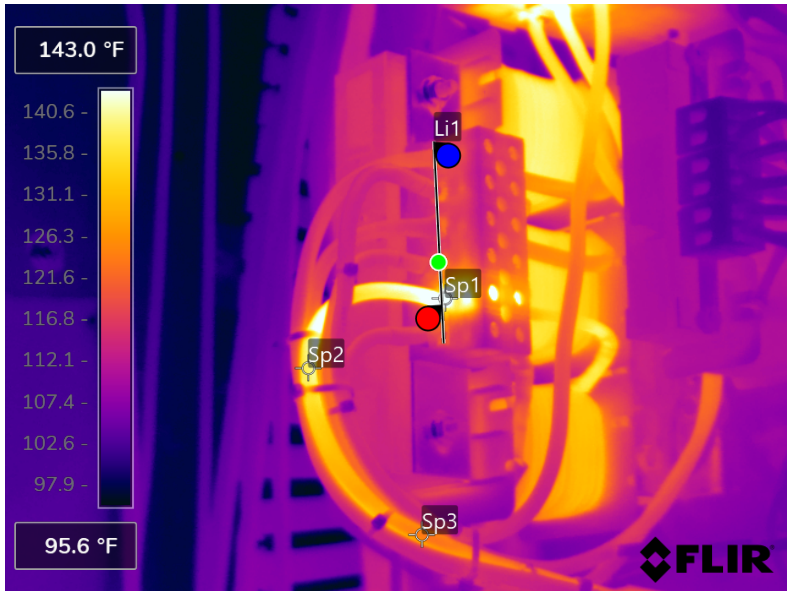
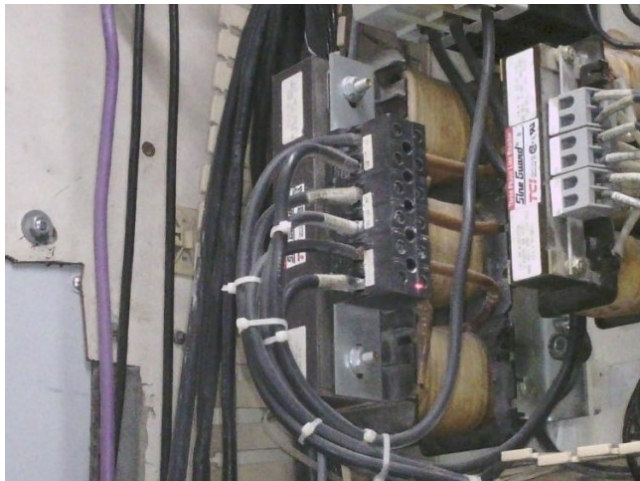
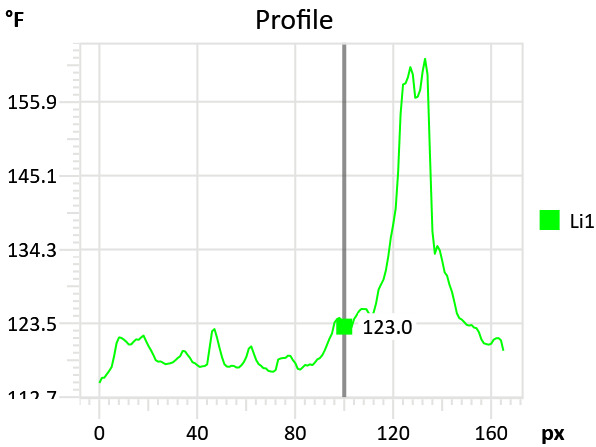
VFD-Forming

Lead wire/connection

Sp2	138.8 °F
Sp3	124.8 °F
Li1	
Max	162.2 °F
Avg	124.4 °F
Min	114.8 °F
Sp1	159.4 °F

Bad wire/connection

CLASS III

Wire has visible damage from connection issue. It is recommended to replace or cut back wire and reconnect ensuring a clean and tight connection.

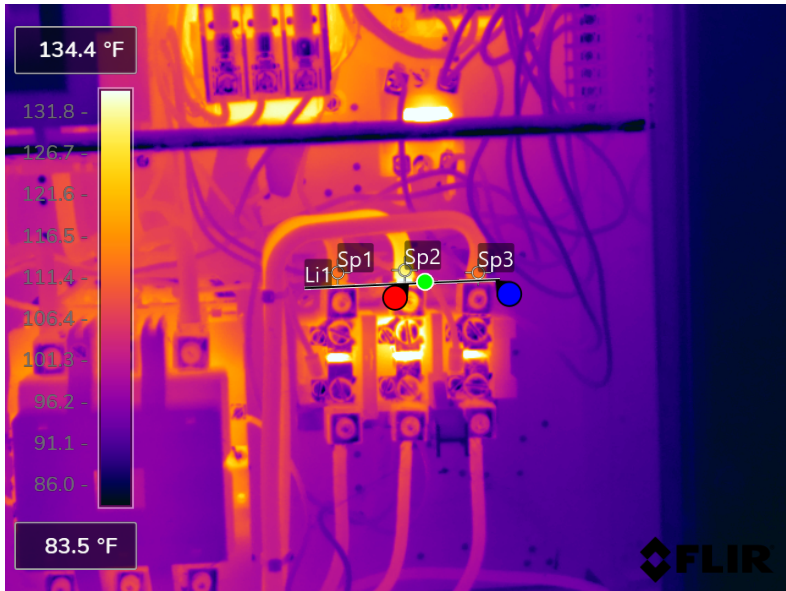
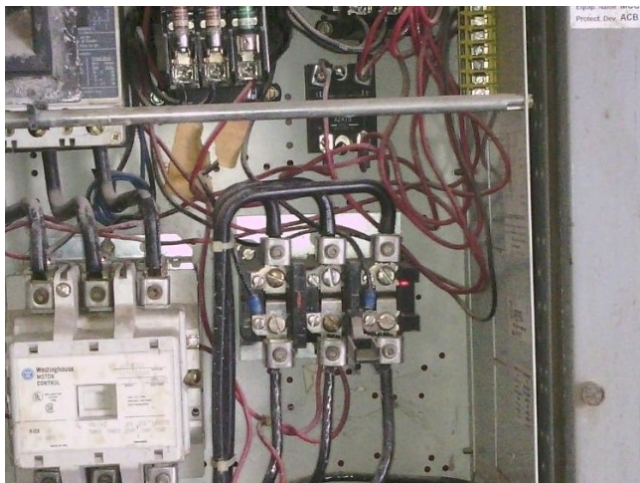
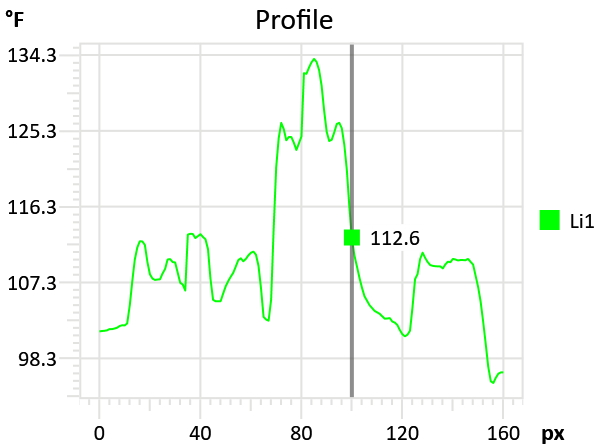
MCC-7B2 M1443 Seal Water Collector Tank Pump

B Phase lead connection

Sp2	129.5 °F
Sp3	113.1 °F
Li1	
Max	133.9 °F
Avg	110.4 °F
Min	95.4 °F
Sp1	113.3 °F

Faulty connection

CLASS I

Looks like a minor issue, but B phase connection appears to be faulty. Check lead/lug and ensure connection is clean and tight.
