**Atlantic Dry Ice Brandon, MS**  
**May 2023 Quarterly Infrared Survey Report**

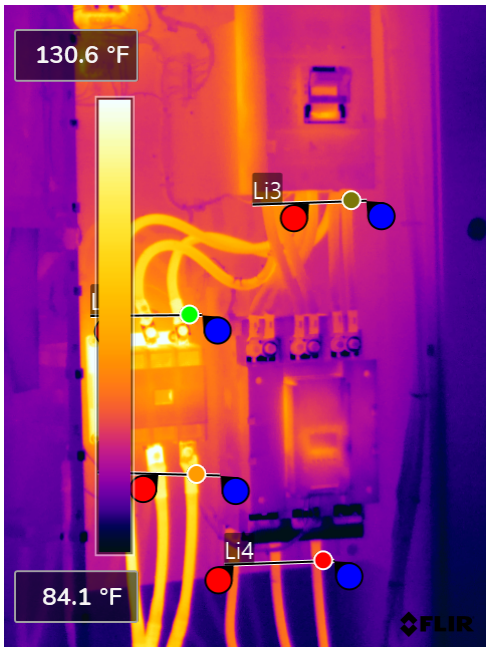
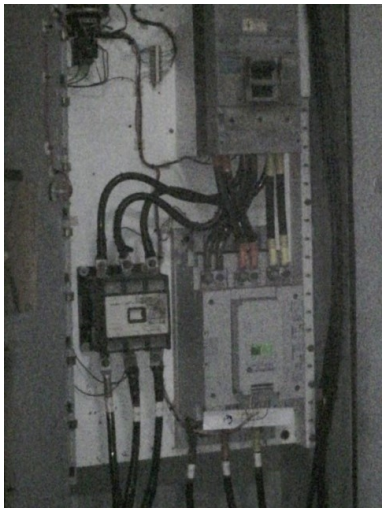
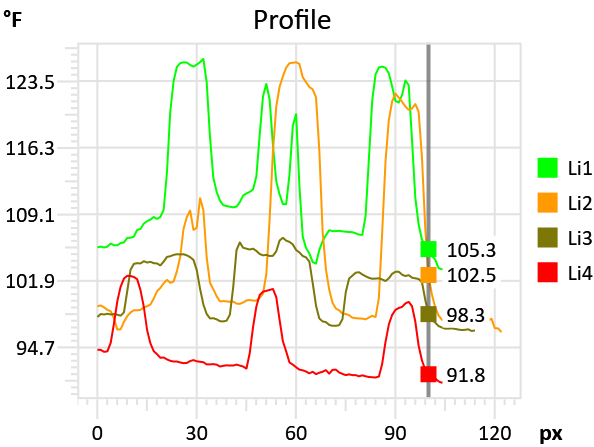
MCC CM-3

<b>Li1</b>	
Max	125.9 °F
Avg	112.1 °F
Min	102.3 °F
<b>Li2</b>	
Max	125.6 °F
Avg	104.9 °F
Min	96.4 °F
<b>Li3</b>	
Max	106.6 °F
Avg	101.5 °F
Min	96.5 °F
<b>Li4</b>	
Max	102.5 °F

None

N/A

No Issues to note.

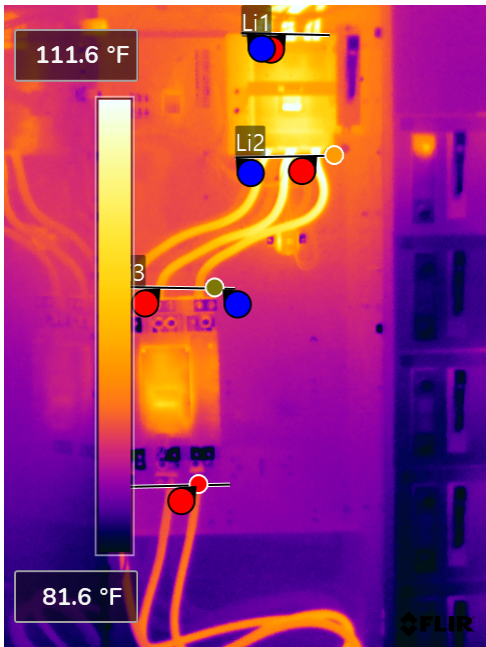
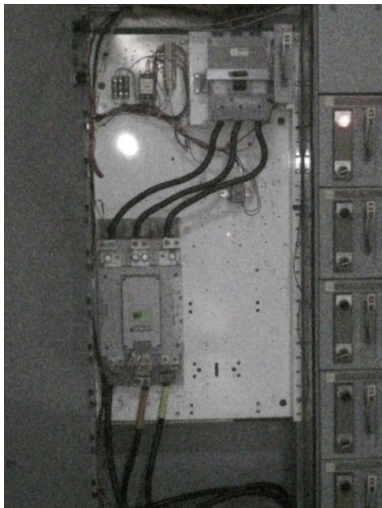
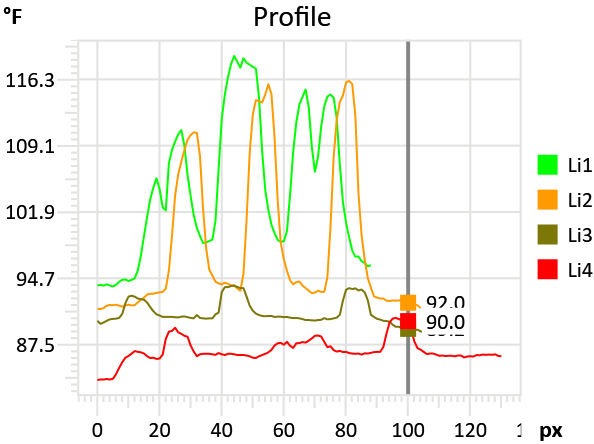
MCC CM-1

<b>Li1</b>	
Max	118.9 °F
Avg	104.6 °F
Min	93.8 °F
<b>Li2</b>	
Max	116.2 °F
Avg	98.4 °F
Min	91.4 °F
<b>Li3</b>	
Max	93.9 °F
Avg	90.8 °F
Min	88.8 °F
<b>Li4</b>	
Max	90.4 °F

None

N/A

No issues to note.

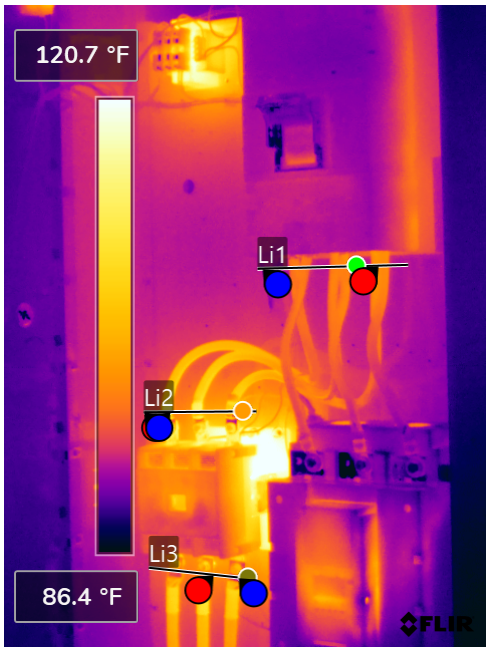
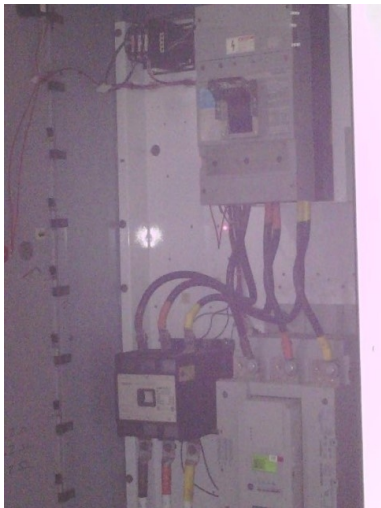
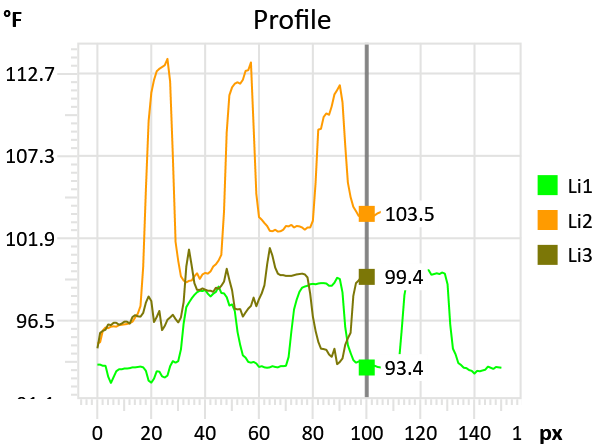
MCC CM-2

Li1	
Max	100.1 °F
Avg	95.5 °F
Min	92.4 °F
Li2	
Max	113.7 °F
Avg	104.0 °F
Min	95.0 °F
Li3	
Max	101.3 °F
Avg	97.6 °F
Min	93.7 °F

None

N/A

No issues to note.
