**MOST Inc.**  
**Jackson, TN**  
**November 2023 Infrared Survey Report**

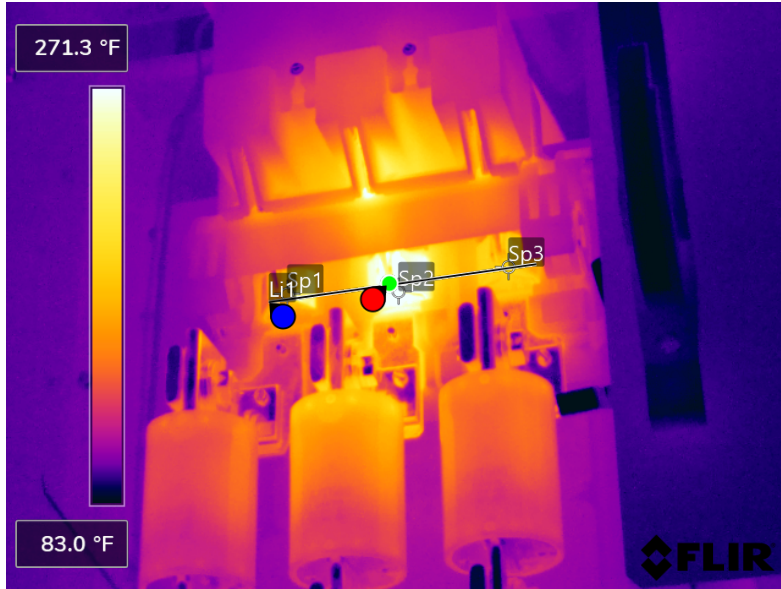
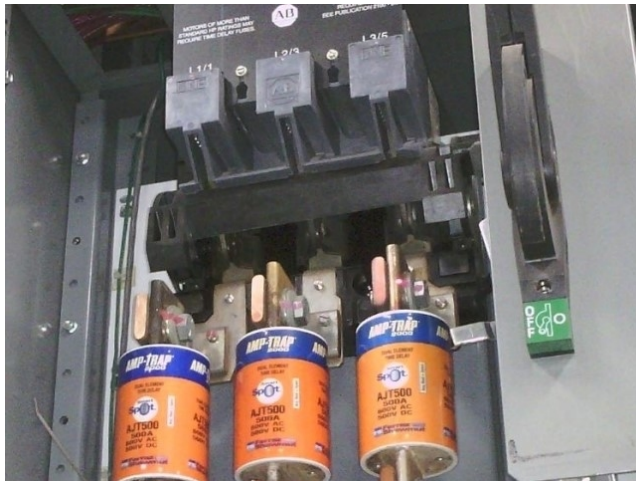
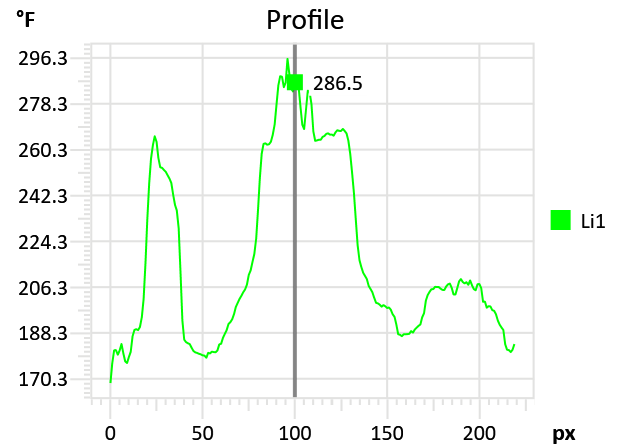
Dust Collector Exhaust Fan WB2

Fuse Knife Switch

Sp2	276.1 °F
Sp3	206.9 °F
Li1	
Max	296.0 °F
Avg	218.1 °F
Min	168.7 °F
Sp1	191.0 °F

Loose/worn fuse knife connections

CLASS II

IR image shows B phase to have issues with knife switching components. Repair/replace knife components as necessary.

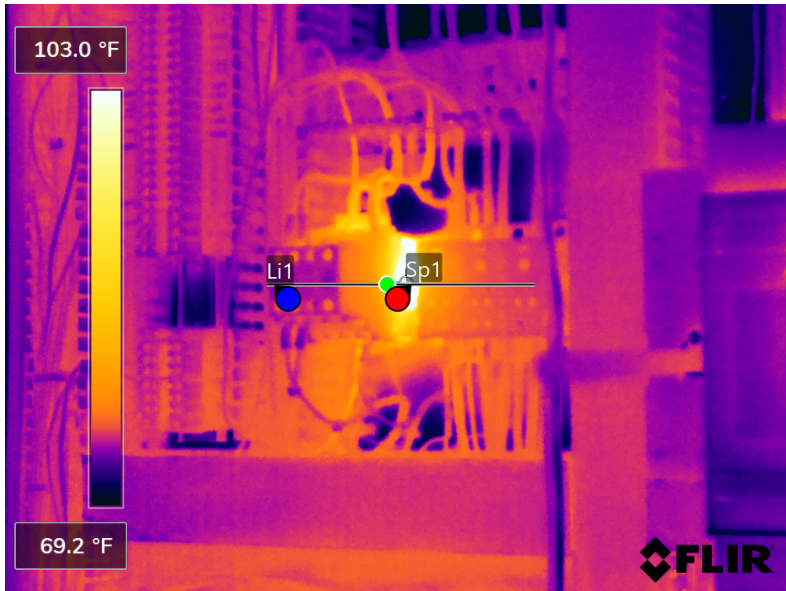
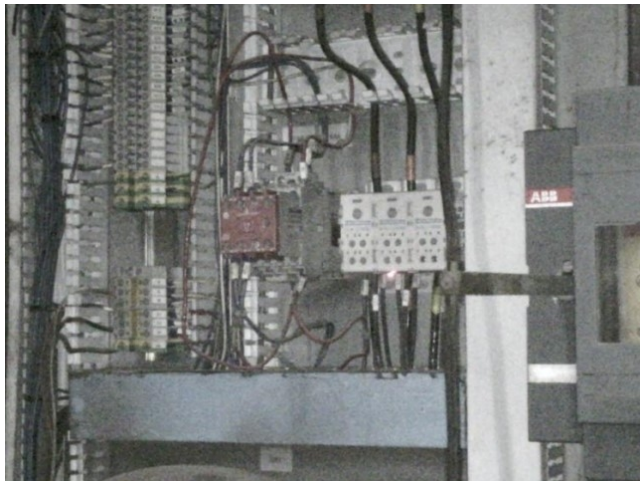
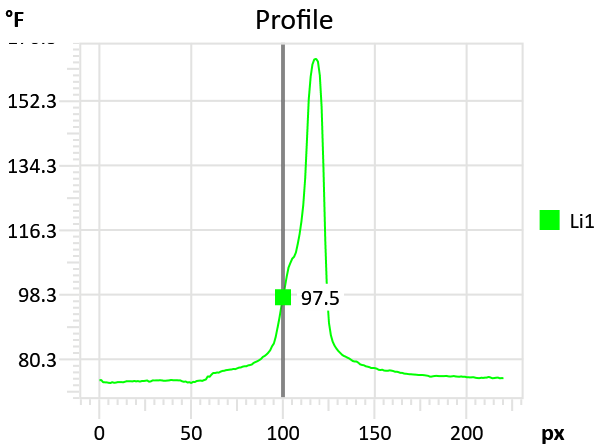
Pre-Ripper Panel

Contactor

Li1	
Max	164.0 °F
Avg	82.7 °F
Min	73.7 °F
Sp1	153.1 °F

Possible issue with contactor

CLASS I

The IR image shows some localized heat at the back end of the contactor. This may indicate issues. Inspect contactor if possible.

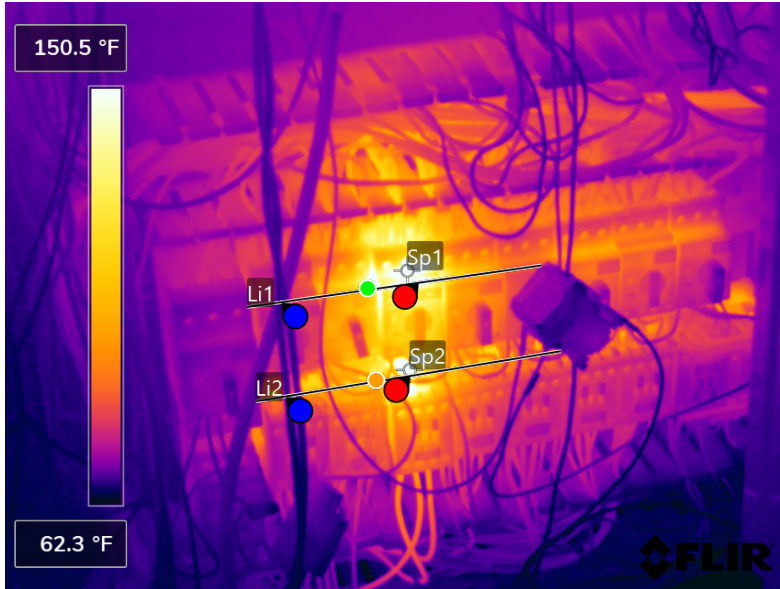
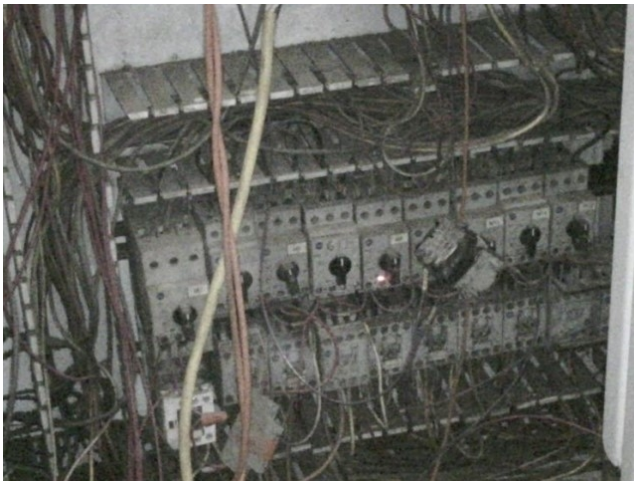
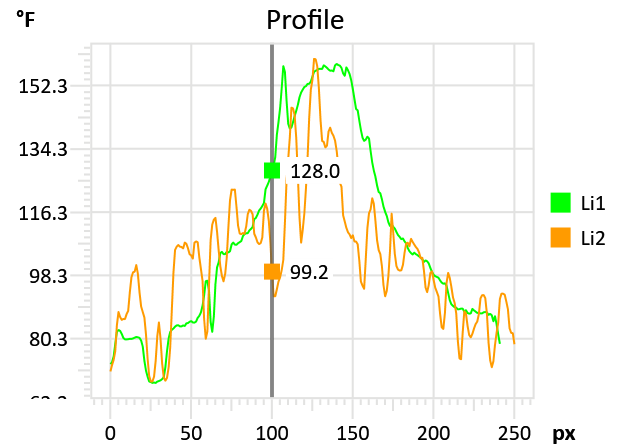
M5 CP1

Connections on breakers

<b>Sp2</b>	158.7 °F
<b>Li1</b>	
Max	158.4 °F
Avg	108.7 °F
Min	67.8 °F
<b>Li2</b>	
Max	159.9 °F
Avg	102.5 °F
Min	68.2 °F
<b>Sp1</b>	158.4 °F

Loose/dirty connections

**CLASS I**

There is likely connection issues on breaker switches according to the IR image. The smaller switches third from the left look to be where the heat is at. Check these switches. Ensure all connection are clean and tight.
