2023 Annual Electrical Infrared Survey Report

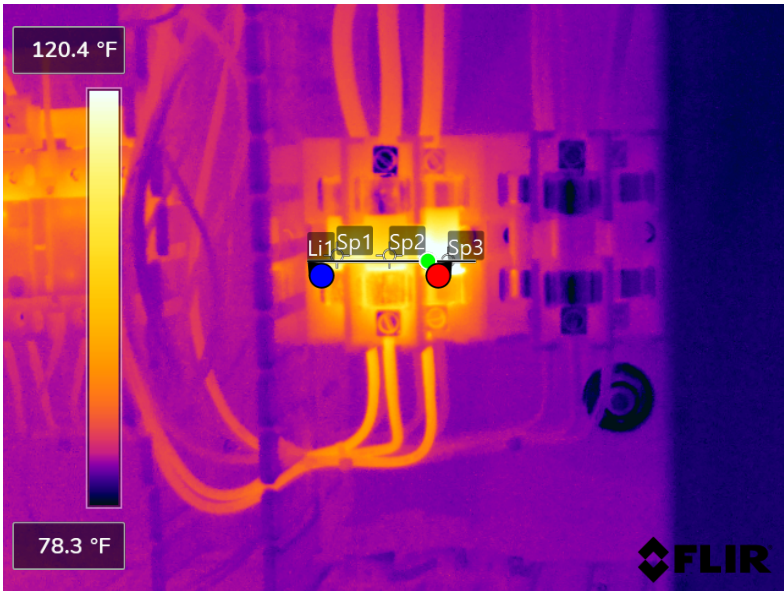
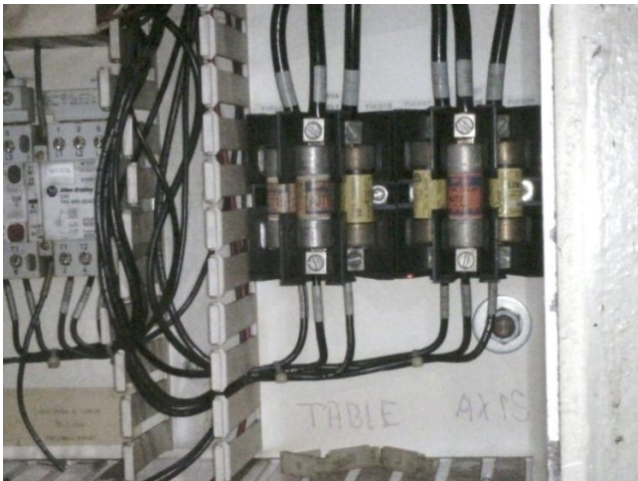
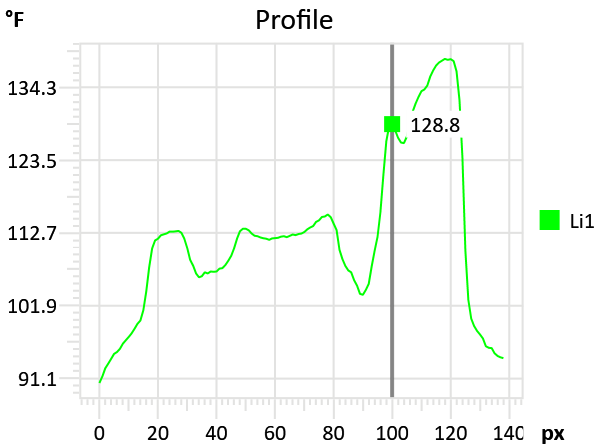
1225

Sp2	109.3 °F
Sp3	136.5 °F
Li1	
Max	138.5 °F
Avg	112.0 °F
Min	90.5 °F
Sp1	110.6 °F

Weak fuse/Fuse connection

CLASS I

IR image shows left fuse section to have a delta T of around 26 degrees F at the right fuse. This may be the fuse itself, so we recommend replacing fuse ensuring fuse holder connections are clean and tight.

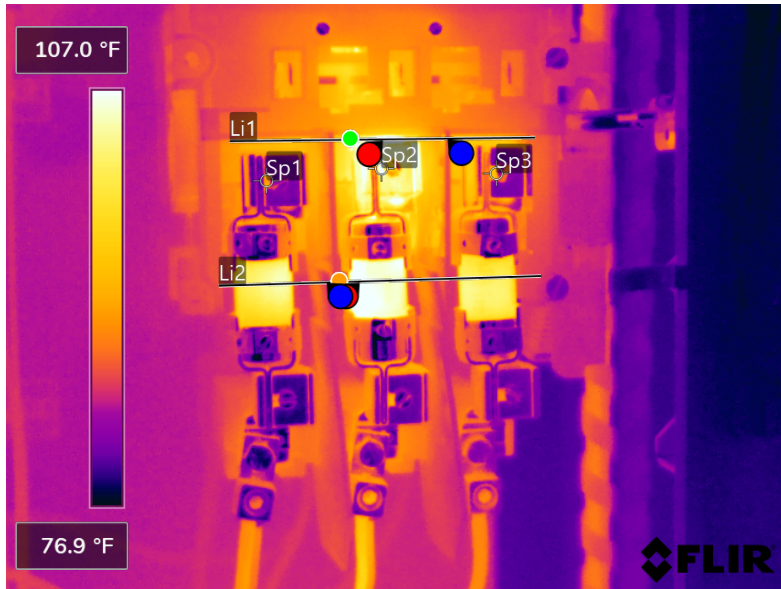
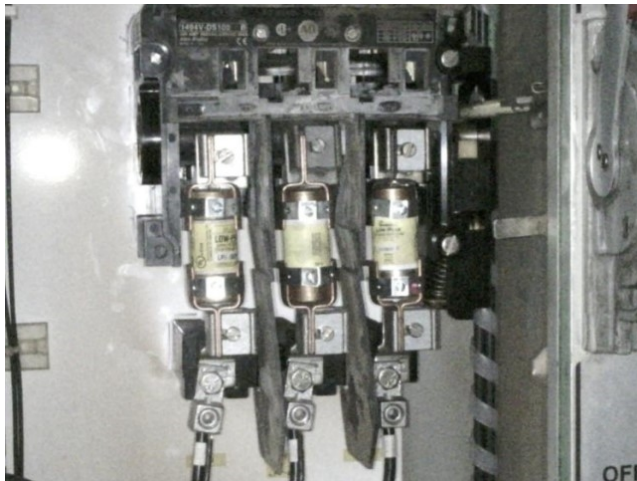
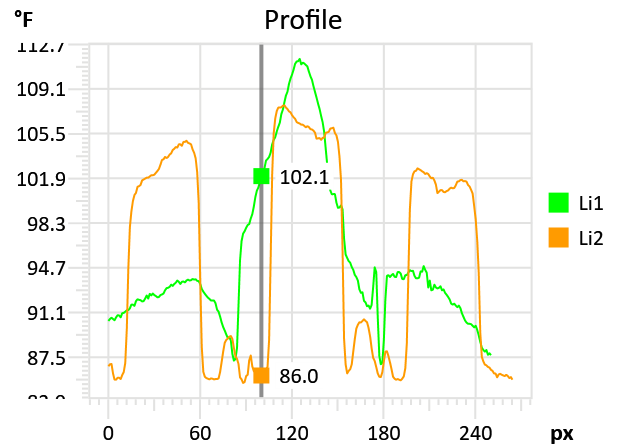
2232

Sp2	109.3 °F
Sp3	91.3 °F
Li1	
Max	111.5 °F
Avg	95.6 °F
Min	87.0 °F
Li2	
Max	107.8 °F
Avg	95.7 °F
Min	85.5 °F
Sp1	91.9 °F

Faulty fuse holder connections

CLASS I

B phase fuse holder connections appear to have some slight issue. Check all fuse components for looseness and wear. Ensure all connections are clean and tight.

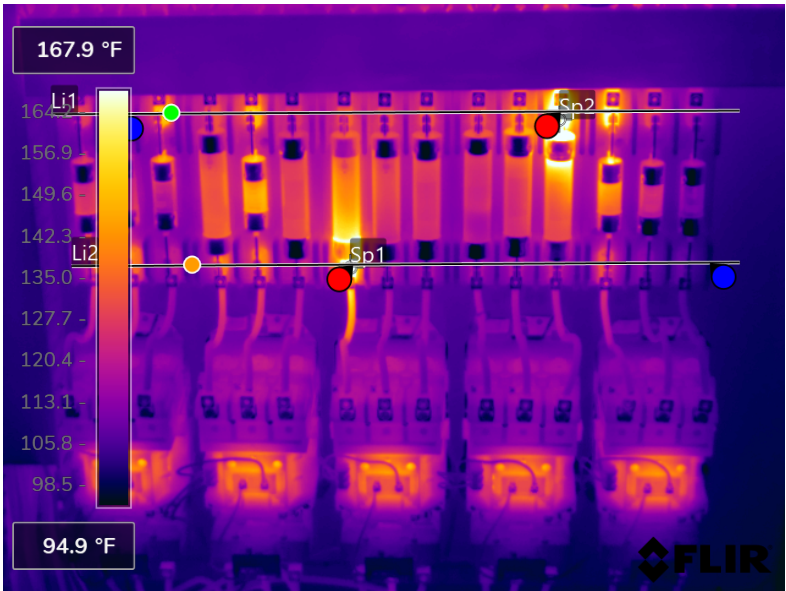
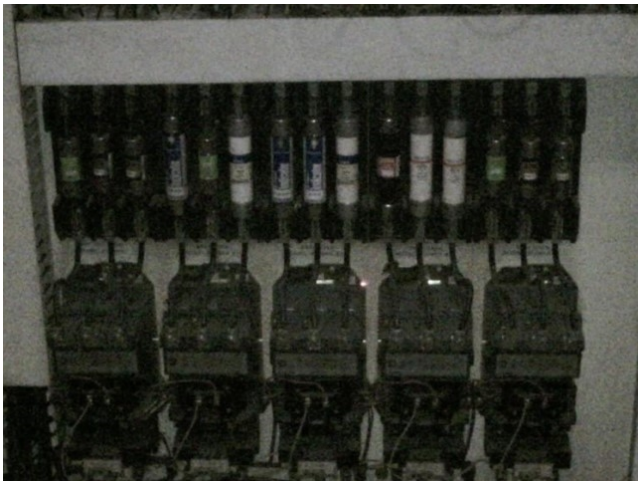
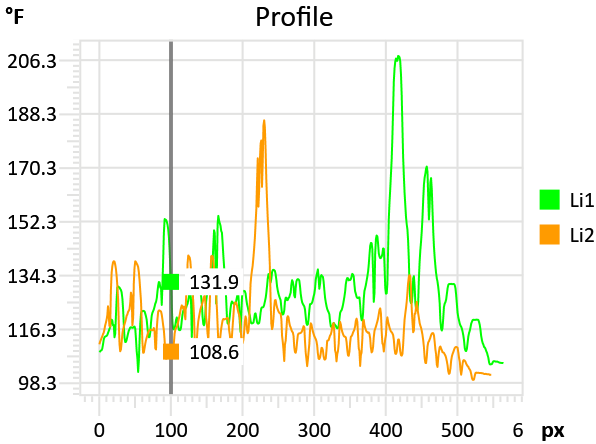
2200 Paint Oven (right side cabinet)

Sp2	170.3 °F
Li1	
Max	207.8 °F
Avg	129.0 °F
Min	102.0 °F
Li2	
Max	186.2 °F
Avg	117.9 °F
Min	99.3 °F
Sp1	175.3 °F

Faulty fuse connections

CLASS II

There appears to be two fuse connection issues here. Inpsct fuse clip/holders for wear and ensure connections are clean and tight.

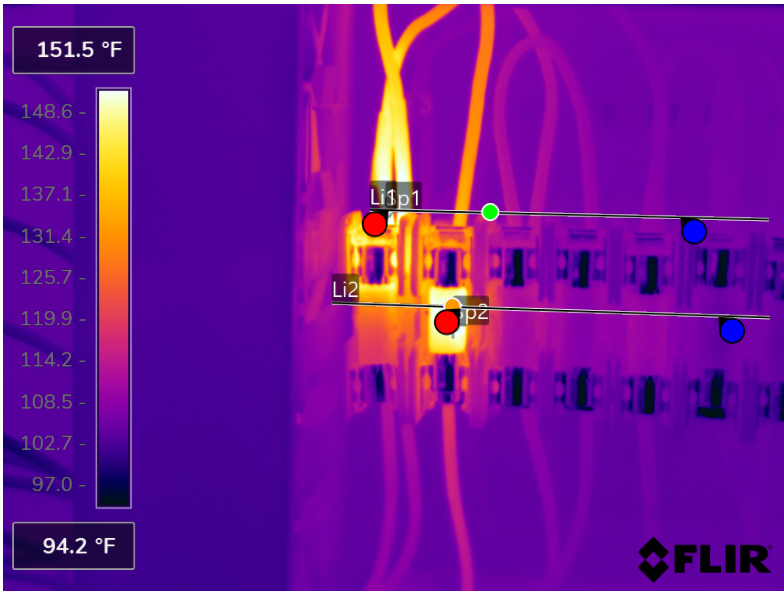
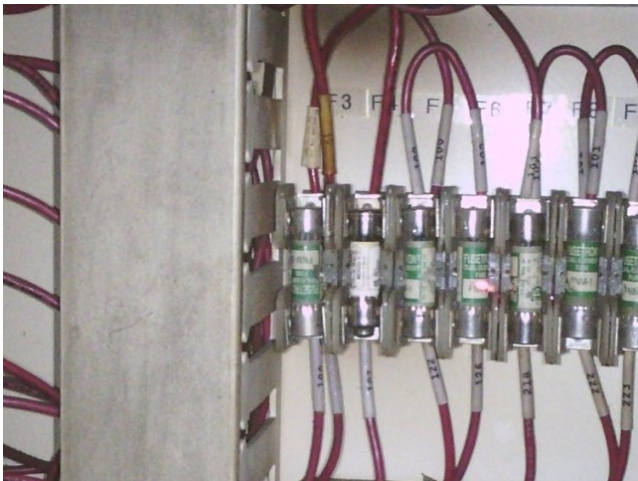
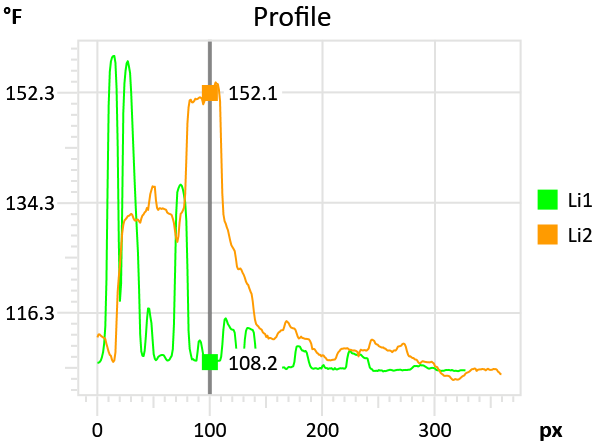
2200 Paint Oven (left Cabinet)

Sp2	151.4 °F
Li1	
Max	158.3 °F
Avg	112.9 °F
Min	106.8 °F
Li2	
Max	154.0 °F
Avg	118.5 °F
Min	105.4 °F
Sp1	158.1 °F

Weak Fuse/faulty fuse connections

CLASS II

IR image shows some issue with the line side connections on the far left side fuse. There also appears to be an issue with the second fuse from the left. Replace this fuse and inspect the line side connections on the far left fuse , ensuring connections are clean and tight.

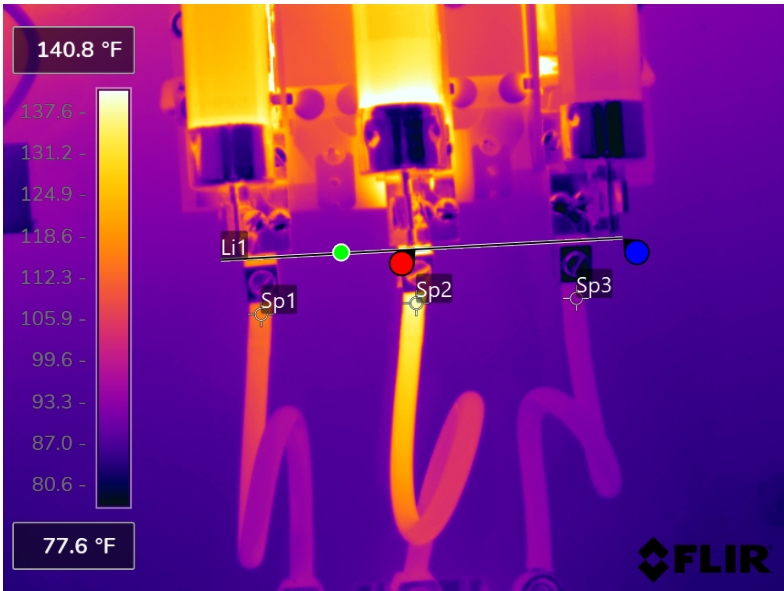
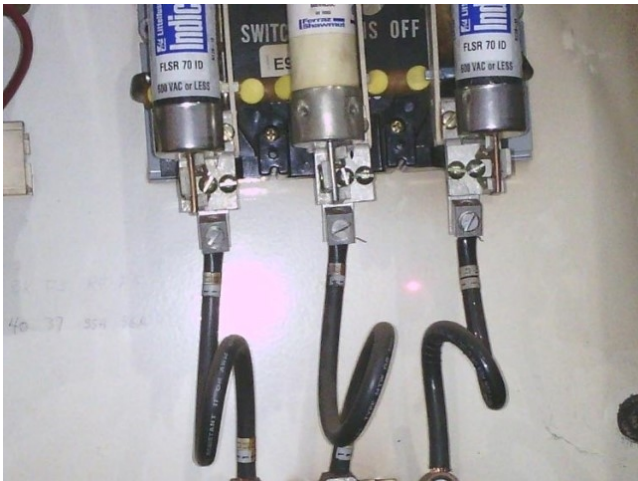
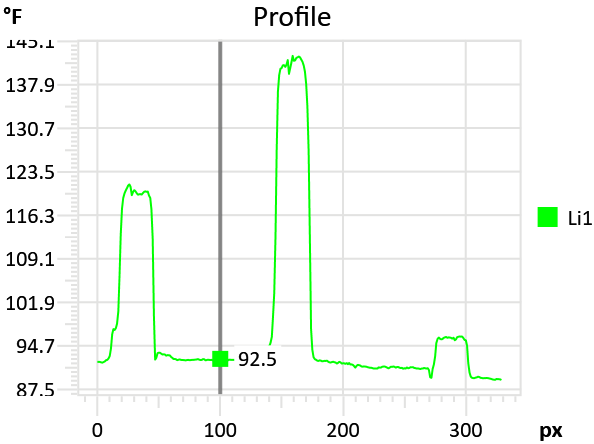
2611

Sp2	138.2 °F
Sp3	94.6 °F
Li1	
Max	142.7 °F
Avg	98.7 °F
Min	89.1 °F
Sp1	116.6 °F

Fuse lead connection issue

CLASS I

IR image shows some issue with the load side connections on the middle fuse. Inspect the load side connections , ensuring connections are clean and tight.

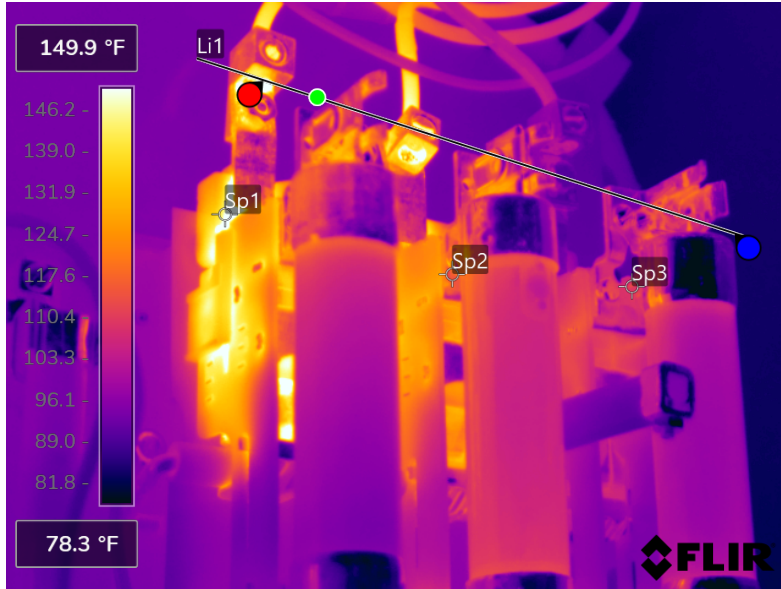
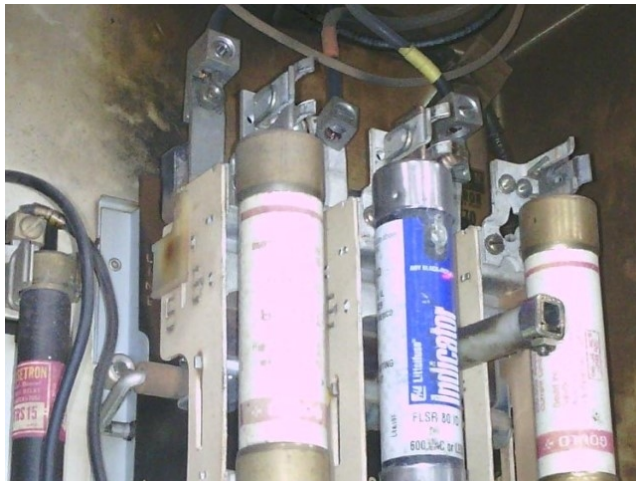
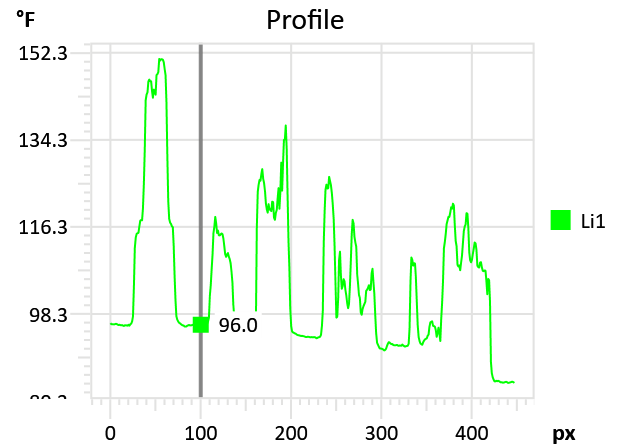
2612

Sp2	119.0 °F
Sp3	114.4 °F
Li1	
Max	151.1 °F
Avg	105.4 °F
Min	84.1 °F
Sp1	151.2 °F

Faulty Fuse Holder/Switch

CLASS II

Image shows some Delta-T behind A phase fuse. This may be due to loose or worn fuse switch components. It is recommended to perform a thorough inspection of the fuse switch/holder mechanism.

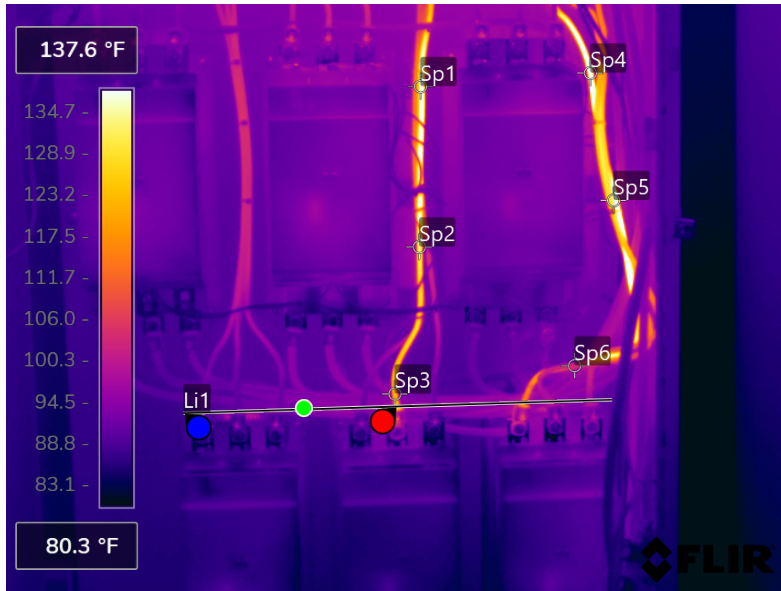
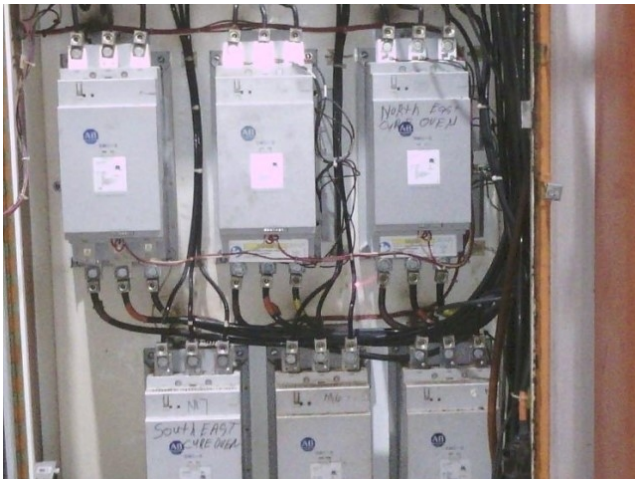
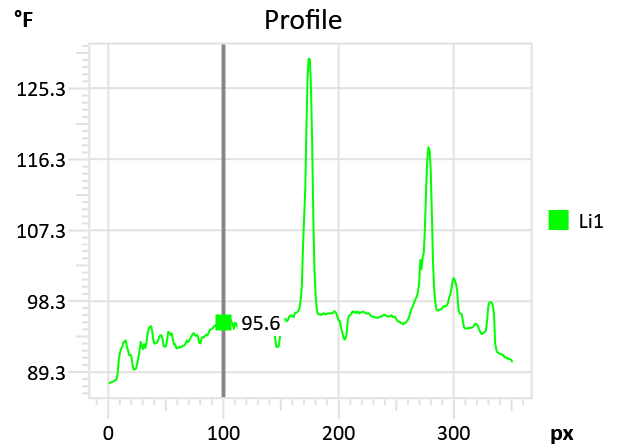
4810 Cure Oven Panel

Li1	
Max	129.0 °F
Avg	96.2 °F
Min	88.0 °F
Sp2	134.6 °F
Sp3	123.6 °F
Sp4	147.7 °F
Sp5	137.0 °F
Sp6	104.7 °F
Sp1	141.1 °F

Load issue and or connection issue

CLASS I

Check lead connections on the leads with the Delta-T as seen in the IR image above. Also check current on each phase ensuring load is balanced.
