DC Repair Report

Arkansas Box

Location: MOTOR SHOP LR
Job Number: 102301
Serial Number: 44596-AL
Status: In For Repair
Description: 30HP ELECTROSTAT DC 2500RPM 327AT

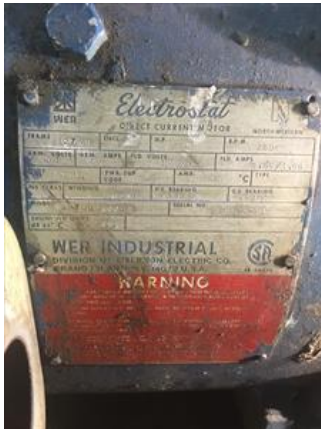
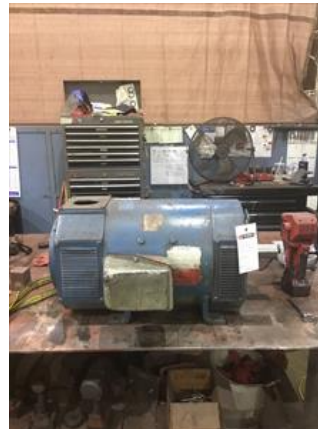
P17

1. Describe the Overall Condition of the Equipment as Received
Serviceable
2. Nameplate Picture

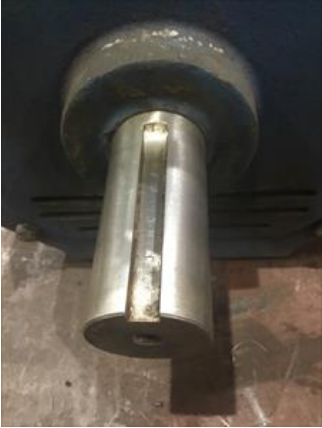
5.	Does Shaft Have Visible Damage?	(No) No	P22

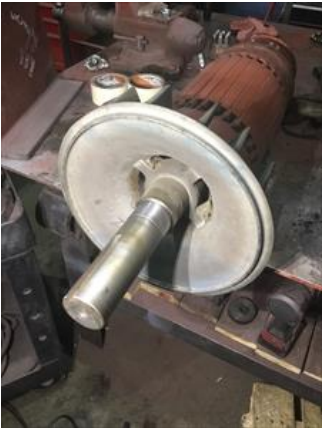
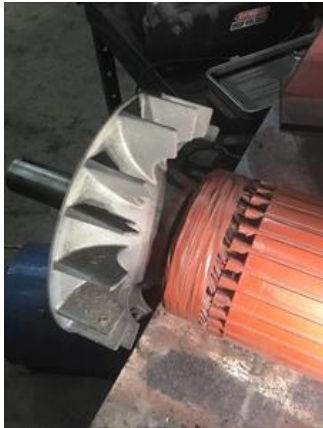
10.	Lead Length	Inches	
11.	Frame Condition	(P) Pass	
12.	Fan Condition	(P) Pass	P81
	Front fan.		
<div>

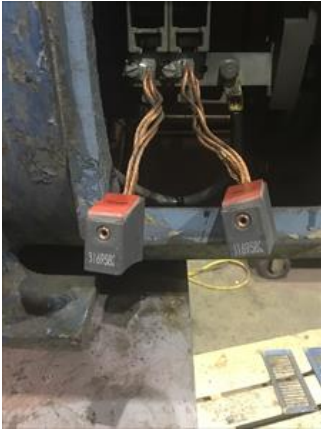
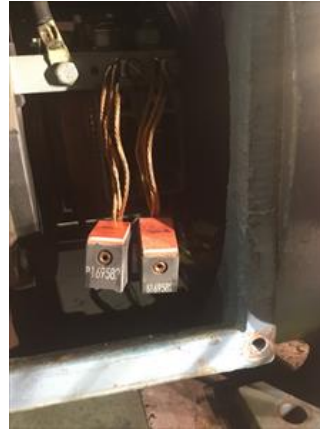
P87

Condition

replace

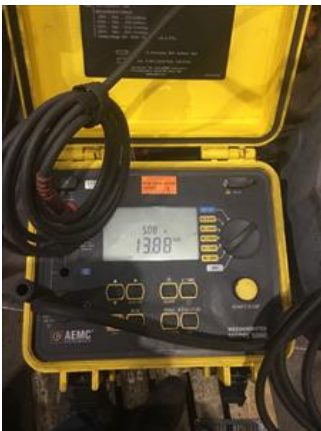
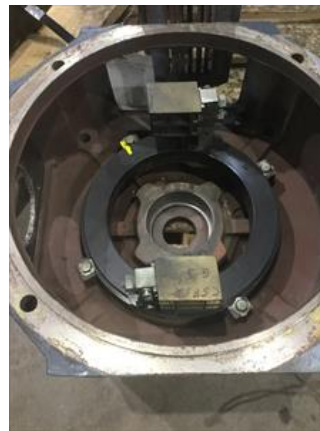
P92

14. Brush Holder Condition - Verify proper gap to Commutator

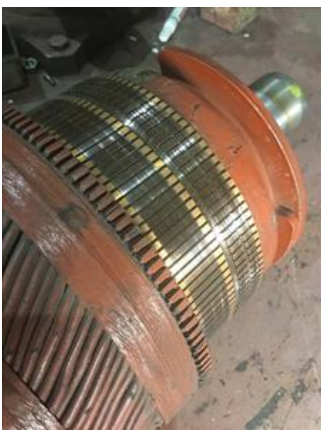
P6

15. General Condition of the Armature/Commutator

worn un-evenly

66.	Failure Locations <i>Both bearings worn from grease contamination. D.E housing fit pitted possibly from minute electrical discharge. Comm is unevenly worn and needs undercut and turned.</i>

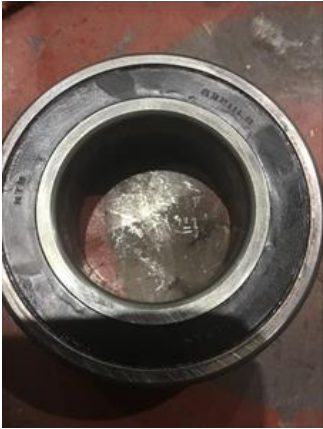
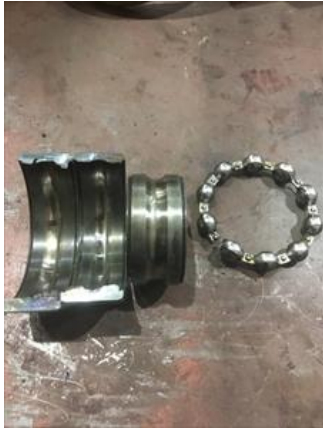
33.	Shaft Runout Drive End	0.001 inches
34.	Shaft Runout Armature	
	Drive End Bearing Journal	Armature Core ODE Bearing Journal
35.	Drive End Bearing Number	NTN 63211 LB P28
	<div style="display: flex; justify-content: space-around;">

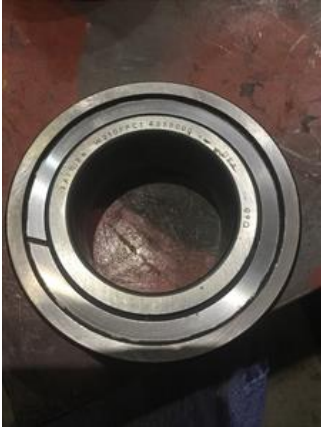
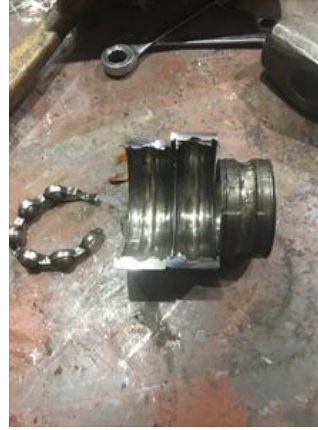
</div>	
36.	Drive End Bearing Quantity	1
37.	Drive End Bearing Type	(Ball) Ball Bearing
38.	Drive End Lubrication Type	(Grease) Grease Lubricated
39.	Drive End Bearing Insulation or Grounding Device?	(NA)
40.	Drive End Wavy Washer/Snap-Ring Other Retention Device?	none
41.	Drive End Bearing Condition	replace

Caused by grease contamination.

50. List Parts Needed Prior to Reassembly
Bearings, sleeve D.E housing fit.

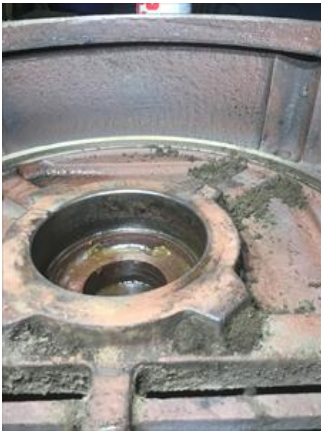
P18

59. Drive End - Endbell Bearing Fit Condition

(F) Fail

Excessive pitting and wear.

D.E housing fit bad
