AC Inspection as Found
Almatis Inc/RCP Bauxite (10014)
4701 Alcoa Road
Bauxite, AR 72011

AC Inspection - Rev. 2

Location: LR Motor Shop

Description: 1.5HP RELIANCE 1800RPM
182TDZ SHAKER

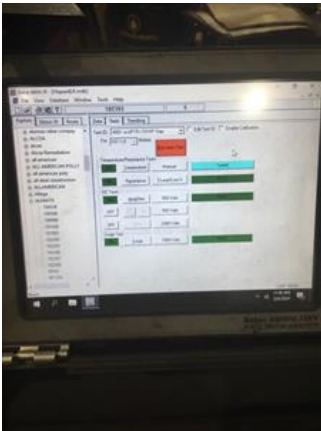
22. Stator Condition

■ *Oil saturation on windings but passed surge test.*

Root Cause of Failure		
66. Failure locations		
	<i>O ring Seals allowed oil to leak into the stator.</i>	
67. Root cause of failure		
	<i>O ring Seals allowed oil to leak into the stator.</i>	
Dynamic Balance Report

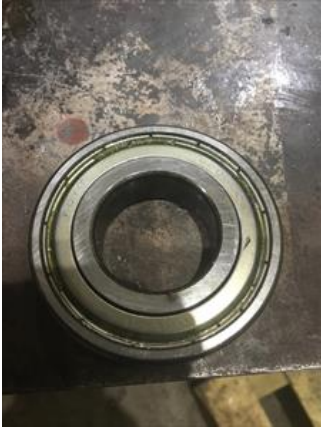
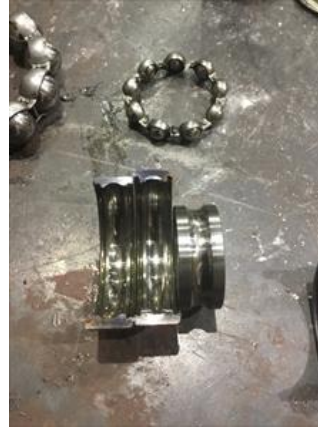
32. Drive End Bearing Condition

replace

<i>Bearings..</i> | |

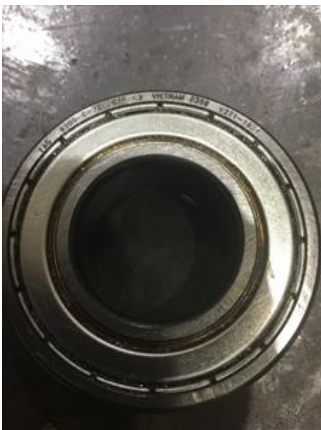
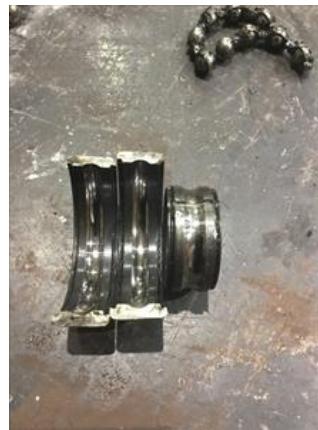
| 40. Opposite Drive End Bearing Condition | replace |
