AC Inspection as Found

FUTURE FUEL CHEMICAL

AC Inspection - Rev. 2

Description: 15/7.5HP 1750/860RPM SIEMENS

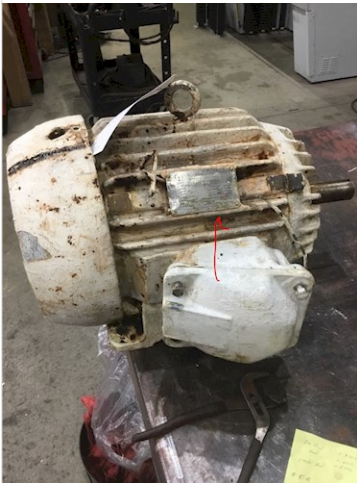
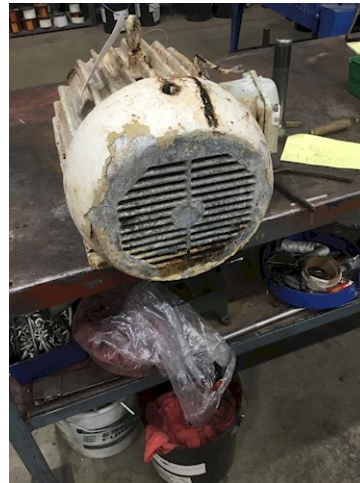
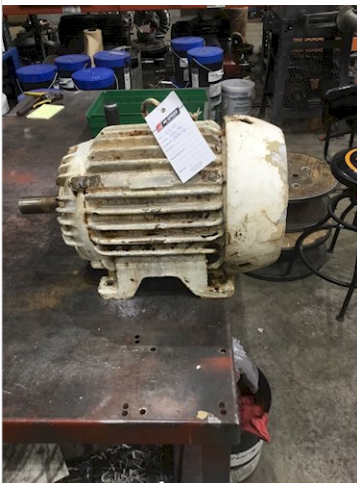
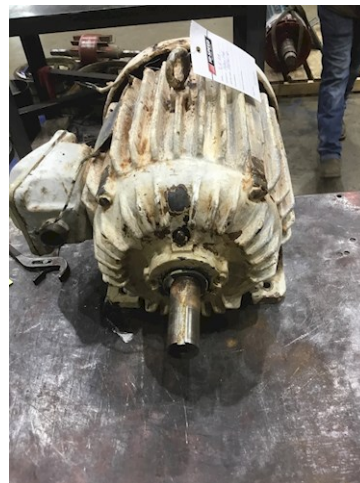
3. Photos of all six sides of the machine.

4. Describe the Overall Condition of the Equipment as Received
Serviceable

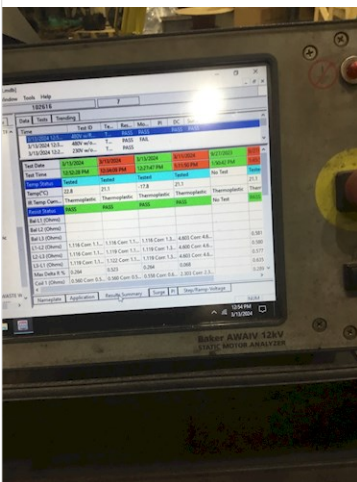
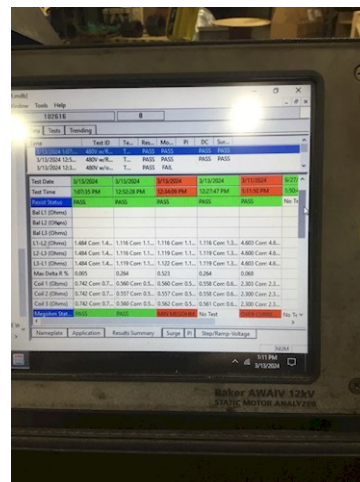
19. Winding Resistance

Pass

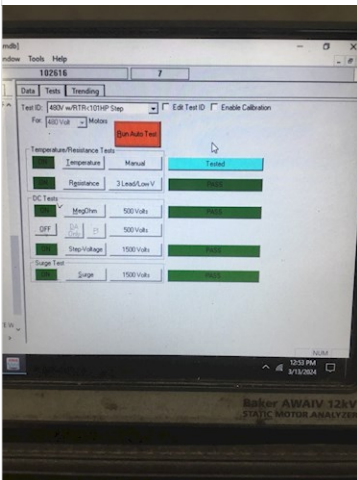
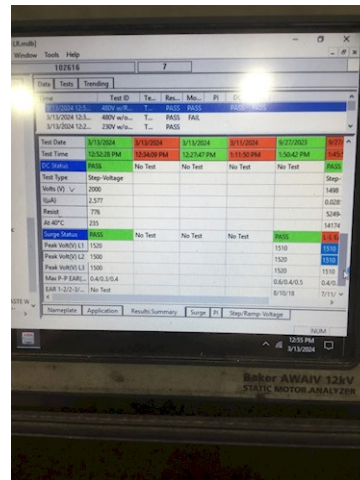
20. Perform Surge Test

(P) Pass

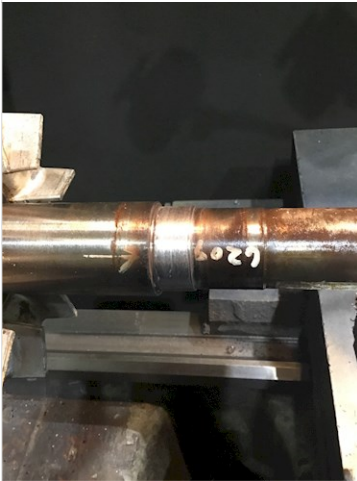
76. Drive End Bearing Shaft Fit Post Repair

53.	Drive End Bearing Shaft Fit		
	0 Degrees	60 Degrees	120 Degrees
	1.7673	1.7662	1.7671
	Worn lip		
54.	Drive End Bearing Shaft Fit Condition (F) Fail		
55.	Opposite Drive End Bearing Shaft Fit		
	0 Degrees	60 Degrees	120 Degrees

Shaft and DE housing fits bad

Contaminated grease in both housings, and DE housing fit out of tolerance. This led to premature bearing failure.

1.7722

1.772

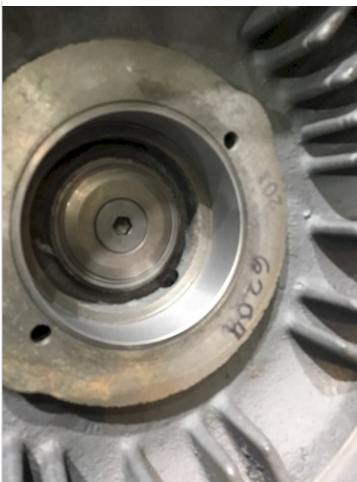
80. Drive End - Endbell Bearing Fit Post Repair

58.	Drive End - Endbell Bearing Fit		
	0 Degrees	60 Degrees	120 Degrees
	Worn lip.		
59.	Drive End - Endbell Bearing Fit Condition (F) Fail		
	Worn lip		
60.	Opposite Drive End - Endbell Bearing Fit		
	0 Degrees	60 Degrees	120 Degrees

3.347
