## AC Inspection as Found

Remington (10243)

### AC Inspection - Rev. 2

Description: 15HP BALDOR 3520RPM

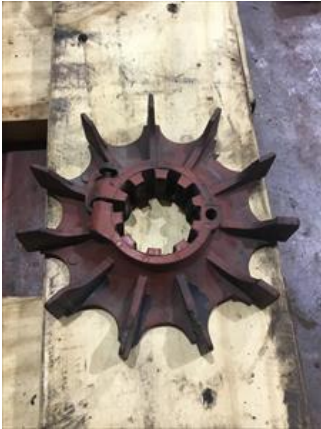
12.	Lead Length	12 Inches	
13.	Does it have Lugs?, If so what is the Stud Size?	(No) No	
14.	Lead Numbers	1-9	
15.	Frame Condition	pass	
16.	Fan Condition	(P) Pass	P115

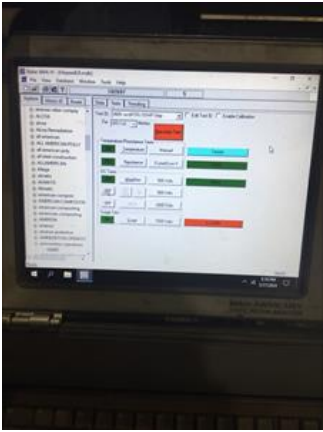
P57

20. Perform Surge Test

(F) Fail

Failed L-L ear. Pulled 17; 16; 16 @ 70 v across all phases.

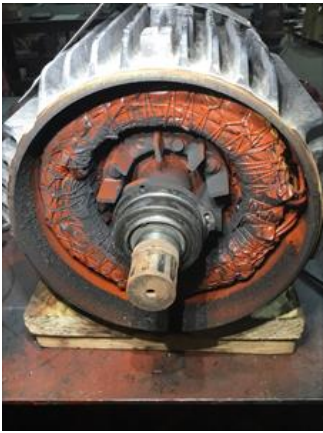
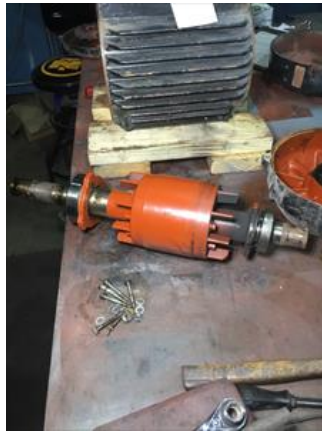
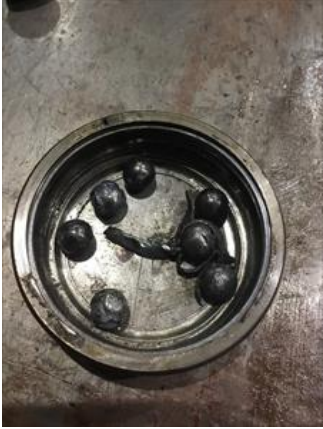
P118

40. Opposite Drive End Bearing Condition

cage failure

*Contaminated grease in both housings caused premature catastrophic bearing cage failure on the opposite drive end.*

52.	Growler Test		(Pass) Pass
53.	Number of Rotor Bars		28
54.	Rotor Condition		pass
55.	List the Parts needed for the Repair Below <i>Sleeve ODE housing fit. Replace bearings and DE housing seal.</i>

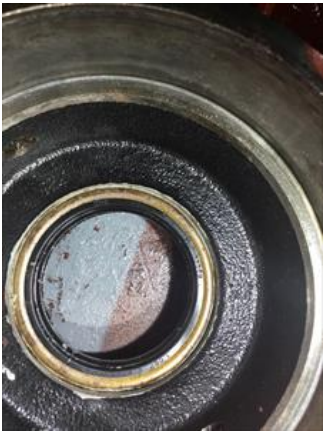
P120

41. Drive End Seal

Cho: 13369 -  
1.087\*2.275\*0.313

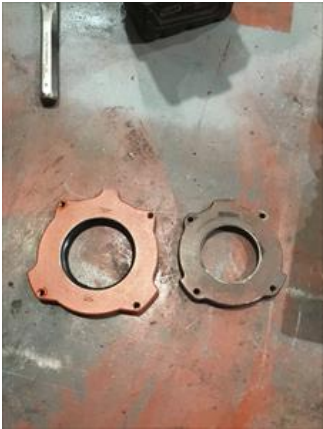
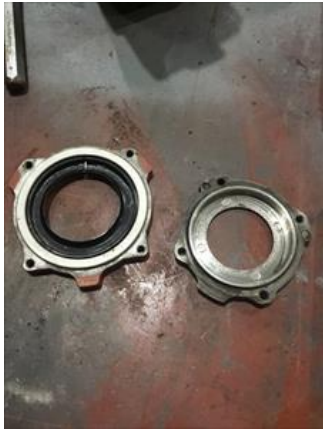
66.	Drive End - Endbell Bearing Fit		
	0 Degrees	60 Degrees	120 Degrees
	3.9377	3.9378	3.9379
67.	Drive End - Endbell Bearing Fit Condition		(P) Pass
68.	Opposite Drive End - Endbell Bearing Fit		
	0 Degrees	60 Degrees	120 Degrees
<div> <div></div> <div>Bad due to excessive wear from catastrophic bearing failure.</div> </div>

69.	Opposite Drive End - Endbell Bearing Fit Condition		(F) Fail
<div> <div></div> <div>Lip worn in.</div> </div>			
70.	Bearing Cap Condition		
	Drive End Bearing Cap	Opposite Drive End Bearing Cap	
	pass	pass	
<div> <div>

71.	End Bell Air Seal Fits		
	Drive End Air Seal	Opposite Drive End Air Seal	
<div> <div></div> <div>Good</div> </div>			
72.	List Machine Work Needed Below		
	Sleeve ODE housing fit.

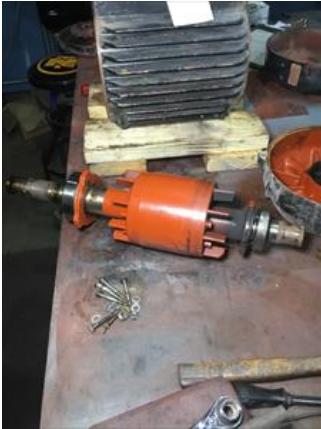
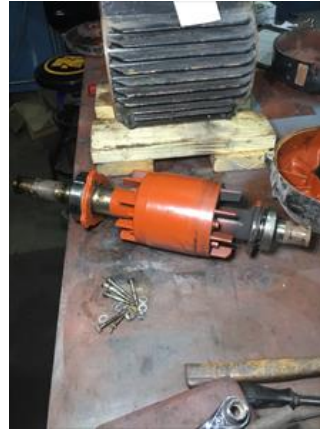
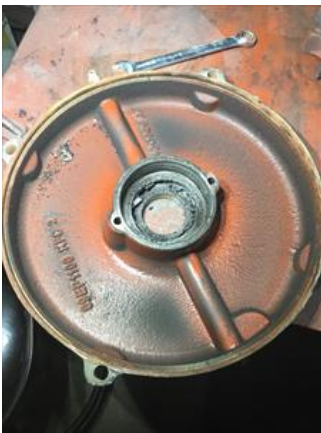
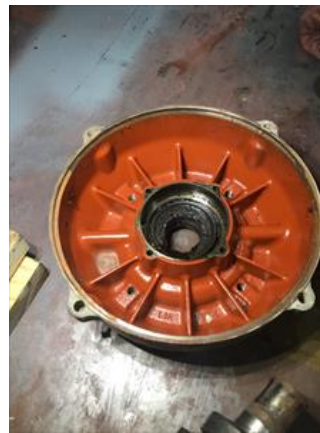
P18

74. Failure locations

*ODE housing fit.*

75. Root cause of failure
