AC Inspection as Found

Remington (10243)

AC Inspection - Rev. 2

Description: 15HP BALDOR 3520RPM

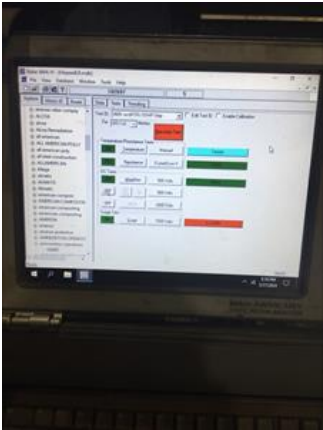
20.

Perform Surge Test

(F) Fail

P57
- Failed L-L ear. Pulled 17; 16; 16 @ 70 v across all phases.

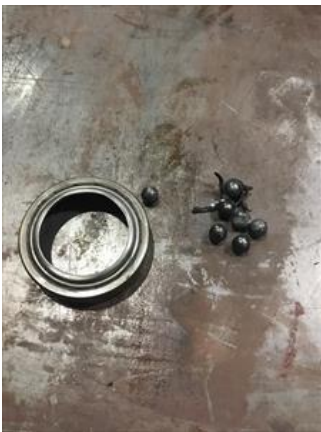
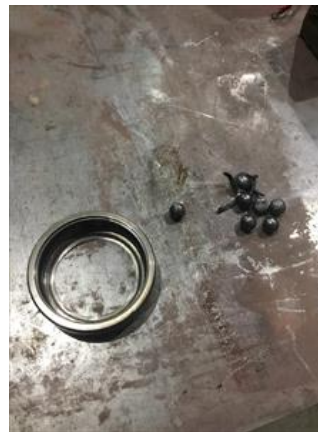
33. Opposite Drive End Bearing Brand

Skf

6208

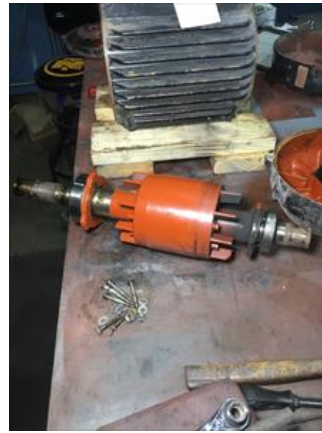
40. Opposite Drive End Bearing Condition

cage failure

Contaminated grease in both housings caused premature catastrophic bearing cage failure on the opposite drive end.

52.	Growler Test (Pass) Pass		
53.	Number of Rotor Bars 28		
54.	Rotor Condition pass		
55.	List the Parts needed for the Repair Below <i>Sleeve ODE housing fit. Replace bearings and DE housing seal.</i>

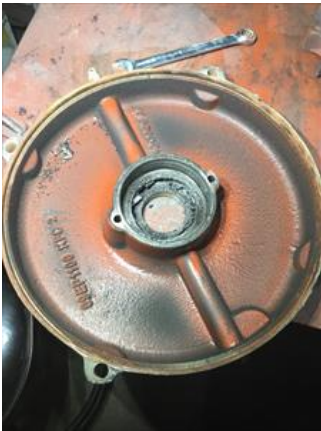
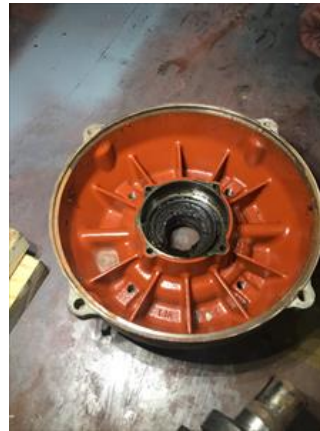
75. Root cause of failure

ODE housing fit.
