AC Inspection as Found

Sage V Foods

AC Inspection - Rev. 2

Description: 10HP PUMP NO N/P

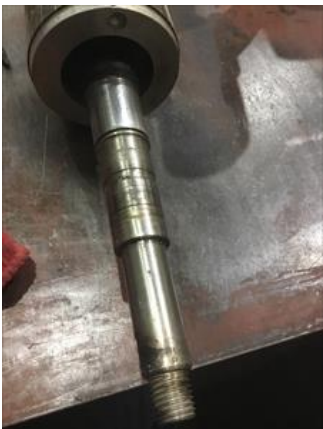
P26

6. Does Shaft Turn Freely? (Y) Yes
7. Does the shaft require T.I.R in Lathe to identify additional repairs? (Yes) Yes
Seal surfaces bad
8. Does Shaft Have Visible Damage? (Yes) Yes
D.E. Seal surfaces bad.

57.	Number of Rotor Bars	27
58.	Rotor Condition	pass
59.	List the Parts needed for the Repair Below <i>Seal and o-ring kit. Repair D.E. Seal surfaces. Re-sleeve D.E and ODE housing fits. Repair ODE shaft bearing journal. Possible rewind due to brittle winding strings in stator housing.</i>

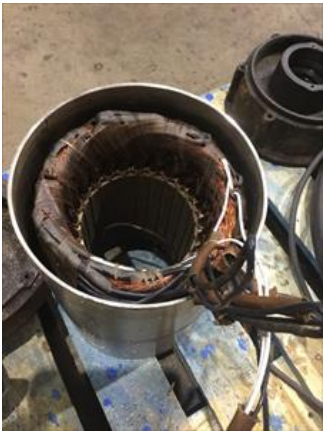
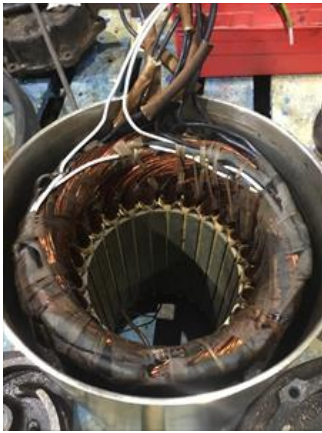
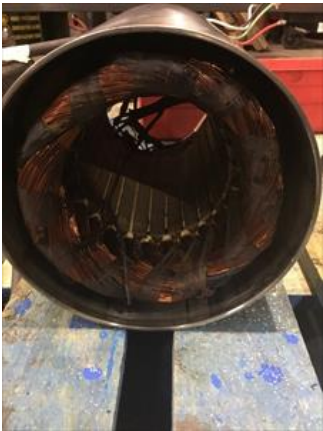
26. Stator Condition P84

Possible rewind due to winding strings being brittle and cracked in multiple places.

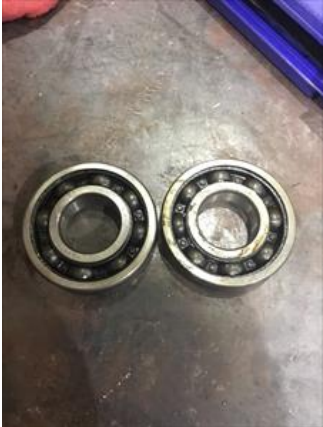
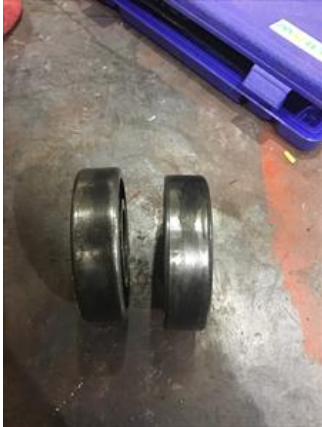
33. Drive End Lubrication Type	(Oil) Oil Lubricated	
34. Drive End Bearing Insulation or Grounding Device?	None	
35. Drive End Wavy Washer/Snap-Ring Other Retention Device?	None	
36. Drive End Bearing Condition	replace	P82

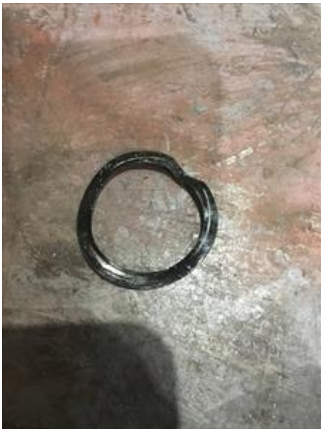
41. Opposite Drive End Lubrication Type	(Oil) Oil Lubricated	
42. Opposite Drive End Bearing Insulation or Grounding Device?	none	
43. Opposite Drive End Wavy Washer/Snap-Ring Other Retention Device?	wavy washer	P114
<div>

<i>Deformed</i> </div>

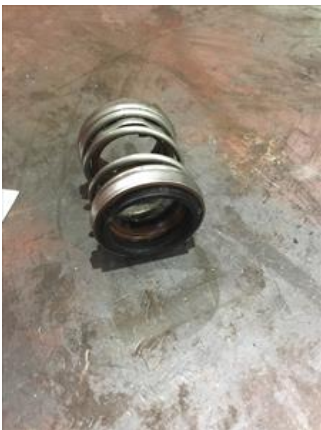
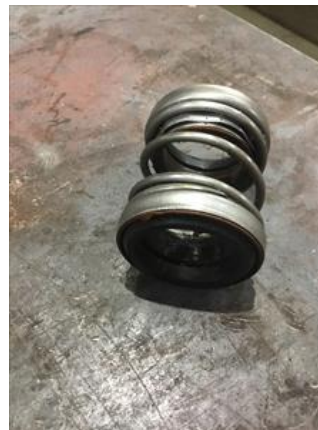
44. Opposite Drive End Bearing Condition	replace	
45. Drive End Seal	replace	
<div>

<i>Proprietary double seal.</i> </div>		
46. Opposite Drive End Seal	na	P123
