AC Inspection as Found

Sage V Foods
5901 SLOAN DRIVE
LITTLE ROCK, AR 72206

AC Inspection - Rev. 2

Description: 10HP PUMP NO N/P

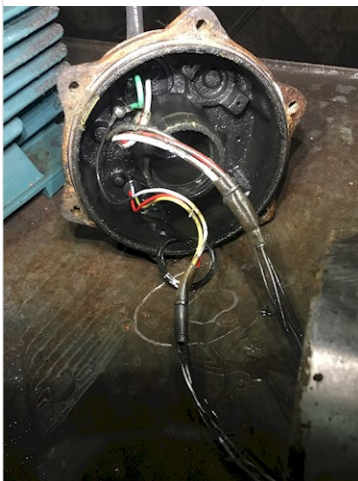
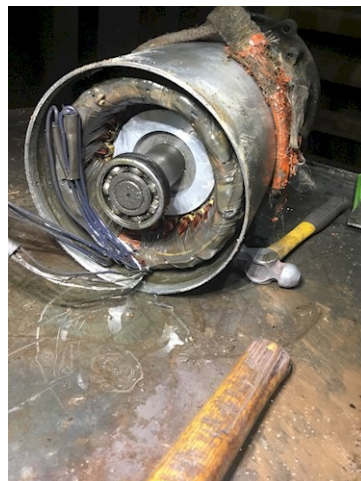
P69

12. Lead Condition

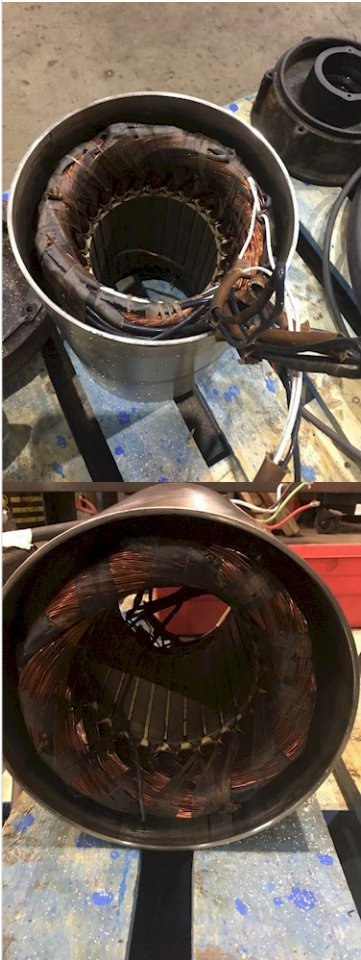
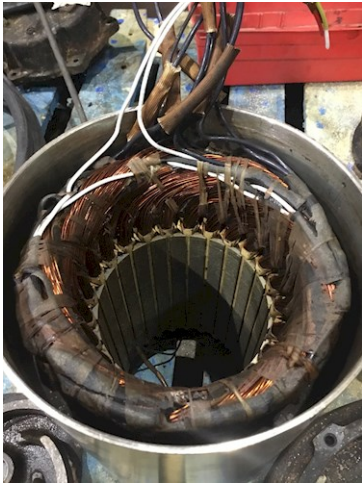
26. Stator Condition P84

Possible rewind due to winding strings being brittle and cracked in multiple places.

78.	Failure locations <i>Both housing fits, ode shaft bearing fit bad and seal surfaces excessively worn. Possible rewind due to brittle and cracked strings on windings.</i>

57.	Number of Rotor Bars	27
58.	Rotor Condition	pass
59.	List the Parts needed for the Repair Below <i>Seal and o-ring kit. Repair D.E. Seal surfaces. Re-sleeve D.E and ODE housing fits. Repair ODE shaft bearing journal. Possible rewind due to brittle winding strings in stator housing.</i>

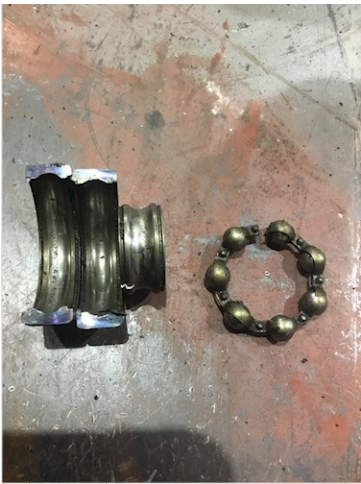
33. Drive End Lubrication Type	(Oil) Oil Lubricated	
34. Drive End Bearing Insulation or Grounding Device?	None	
35. Drive End Wavy Washer/Snap-Ring Other Retention Device?	None	
36. Drive End Bearing Condition	replace	P82

79.	Root cause of failure <i>Seal failure allowed moisture to penetrate the housing and additionally compromise lubrication for both bearings.</i>	
Dynamic Balance Report

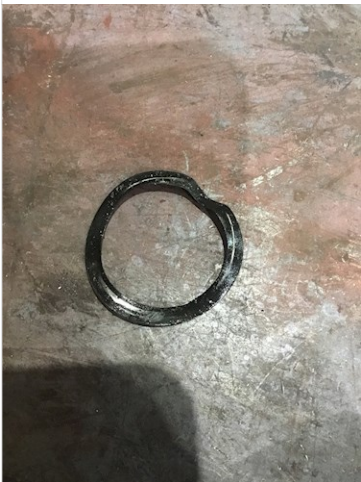
41.	Opposite Drive End Lubrication Type	(Oil) Oil Lubricated	
42.	Opposite Drive End Bearing Insulation or Grounding Device?	none	
43.	Opposite Drive End Wavy Washer/Snap-Ring Other Retention Device?	wavy washer	P114
	Deformed

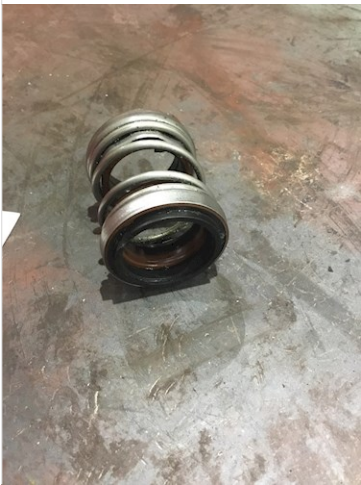
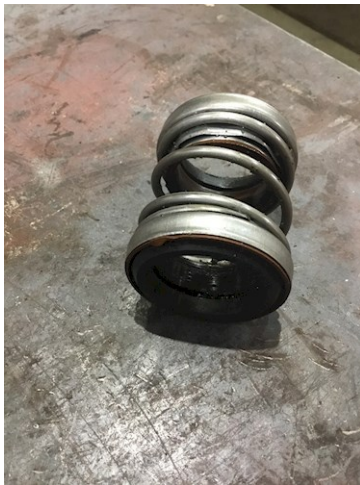
44.	Opposite Drive End Bearing Condition	replace	
45.	Drive End Seal	replace	
	Proprietary double seal.		
46.	Opposite Drive End Seal	na	P123

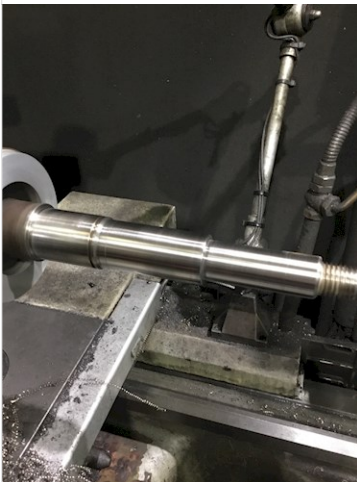
Repaired D.E. Seal surface			
99.	Shaft Repair Sign-off		Gary
Mechanical Fits- Bearing Housings - Post Repair

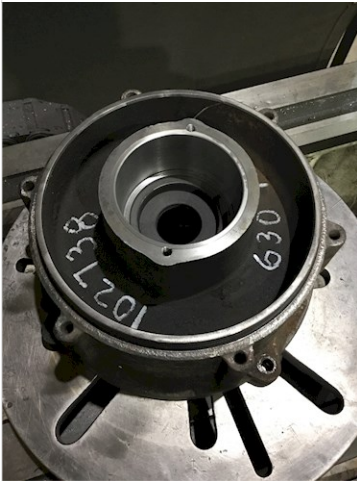
P5

100. Drive End - Endbell Bearing Fit Post Repair

76.	List Machine Work Needed Below <i>Sleeve DE & ODE housings. Repair DE housing fit.</i>	
77.	Technician	Terrence. Holland

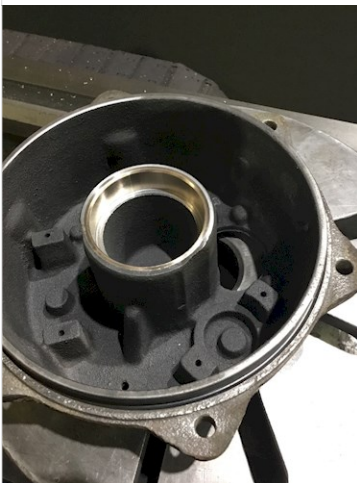
P19

101. Opposite Drive End - Endbell Bearing Fit Post Repair
