AC Inspection as Found

Location: MOTOR SHOP LR

Serial Number: A2104132051

Description: 150HP BALDOR 1190RPM

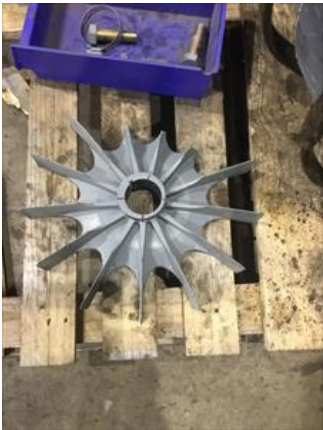
12. Lead Length	35 Inches	
13. Does it have Lugs?, If so what is the Stud Size?	(No) No	
14. Lead Numbers	1,2,3	
  2 of each.		
15. Frame Condition	pass	
16. Fan Condition	(F) Fail	P115

3 ea. blades broken.

Fan blade needs replaced.

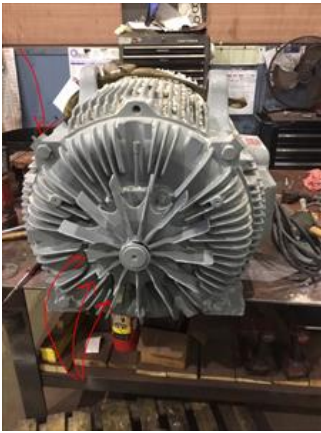
17. Broken or Missing Components	broken bolt on ode housing needs drill and tap.	P122

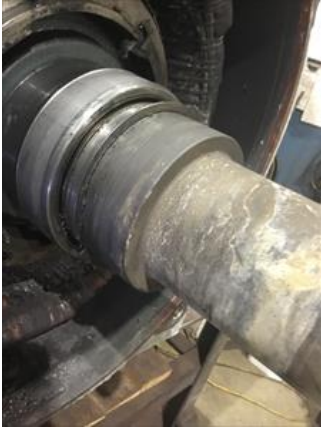
32. Drive End Bearing Condition

replace

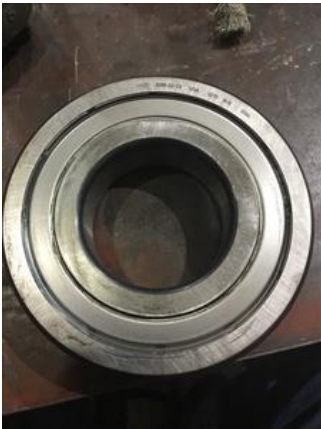
40. Opposite Drive End Bearing Condition

replace

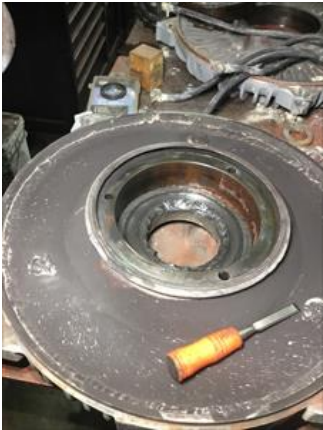
Excessive pitting and wear.

Sleeve both housing fits.

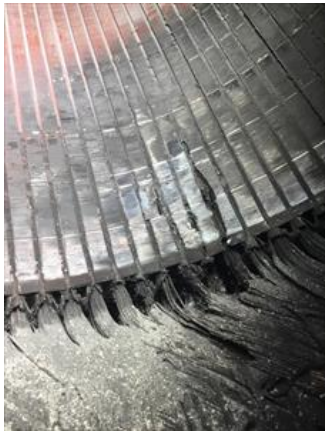
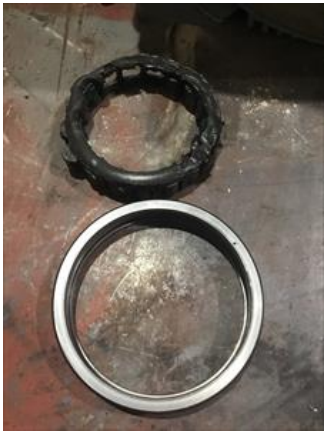
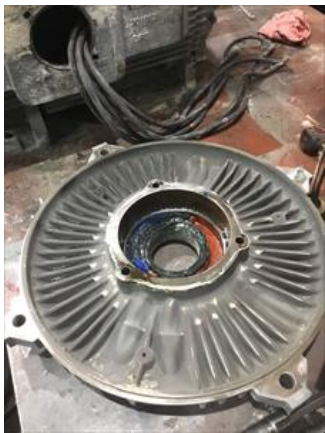
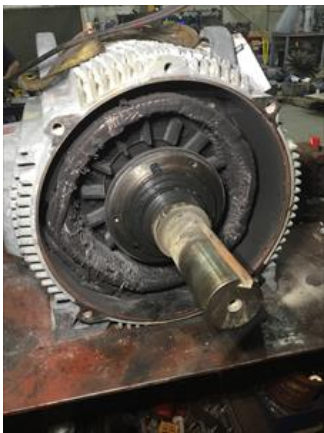
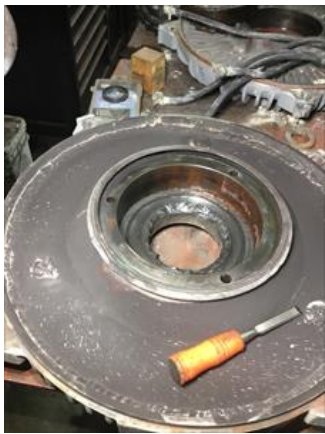
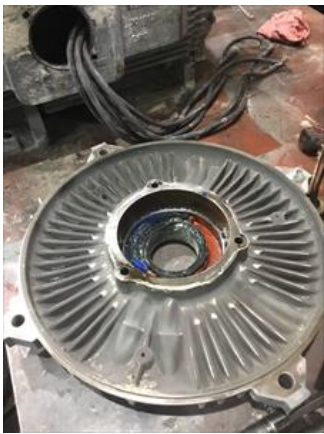
66. Failure locations

NU, D.E. bearing suffered catastrophic failure from contaminated hardened grease. This caused the rotor to drop onto the stator core and windings resulting in shorted windings and a damaged core. Both housing fits show excessive wear and requires re-sleeve.

Contaminated hardened grease, resulting in premature DE bearing failure.

47. List the Parts needed for the Repair Below	<i>Replace bearings, rewind stator. Stator core requires core test due to damage from rotor drop. Fan blade has 3 broken blades. Re-sleeve both housing fits.</i>
