AC Inspection as Found

acme brick

AC Inspection - Rev. 2

Location: MOTOR SHOP LR
Serial Number: Q2-E15T5803GPE 1
Description: 150HP SIEMENS 1190RPM

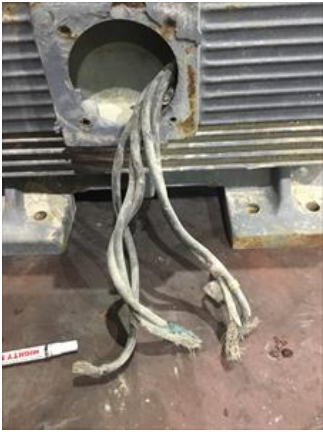
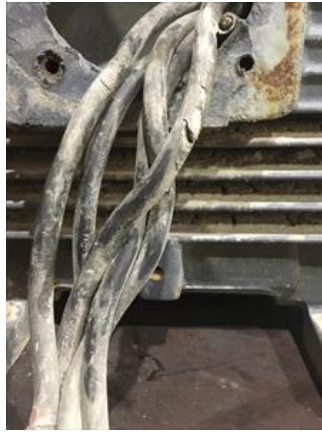
One lead cut very short. Also several leads have insulation cut and showing bare wire.

Motor requires re-lead de to insulation worn and cut on various leads. ODE housing worn and has excessive pitting. Bearing grease was dirty and contaminated.

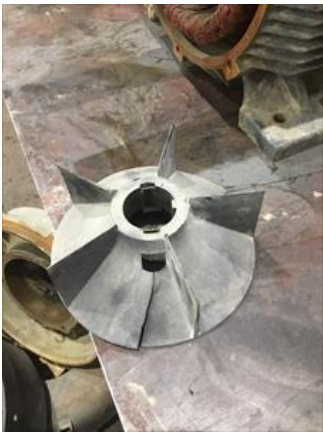
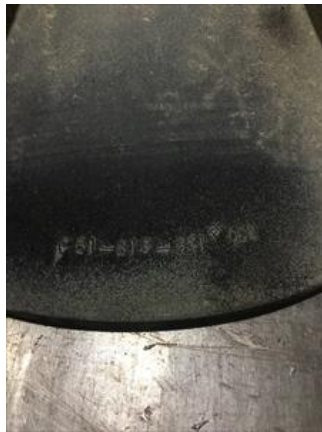
13.	Lead Length	11 Inches
14.	Does it have Lugs?, If so what is the Stud Size?	(No) No
15.	Lead Numbers	1,2,3
	6 leads	
16.	Stator Temperature Detector Rating and Function	
	Quantity	Rating
		Quantity Passed
	Na	
17.	Bearing Temperature Detector Rating and Function	
	Quantity	Rating
		Quantity Passed
	Na	
18.	Frame Condition	pass
19.	Fan Condition	(F) Fail
	Cracked

20.	Heater Quantity, Ratings		
	Quantity	Volts/Watts	Pass/Fail
	Na		
21.	Broken or Missing Components		
	All end bell housing mount bolts missing.

49.	Number of Rotor Bars	54
50.	Rotor Condition	pass
51.	List the Parts needed for the Repair Below <i>Sleeve ODE housing fit. Replace all attachment bolts for both housings and bearing caps.</i>

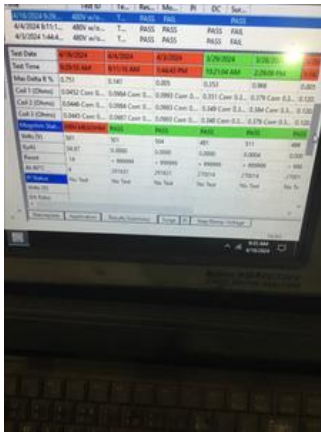
P8

22. Insulation Resistance/Megger

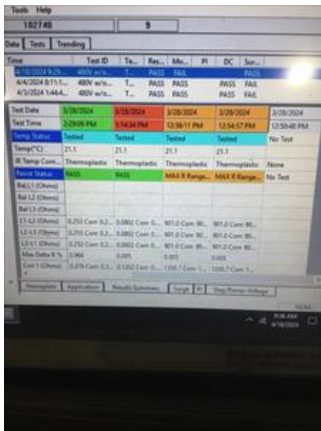
P20

23. Winding Resistance

1-2
0.2531-3
0.2552-3
0.252

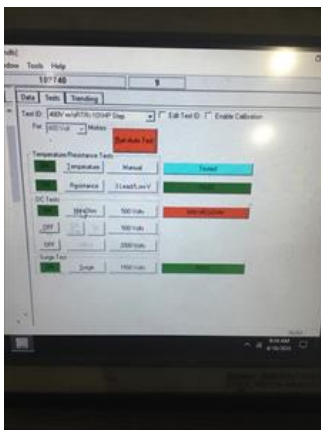
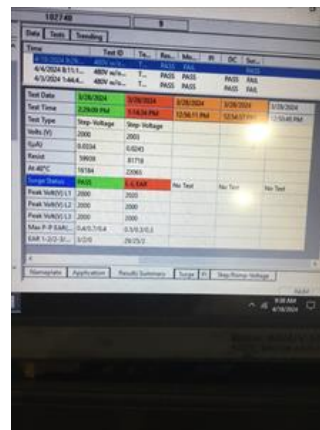
P57

24. Perform Surge Test

(P) Pass

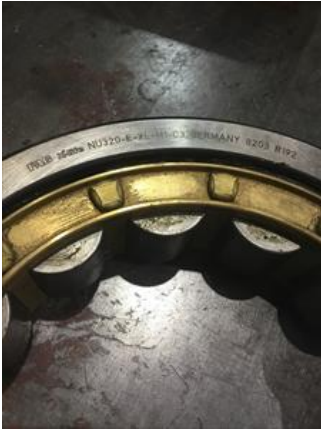
29. Drive End Bearing Brand	FAG	
30. Drive End Bearing Number-	NU 320-E-M1-C3	P32

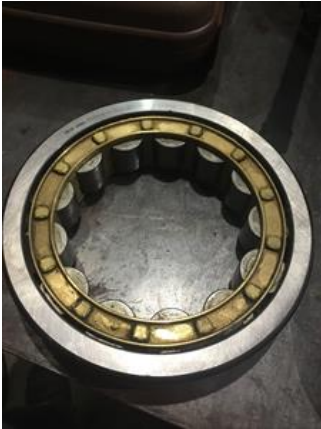
31. Drive End Bearing Qty.	1	
32. Drive End Bearing Type	(Roller) Roller Bearing	P51

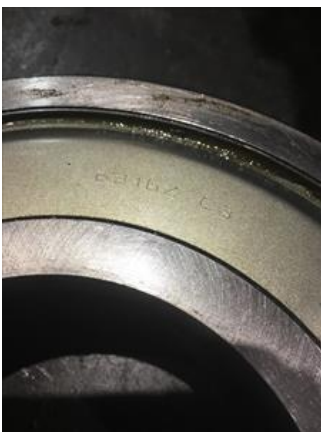
33. Drive End Lubrication Type	(Grease) Grease Lubricated	
34. Drive End Bearing Insulation or Grounding Device?	none	
35. Drive End Wavy Washer/Snap-Ring Other Retention Device?	none	
36. Drive End Bearing Condition	replace	
37. Opposite Drive End Bearing Brand	Nachi	
38. Opposite Drive End Bearing Number-	6316	P99

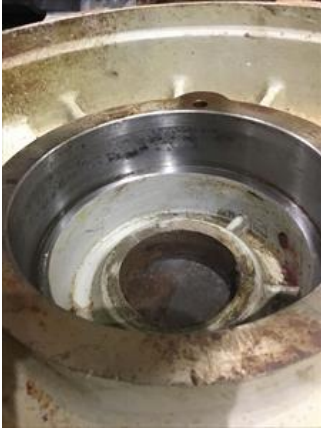
P39

Excessive pitting.

65. Opposite Drive End - Endbell Bearing Fit Condition

(F) Fail

Sleeve ode housing fit.

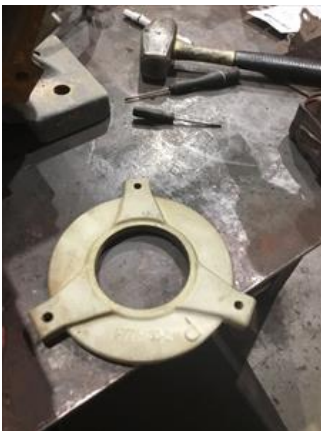
P52

66. Bearing Cap Condition

Opposite Drive End Bearing Cap
pass

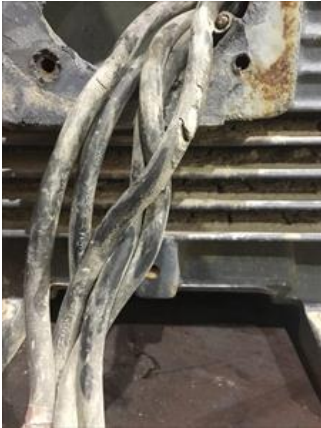
P9

Lead insulation was cut on various leads and one lead was cut very short. Also ODE housing fit is out of tolerance and pitted.
