AC Inspection as Found

Tyson Foods (10914)

AC Inspection - Rev. 2

Description: PUMP

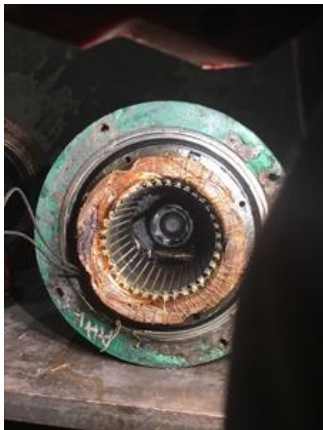
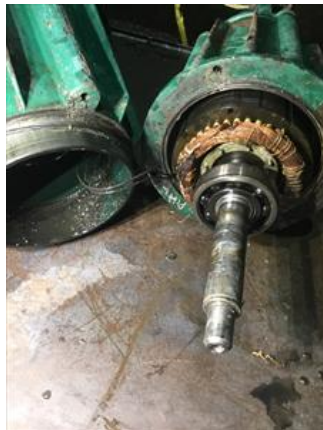
P57

Motor windings shorted in coil.

22.	Number of Stator Slots	36
23.	Stator Condition	rewind
24.	Stator Thermistors/Ohms	na
25.	Stator Overloads/Ohms	0.7
Mechanical Inspection

45.	Growler Test	(Pass) Pass
46.	Number of Rotor Bars	48
47.	Rotor Condition	pass
48.	List the Parts needed for the Repair Below <i>2 ea. carbon ceramic seals # D-1250-352</i> <i>8 ea. stainless steel hex head, seal mount plate bolts. 1/4*20*1/2"</i> <i>Rewind stator & repair shaft seal surface, and DE bearing fit.</i> <i>Replace power & sensor cords.</i>

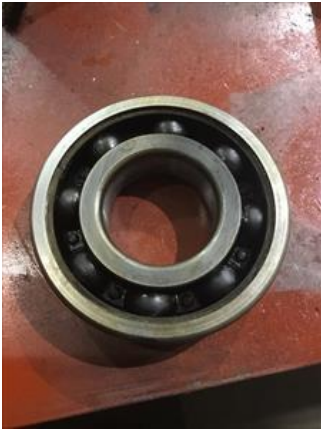
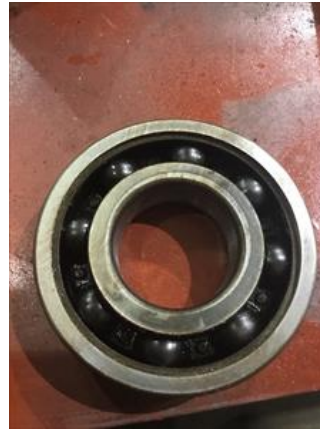
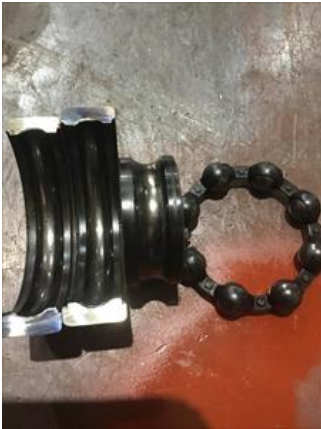
26.	Drive End Bearing Brand	Not listed
27.	Drive End Bearing Number-	6308
28.	Drive End Bearing Qty.	1

33. Drive End Bearing Condition

replace

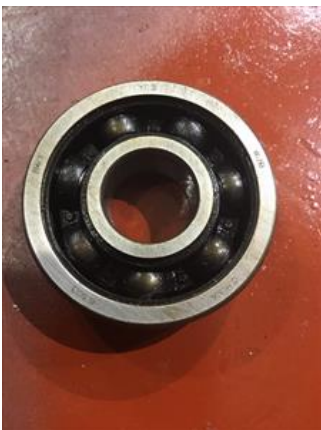
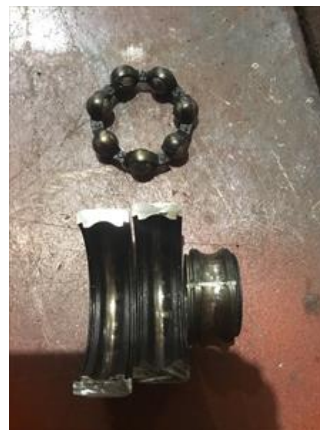
P99

41.	Opposite Drive End Bearing Condition	replace
42.	Drive End Seal	carbon ceramic
	#D-1250-352	
43.	Opposite Drive End Seal	carbon ceramic
Rotor Inspection

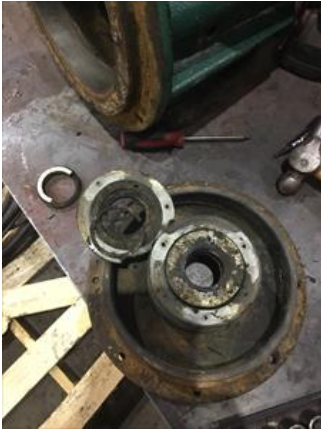
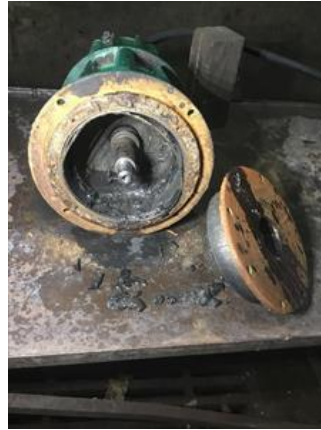
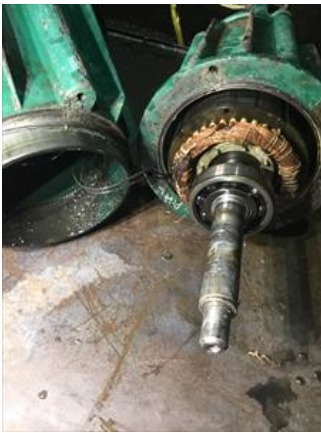
Witness: Trevor Hall		
Root Cause of Failure			
67.	Failure locations		
	Windings, power cord, seals and housing and shaft fit on DE.

Outer seal seat was found to be cracked. This allowed water to enter the stator and cause a short circuit in the stator coils.
