## AC Inspection as Found

Tyson Foods (10914)

### AC Inspection - Rev. 2

Description: 5HP GOULDS PUMP

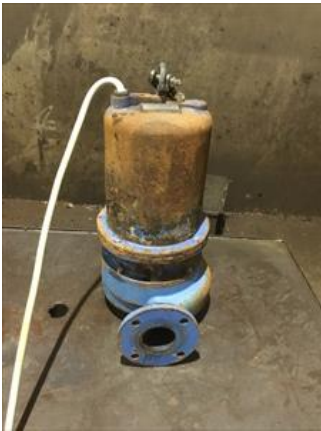
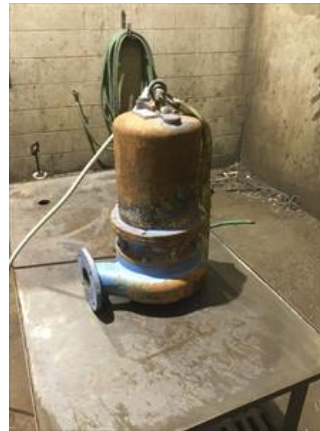
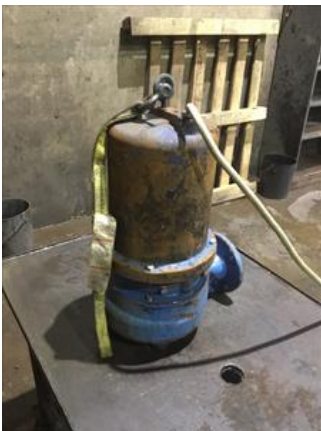
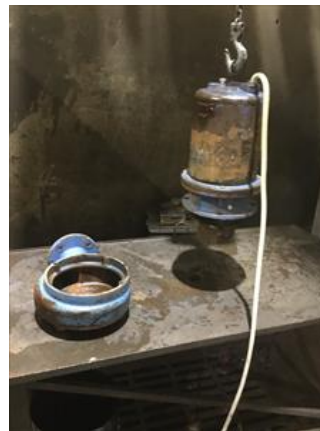
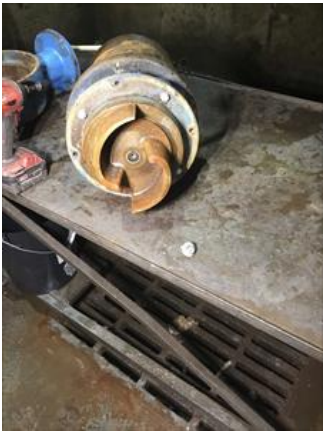
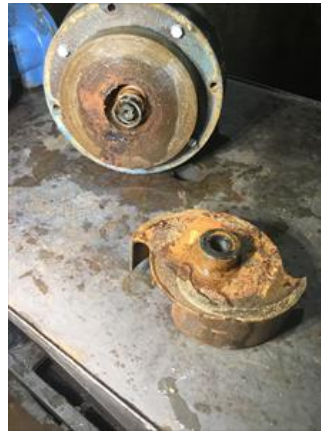
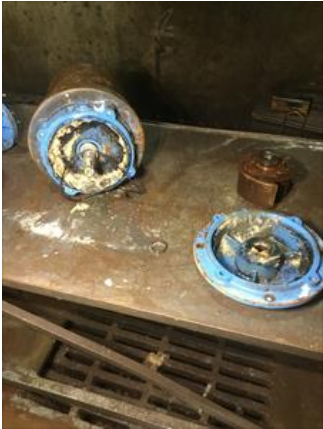
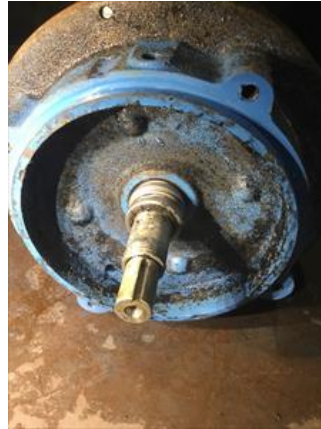
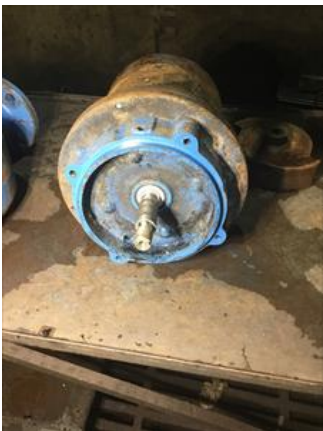
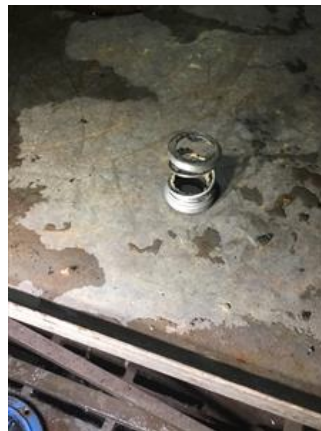
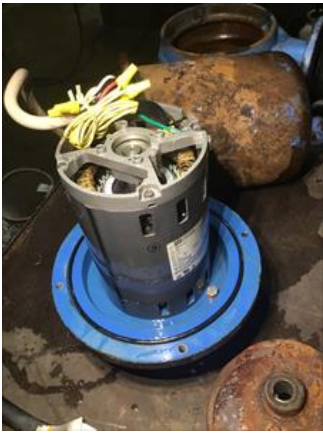
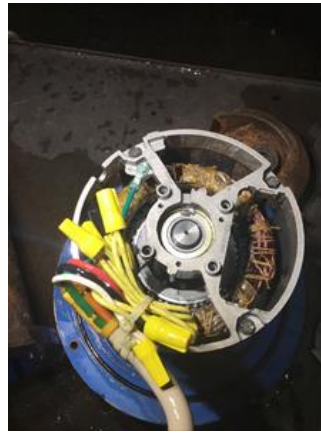
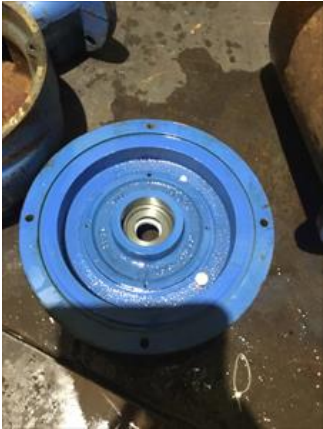
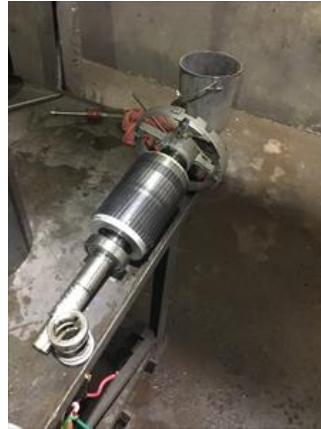
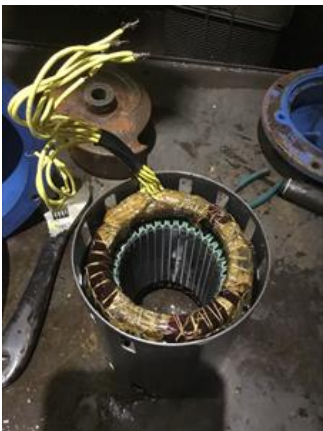
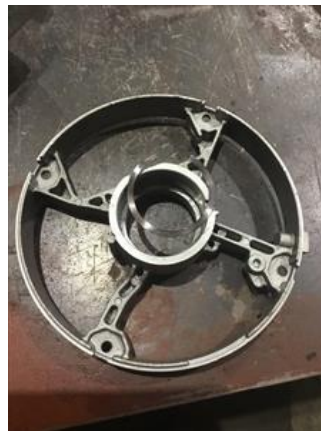
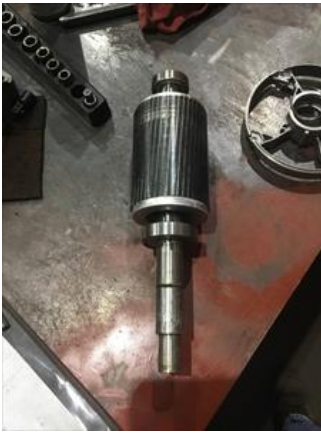
3. Photos of all six sides of the machine.

4. Describe the Overall Condition of the Equipment as Received  
*Serviceable*

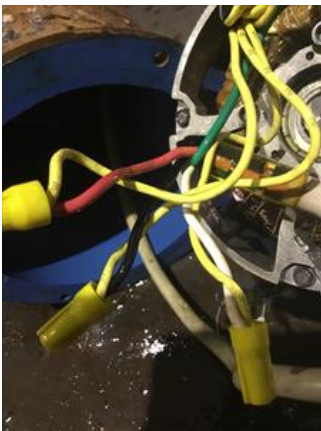
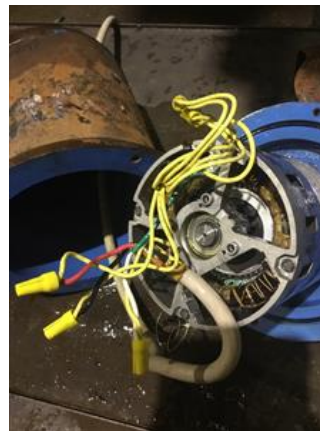
| 11. Lead Condition | (P) Pass |

| 12. Lead Length | 11 Inches |
| Connection is 1)wht, 2)blk 3)red<br>4-7, 5-8, 6-9 | |

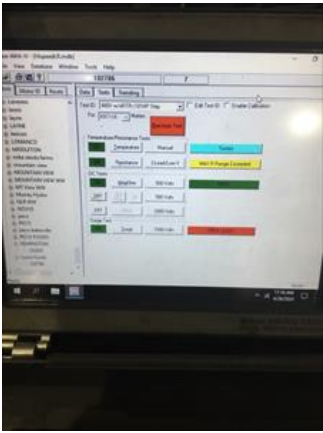
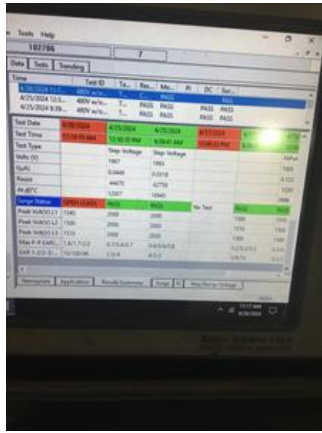
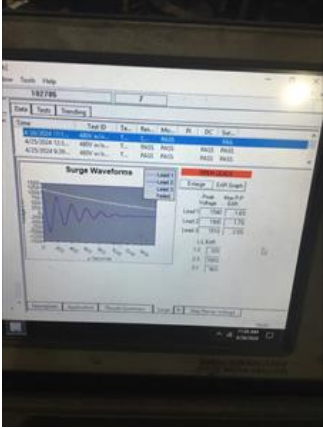
## 20. Perform Surge Test

(F) Fail

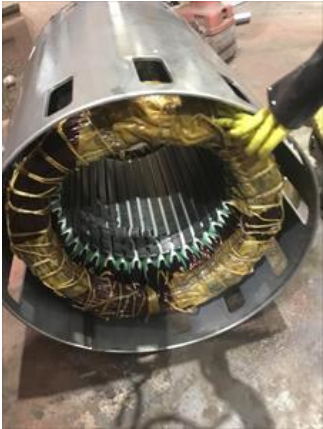
22. Stator Condition

Stator iron core damaged from rotor contact.

<b>Root Cause of Failure</b>			
66.	Failure locations <i>Stator core laminates out of alignment from rotor drop. Rewind required. Rotor shaft bent. Replace seals and O-rings.</i>

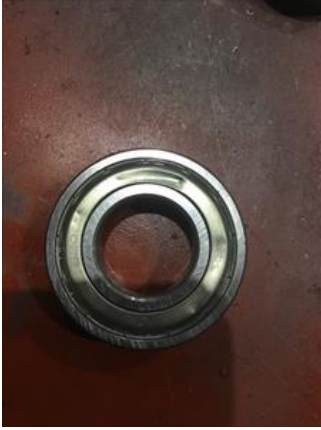
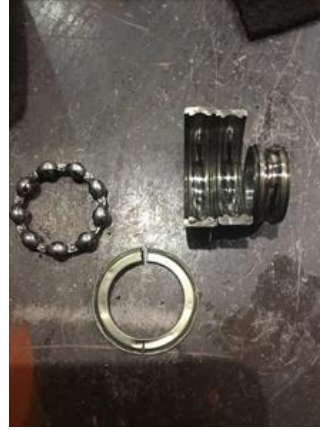
27. Drive End Bearing Qty.	1	
28. Drive End Bearing Type	(Ball) Ball Bearing	
29. Drive End Lubrication Type	(Oil) Oil Lubricated	
30. Drive End Bearing Insulation or Grounding Device?	none	
31. Drive End Wavy Washer/Snap-Ring Other Retention Device?	Na	
32. Drive End Bearing Condition	replace	
33. Opposite Drive End Bearing Brand	C&U	
34. Opposite Drive End Bearing Number-	6204	P99

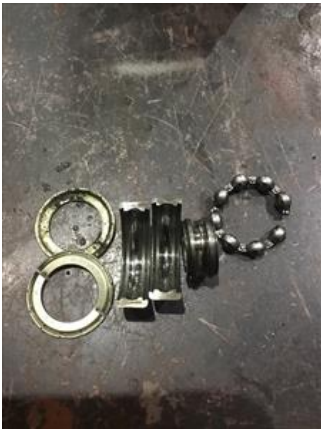
35. Opposite Drive End Bearing Qty.	1	
36. Opposite Drive End Bearing Type	(Ball) Ball Bearing	
37. Opposite Drive End Lubrication Type	(Oil) Oil Lubricated	
38. Opposite Drive End Bearing Insulation or Grounding Device?	none	
39. Opposite Drive End Wavy Washer/Snap-Ring Other Retention Device?	wavy washer	
40. Opposite Drive End Bearing Condition	replace	
41. Drive End Seal	carbon ceramic	
42. Opposite Drive End Seal	carbon ceramic

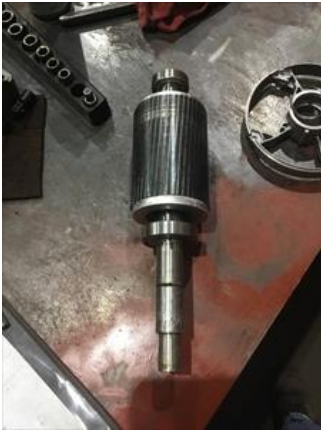
### Rotor Inspection

46. Rotor Condition passed growl test

Shaft bent 1.000

47. List the Parts needed for the Repair Below  
*Bearings, seals, shaft bent. Shaft seal surface needs repair.  
 6206/6204*

63.	End Bell Air Seal Fits		
	Drive End Air Seal	Opposite Drive End Air Seal	
	Na		
64.	List Machine Work Needed Below <i>Shaft bent, and seal surface requires repair.</i>

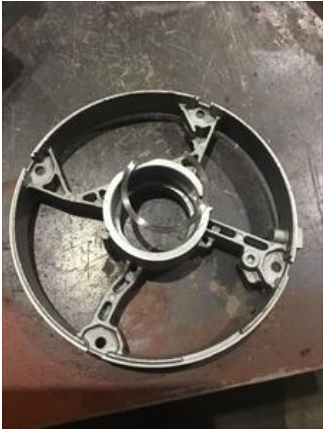
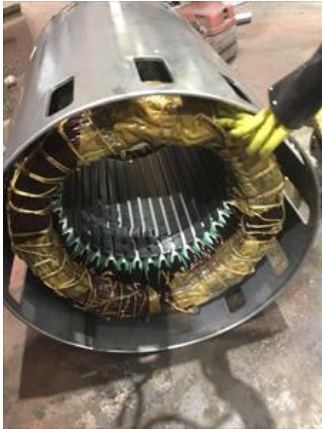
*Outer seal seat was cracked, allowing water to penetrate into the stator. Also the ode wavy washer was broken, and missing pieces found their way into the windings. Additionally the rotor dropped onto the stator core causing the iron to become misaligned.*
