AC Inspection as Found
Arkansas Lime Company
600 Limedale Rd
Batesville, AR 72501

AC Inspection - Rev. 2

Location: LITTLE ROCK MOTOR SHOP
Serial Number: AF943097
Description: 150 HP BALDOR 1780 RPM

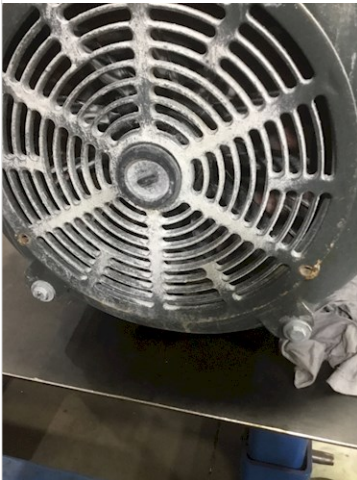
P122

17. Broken or Missing Components

Fan shroud bolts.

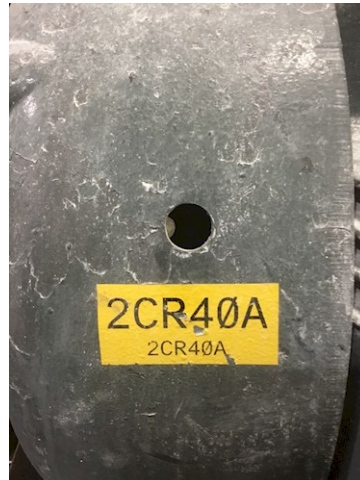
ODE grease fitting not lined up.

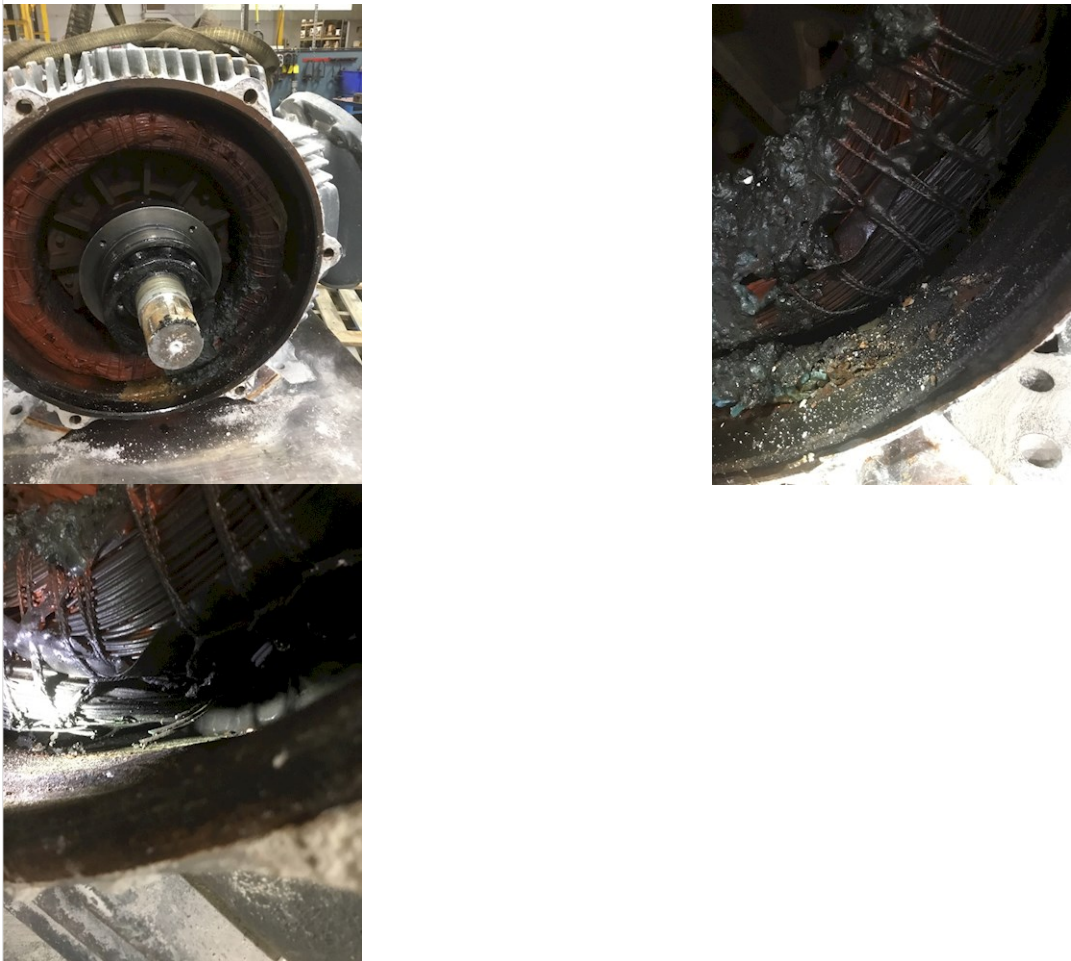
19.	Winding Resistance			
	1-2	1-3	2-3	
	0	0	0	
● 20.	Perform Surge Test		(F) Fail	
21.	Number of Stator Slots		60	
22.	Stator Condition		Requires rewind	P84

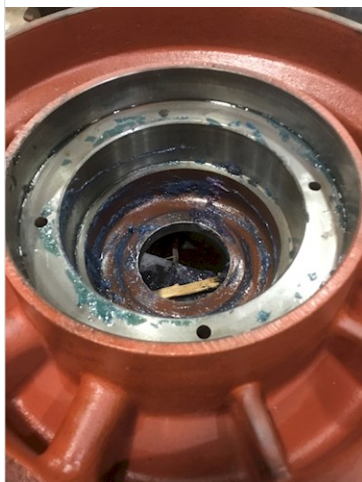
Tolerance is 5.9055-5.9065. Bearing spun and us oversized. Requires bore and bushing installed.

61. Opposite Drive End - Endbell Bearing Fit Condition (F) Fail

Bore and bush opposite drive end end bell

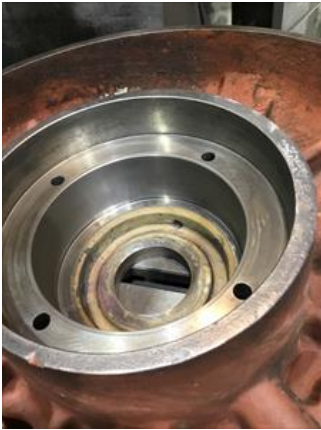
P100

81. Opposite Drive End - Endbell Bearing Fit Post Repair
