AC Inspection as Found

Peco Foods

AC Inspection - Rev. 2

Description: HOWDEN ROTARY BLOWER

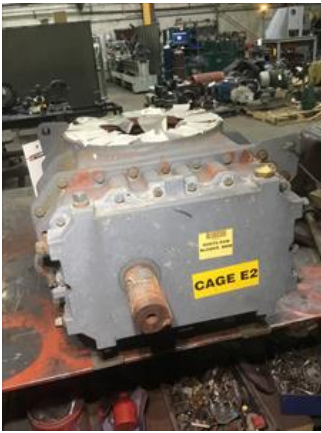
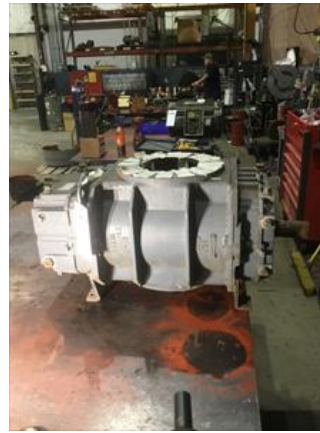
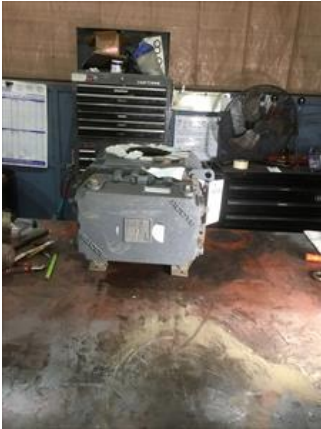
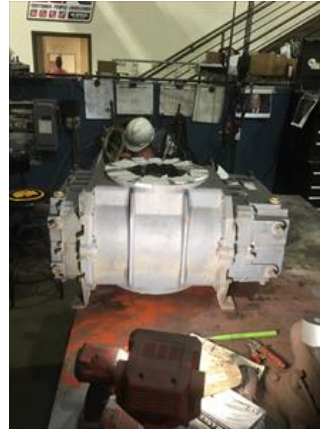
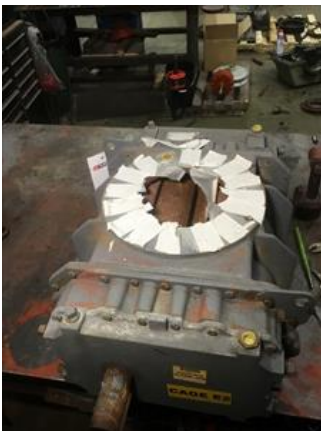
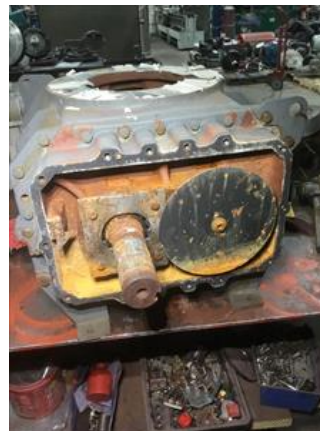
3. Photos of all six sides of the machine.

4.	Describe the Overall Condition of the Equipment as Received <i>Rusted</i>		
5.	Distance from the end of the shaft to the Coupling/Sheave		inches
	<i>Na</i>		
Initial Mechanical/Electrical

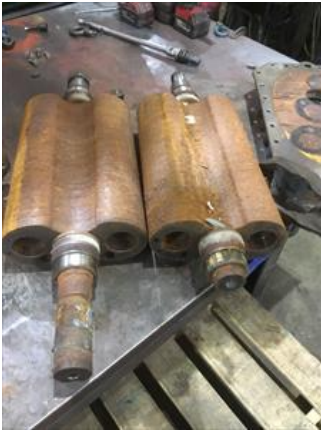
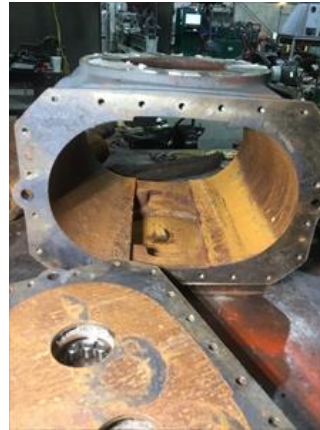
23. Stator Condition

Requires extensive cleaning

rusted

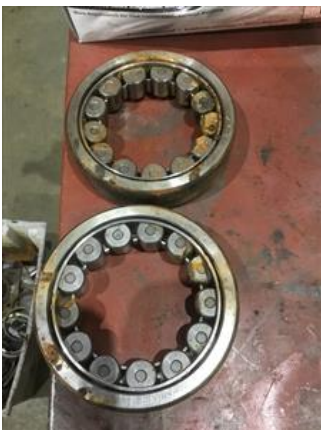
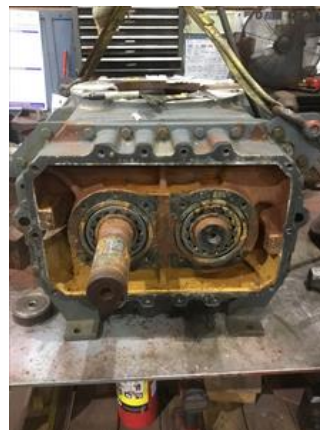
P82

Na
32. Drive End Wavy Washer/Snap-Ring Other Retention Device?	wavy washers
33. Drive End Bearing Condition	rusted

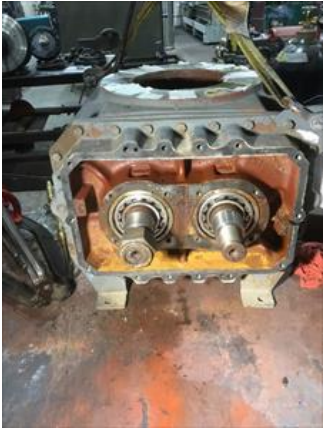
None		
40.	Opposite Drive End Wavy Washer/Snap-Ring Other Retention Device?	wavy washers	
41.	Opposite Drive End Bearing Condition	rusted	P118

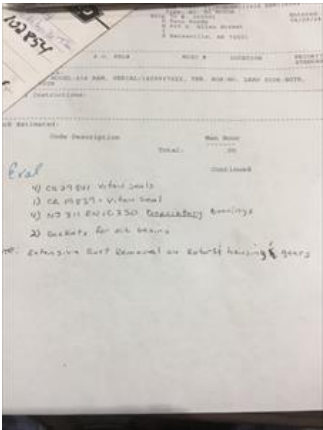
Na		
47.	Rotor Condition	rusted	
48.	List the Parts needed for the Repair Below		P47
	See photo

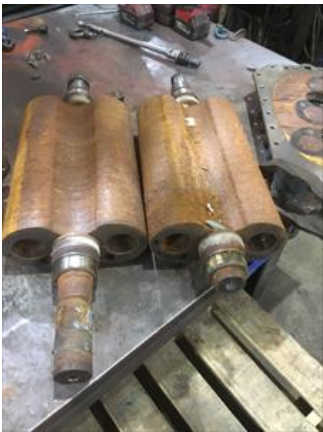
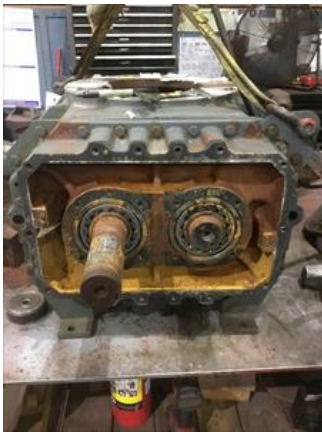
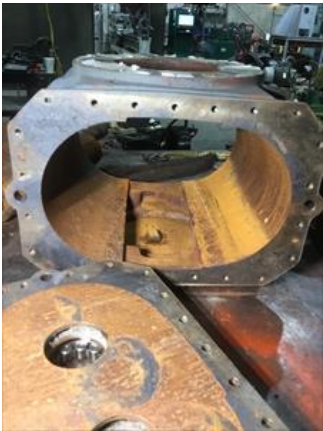
67. Failure locations	
	<i>Bearings, rotors, & housing.</i>

68. Root cause of failure
Entire oil basin on both ends contained nothing but water. Unit is completely coated internally with rust.
